## Coffin Elementary School

### Overview

### Coffin Elementary School

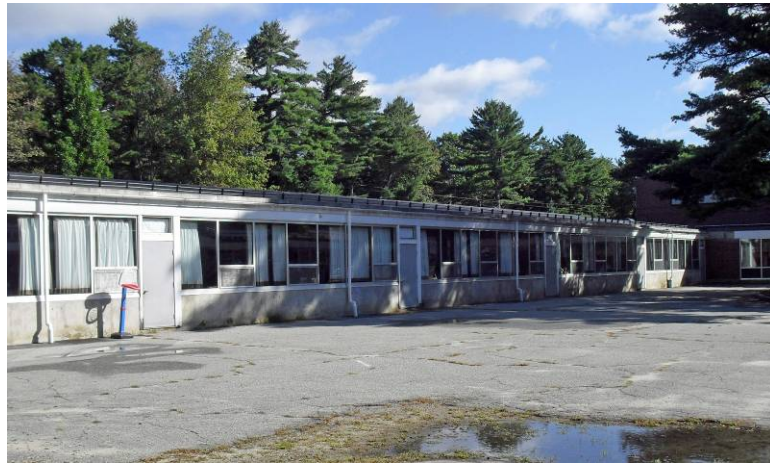
The exterior of the building is a combination of brick veneer and window wall construction. The brick veneer appears to be in sound condition. The window wall is located on the south face of all the classrooms as well as the south and west sides of the cafeteria. Below the window wall system is a concrete stem wall. The classrooms also have a clerestory band of windows on the north side of the rooms. However, some of these windows have been blocked as a result of the ventilation improvements, such as piping and ductwork that were done a few years ago. See photos below.

Typical Classroom  
Windowwall System

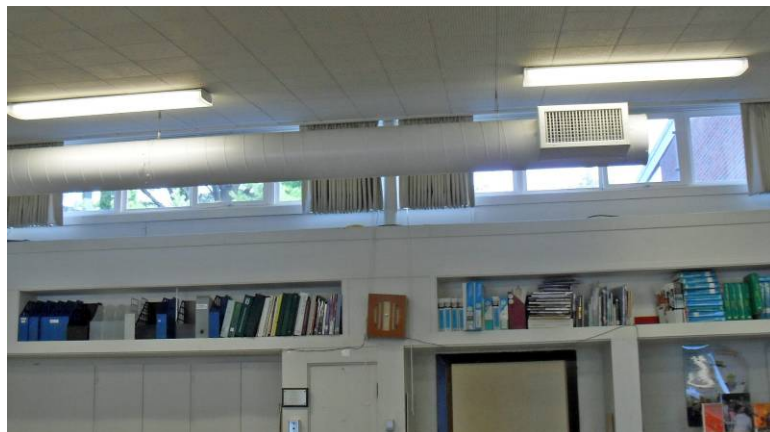
Most all of the administrative and support spaces have a band of higher windows on the north facing wall. See photo on previous page. The corridors connecting the front and rear classroom wings and the cafeteria are also glazed windowwalls. The original windows were wood framed but many have been replaced with aluminum windows with insulating glass within the last 10 years. It does not appear that the clerestory windows have been replaced and should be considered for future replacement.

Typical Classroom  
Clerestory Windows  
blocked by ductwork

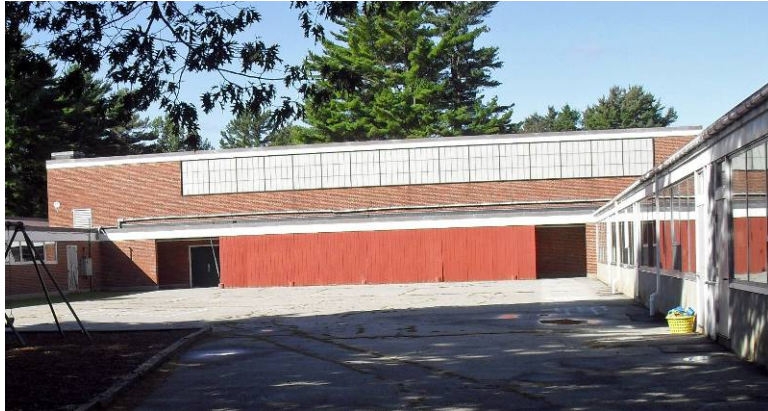
Exterior of Gym  
(Note infill storage with  
plywood siding)

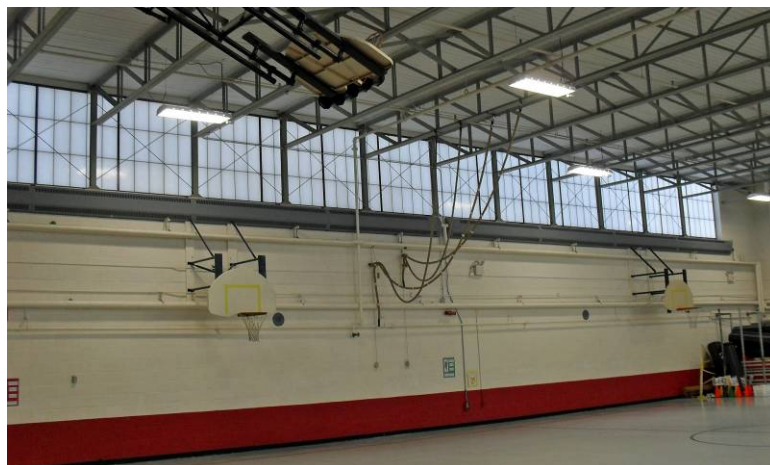
Translucent  
Wall Panels at Gym

The exterior walls of the gymnasium are masonry with translucent wall panels high on the east and west facing walls. These appear to be original to the building and appear to be in good condition.

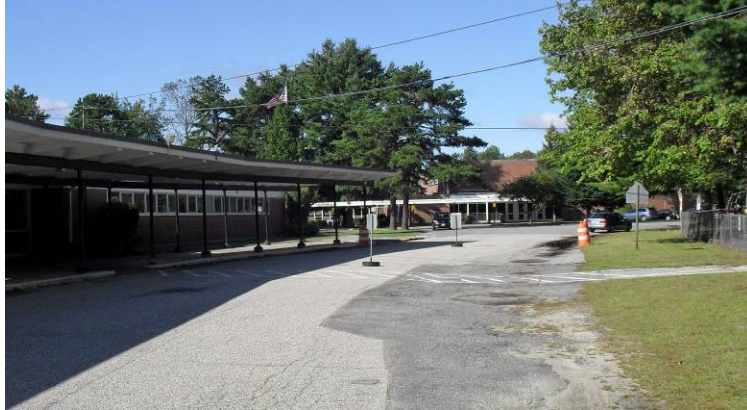
Main driveway  
in front of Coffin School

The main entrance drive is the primary route for the buses to drop off and pick up students for the school. This also serves as a parent vehicle drop-off area, which adds to the traffic congestion twice each day. Separating parent vehicles from the bus drop-off area would improve traffic movement and greatly enhance safety.

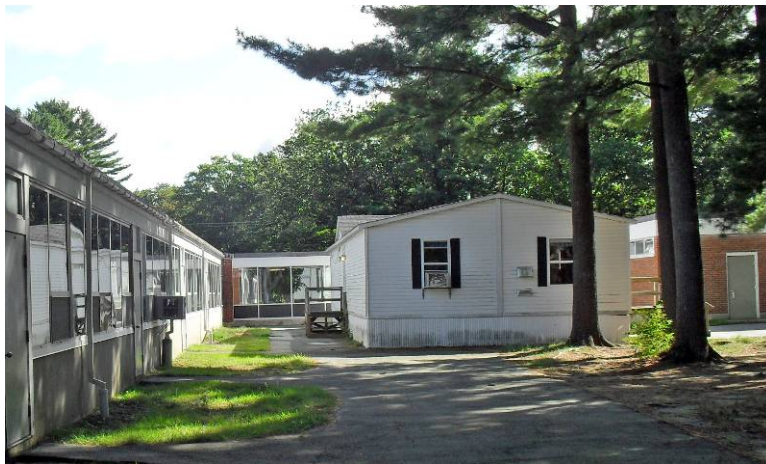
Double Portables  
Adjacent to Classrooms

While the portables have ramps to make them accessible, the fact that students must travel outside the building to get to the portables, limits the accessibility to those programs, particularly during inclement weather and more specifically the winter months.. Eliminating the portables and moving the programs into the main building would solve the accessibility issue.

- § Eliminate all six portables and provide appropriate program space within the building for the programs that are currently located within the portables.

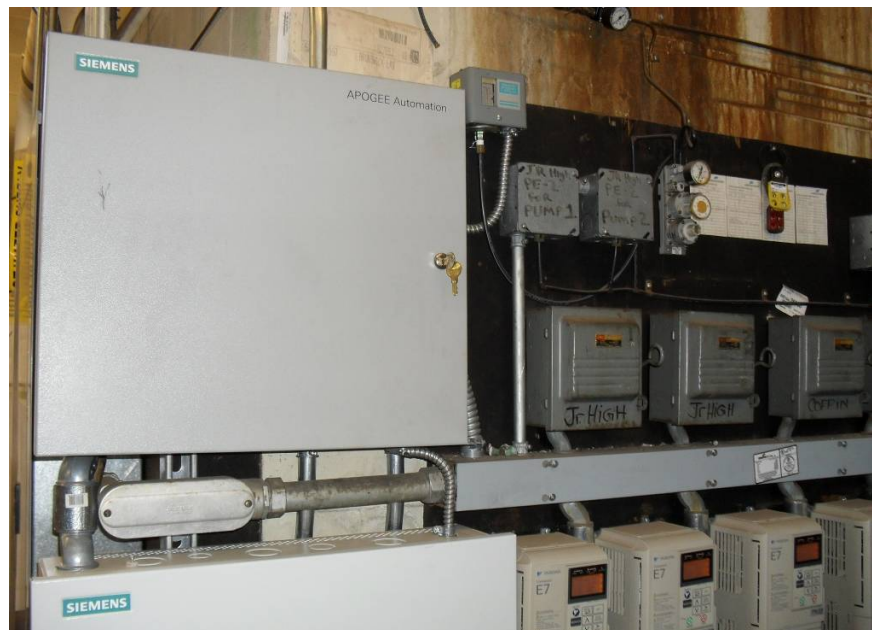
Figure 7 - DDC  
Controller

The temperature controls in the facility are a combination of pneumatic and DDC controls. Reports are that this system has not provided consistent temperature control throughout the facility. Some areas are quite warm while others can be quite cool. The system as installed is Siemens and is also being serviced by Siemens.

There have been reports that the school has experienced areas where the temperature is not consistent. We believe that most of these issues can be resolved with modifications to the control strategies. We recommend removing any remaining pneumatic system control which includes all controllers, air compressor, dryers, tubing, actuators, sensors and all other associated accessories. The Siemens Apogee DDC system should be expanded to cover the entire facility. This control system will be expanded by Siemens and will all be mapped back to the main head end in the Facility Director's office.

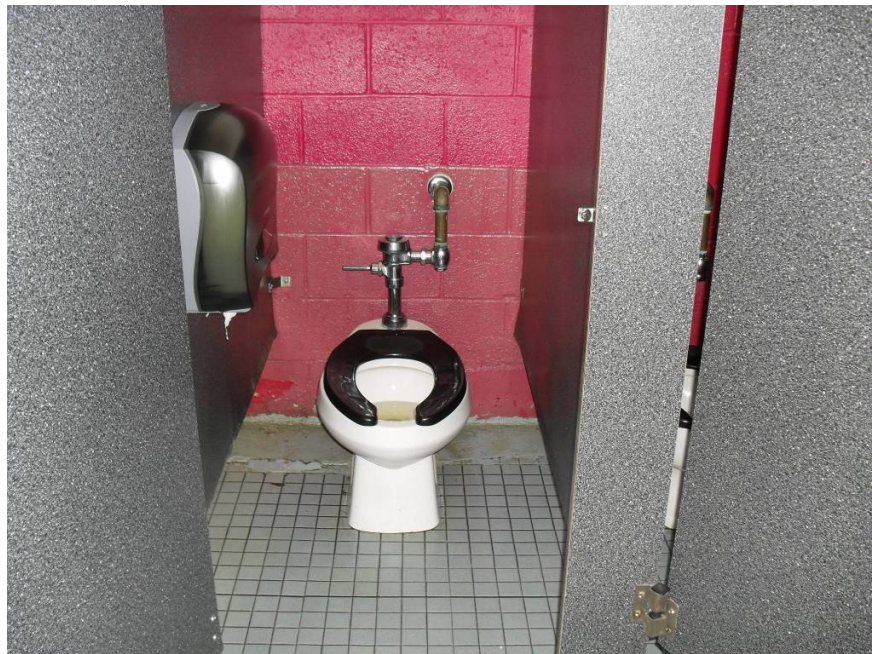
Figure 8 - Typical closet

The plumbing fixtures appear to all be original. The water closets are approximately flushing at 3.5 gallons per minute and the urinals are flushing at 1.25 gallons per minute. No handicap fixtures were noted throughout the school.

Since all of the plumbing fixtures appear to be original, we would recommend replacing them all with low flow fixtures. Handicap fixtures will also be required throughout the facility to bring it in compliance with ADA requirements. Additional modifications will be required to make all toilets accessible.

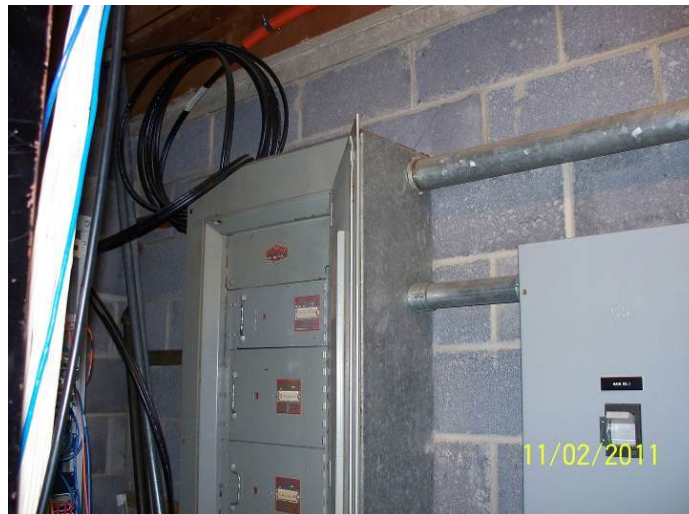
## Main #1

The main distribution panel is a very old fuse type panel, with some dead-front panels missing that expose live parts when the door is opened. Sub-panels are located in the corridors of each wing, multi-purpose space, boiler room, and kitchen. This is a good distribution that limits the lengths of branch circuits to acceptable distances. Most sub-panels appear to be in serviceable condition. The panels in the kitchen have been modified indicating the original panels do not provide the necessary circuitry.

The equipment that comprises the service entrance is in violation of the National Electric Code because of lack of required clearances. Also, the configuration of multiple main breakers may be a safety concern as it is quite confusing as to which main controls which sub-panels. The capacity of the existing service is currently limited by the transformers located in the vault to 150kVA, but, the equipment when totaled (Main #1 - 400A @ 208V/3Ø), (Main #2 - 400A @ 208V/3Ø), (Main #3 - 200A @ 208V/1Ø), (Main #4 - 200A @ 208V/1Ø) is capable of approximately 297kW. This is very low for a building of this size (57k SF +/-). Most of the existing sub-panels are relatively new and in good condition, but, the panels in the Kitchen area are not in good condition and have been modified.

The existing service entrance equipment should be upgraded to combine distribution and eliminate mains, provide required clearances and additional capacity if deemed necessary. The main distribution panel is very old and unsafe and should be replaced as soon as possible. The electrical needs in the Kitchen should be evaluated and the panels upgraded accordingly. Replacing the existing service entrance equipment and getting the required clearances is going to be difficult as there is limited space available to work with.

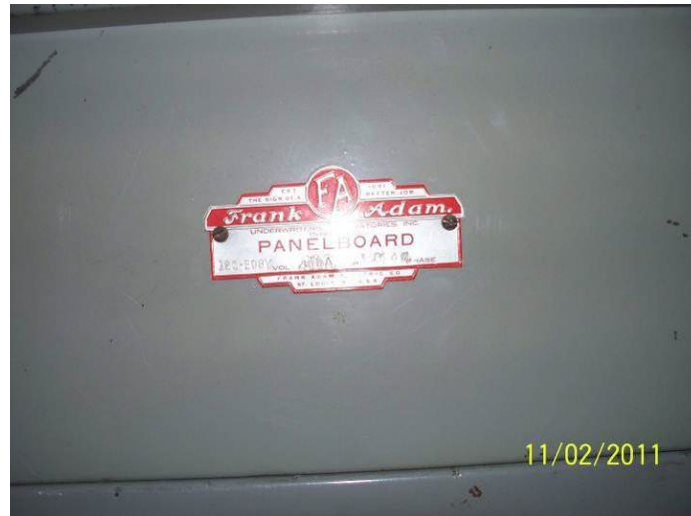
Frank Adam Equipment,  
no longer manufactured

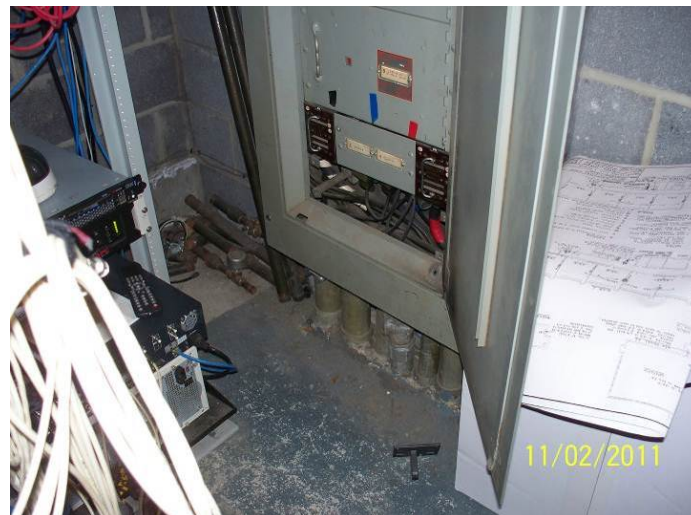
Interior cover missing

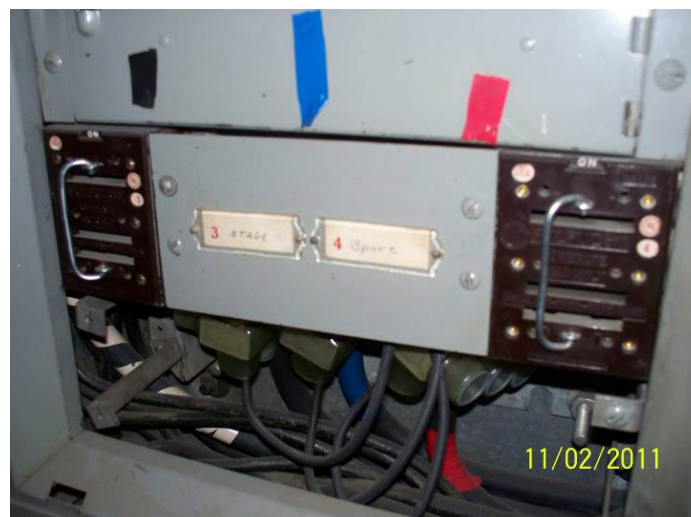
Conductors tapped off  
main lugs

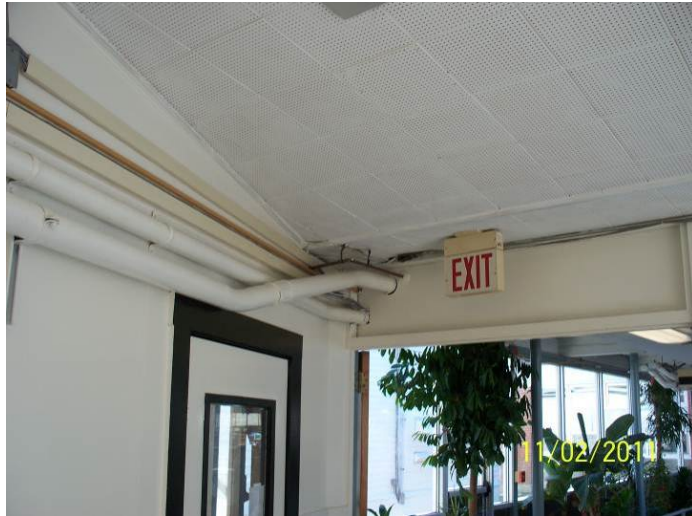
The Coffin Elementary School is served with self-contained (each unit has its own battery) exit signs and emergency life safety lighting throughout the building. Many of the exit signs do not appear to be working under normal conditions.

Typical self-contained exit sign (ON??)

All battery units should be tested to verify proper operation. Internally illuminated exit signs should be added at all required egress doors and units that are in poor condition should be replaced. Emergency lighting units and exit signs should be added so that all paths of egress are properly marked and illuminated.

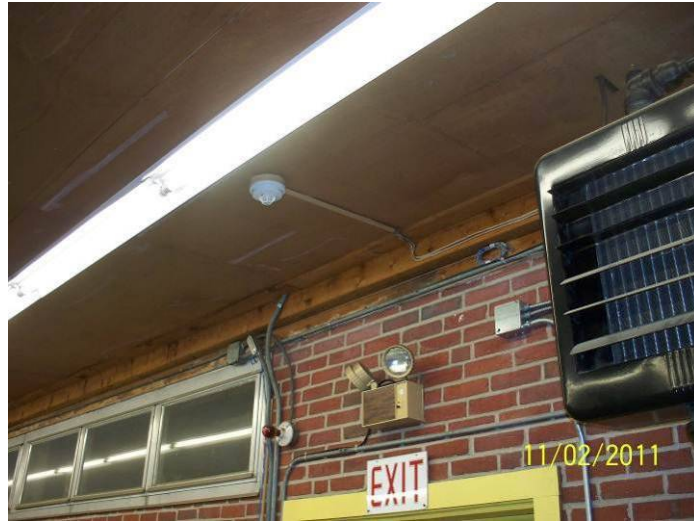
Typical emergency light  
and non-illuminated exit  
sign

No record of testing of the emergency units was observed. It is very possible that the emergency battery units will not function properly if a strict testing and maintenance policy is not being followed. Some areas of paths of egress are not properly marked (exit signs) and do not appear to be sufficiently covered with emergency fixtures to provide an average of 1 fc during a power outage.

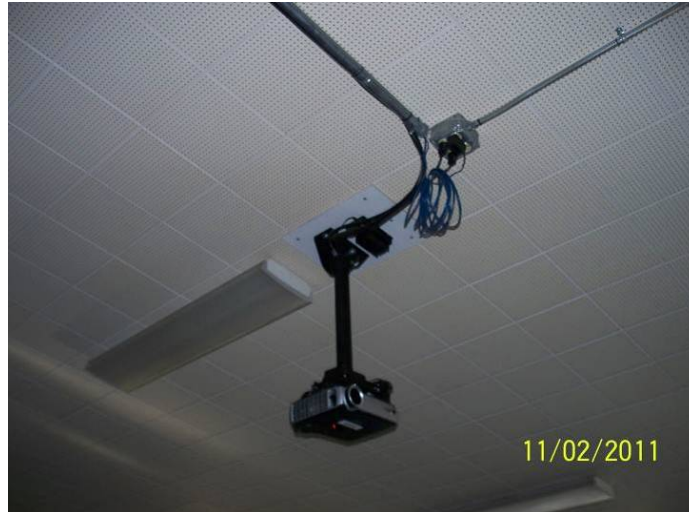
Quad Receptacle added to serve projector

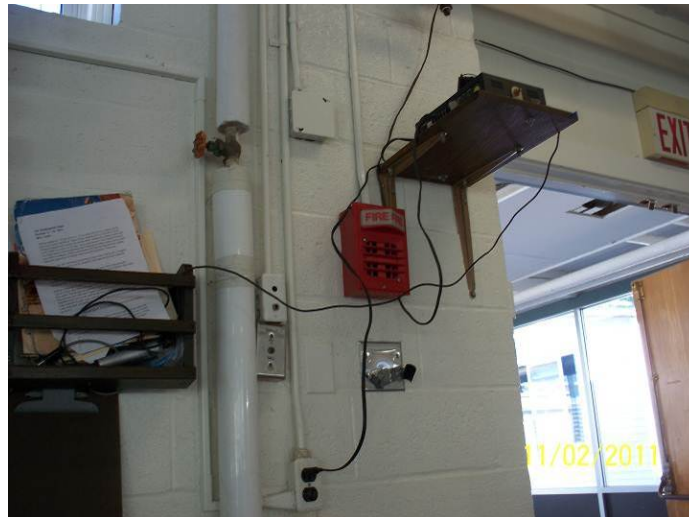
Surface receptacle with wiremold serving adjacent receptacle

Additional receptacles are required throughout the school to provide service where needed. In many locations circuits have been extended with surface wiring to provide service for specific equipment. Exterior receptacles outlets should be added as needed to provide service for maintenance purposes. Receptacles should be added in locations as necessary to reduce or eliminate the need for extension cords.

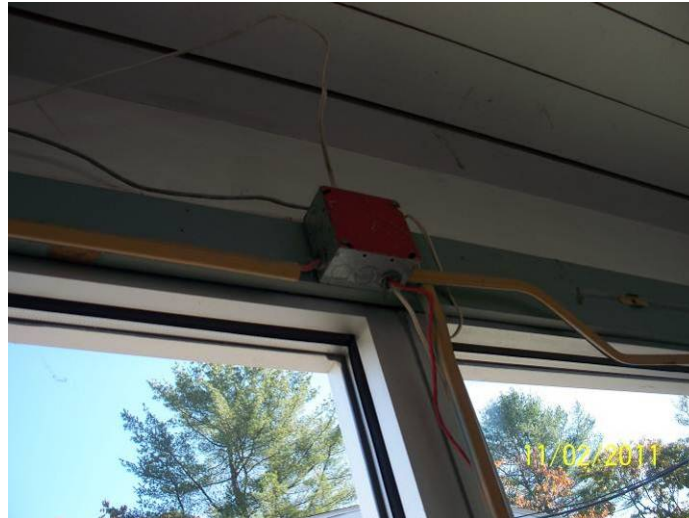
Fire alarm cabling  
susceptible to damage

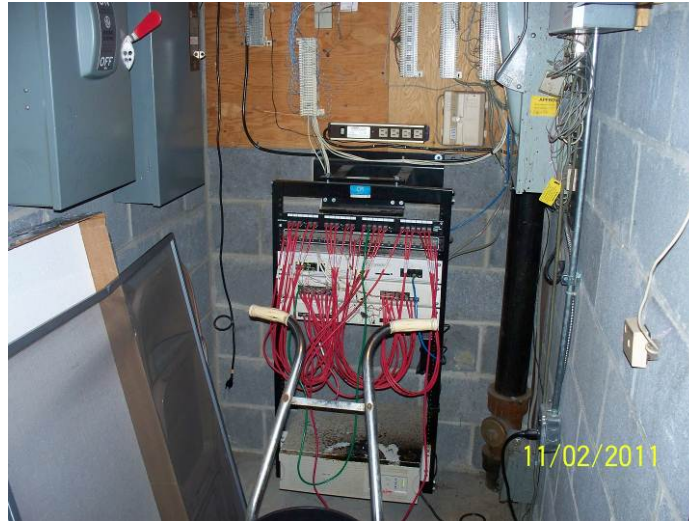
Phone System

The phone system is by Avaya and is rack mounted in the Electrical room between Main #3 and Main #4. This system is impeding on the required clear space in front of the electrical equipment. This system appears to be in service able condition. Also, the school network fiber connection to the internet was noted at this location. connection to the internet. There is also a data rack at the opposite end of the room that is floor mounted in front of the electrical main distribution panel, impeding the required clear space in front of that panel. Voice/data outlets appear to have been added throughout the school as needed, with cabling strung and run haphazardly. In locations where multiple PC's are located, wireless hubs have been installed.

The existing phone system appears functional, but, the space it occupies is needed for required clearance for electrical equipment. Voice/data cabling is in very poor condition in this building. All cables are run on building surfaces, many without raceways. These cables are very susceptible to damage. Also, it appears that most spaces are lacking sufficient “drops” for telephone and data when compared to modern schools.

A new space should be allocated for voice/data equipment to provide clear space in front of the electrical equipment. The existing cabling system should be replaced with new cables that are properly supported and protected. Connectivity should be upgraded to at least Cat 5e and to Cat 6 if budget allows.

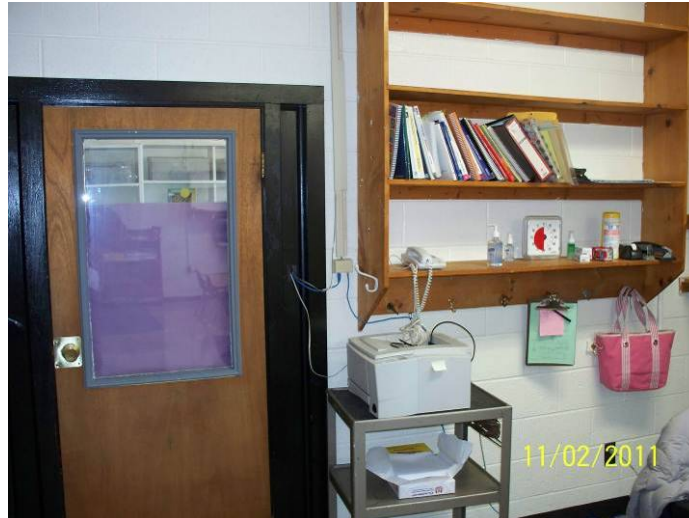
Typical surface wiring for voice/data cabling.  
Note cables running through door frame

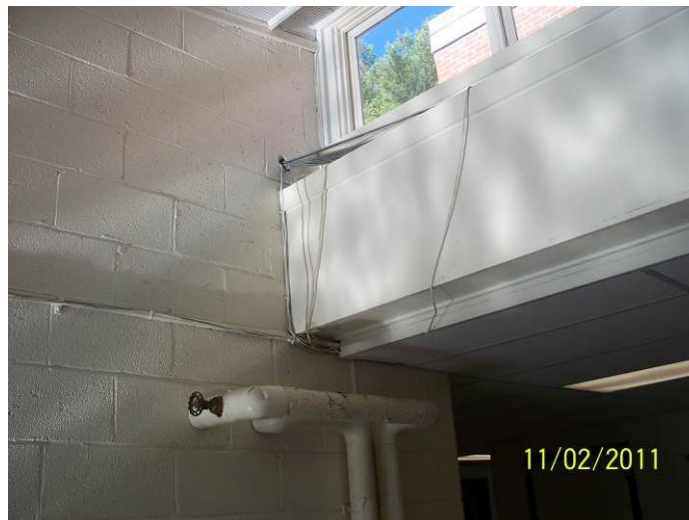
Voice/data cables run surface on block and through block unprotected

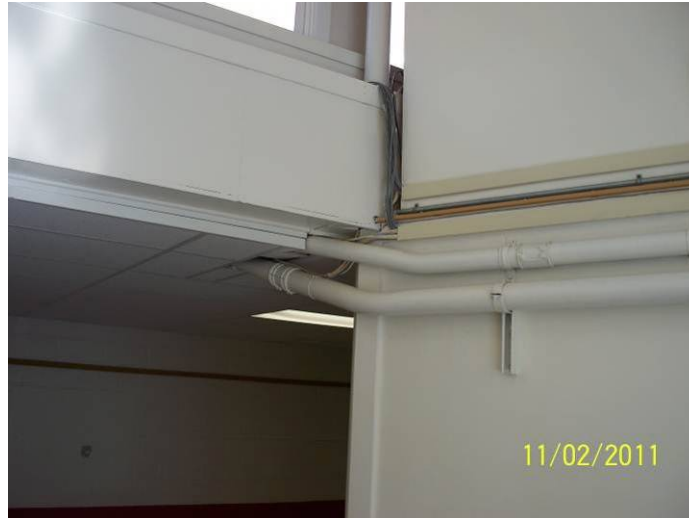
Voice/data cabling run surface on wall

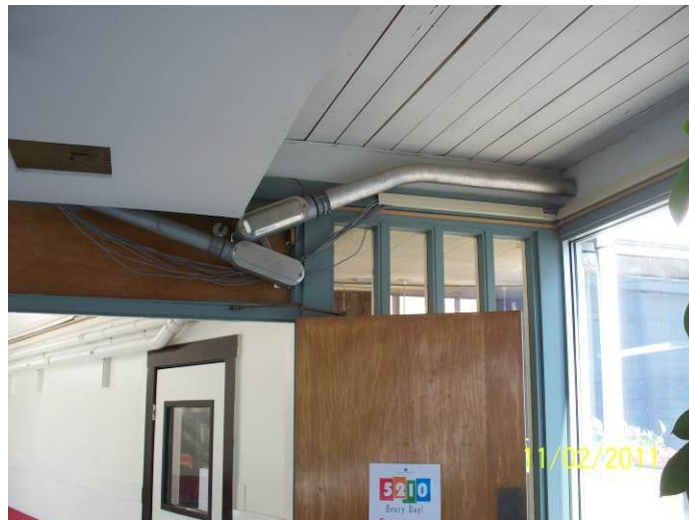
Voice/data cabling unsupported

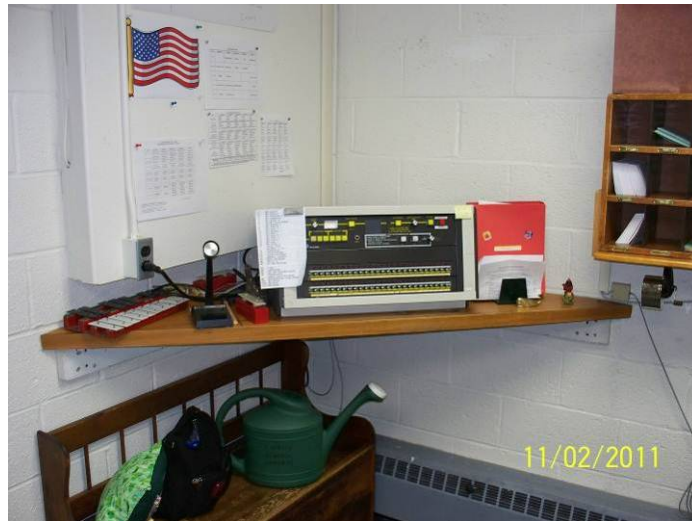
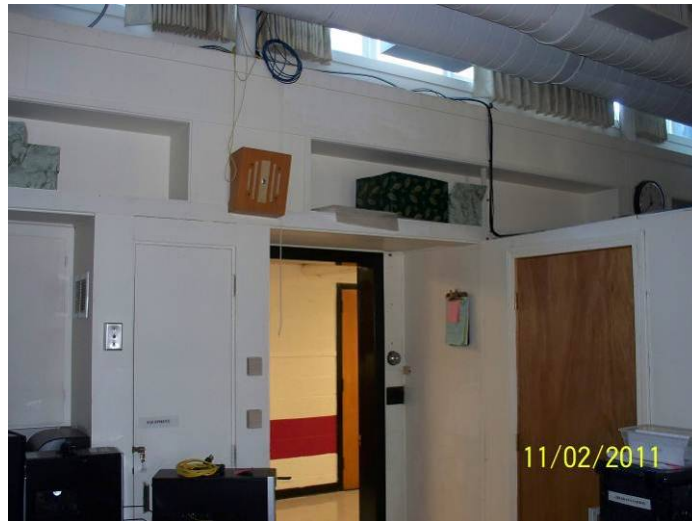
The existing Intercom system is beyond its useful life. Dukane no longer manufactures parts for switch-bank type systems, therefore any repairs requiring parts could lead to lengthy down time. Spare parts come from "old stock" and salvage from old consoles.

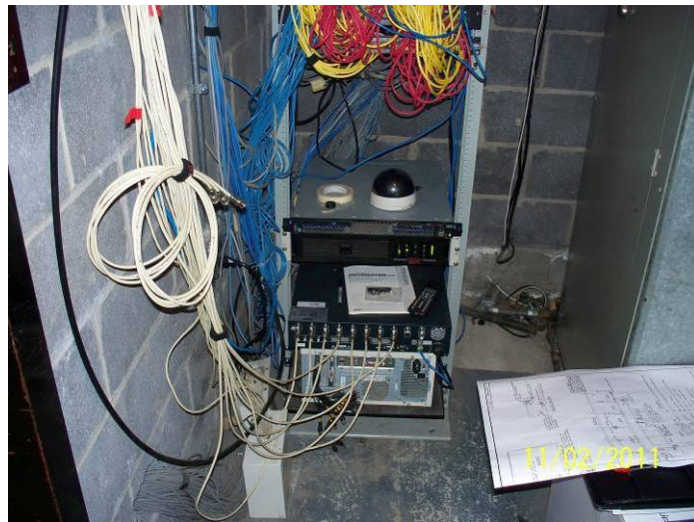
## Head-End equipment

We were unable to determine if the camera system was functional and it is possibly not functioning at this time.

The system should be evaluated by a camera system vendor to determine operability and repair as required. Wiring for this system should be addressed to provide reliability and increase maintainability.
