# Brunswick Junior High School

## Overview

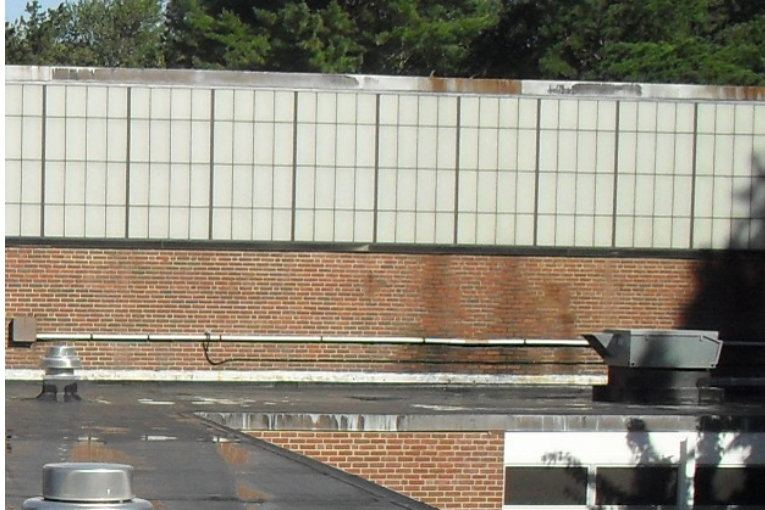
The exterior of the building is predominantly of brick veneer. There are a few locations of wood siding but it is limited. Overall, the brick is in good condition although some areas need to be cleaned and repointed where moisture has caused discoloration of the brick (potential mold issues) and deterioration of the mortar from water draining over the roof edge and down the face of the wall. Correcting the roof drainage should be a priority to eliminate the continuing moisture problems, which will only continue to be detrimental to the brick veneer as well as to the windows.

Staining of brick  
at south wall of Gym

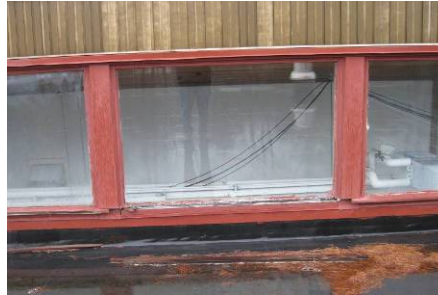
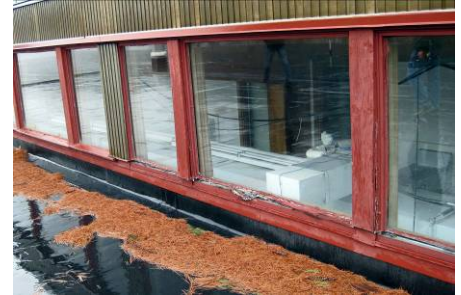
### Rotting wood windows

There have been a variety of window types used relative to the different additions and renovations. Aluminum windowwall was used on the original 1959 building along with the 1966 classroom addition. The 1976 additions and the 1983 renovations used non-clad wood windows. There is glazed aluminum storefront at the main and gym entrances. All glazing appears to be insulated glass. It has been reported that much of the original windowwall is leaking. In addition, some of the wood windows are rotting. This is particularly evident at the clerestory windows of the 1976 classroom addition. The windows in the gym are translucent wall panels – Kalwall - that were installed in 2000. Replacement of the original windowwall and the rotting wood windows should be a priority and are currently included in the capital improvement budget. Replacement of the remaining wood windows in the two story wing, although not a high priority, should be considered for a future project.

1976 clerestory windows (Note: wood siding above windows)

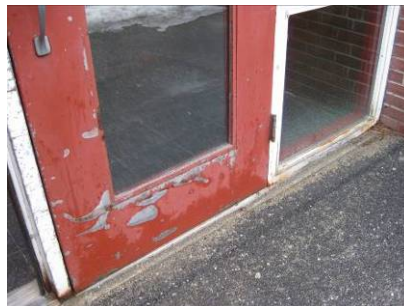
### Exterior Hollow Metal Doors & Frames

Many of the exterior hollow metal doors and frames that are not in protected locations are showing signs of rust and deterioration of the finish. The hollow metal doors and frames that are in the worst condition should be considered for replacement. Those doors that are currently unprotected and most vulnerable to damage caused by moisture and rusting may want to be replaced with heavy duty aluminum doors and frames. Other doors and frames that are in more protected locations may be able to be repaired and repainted depending on the level of rust damage.

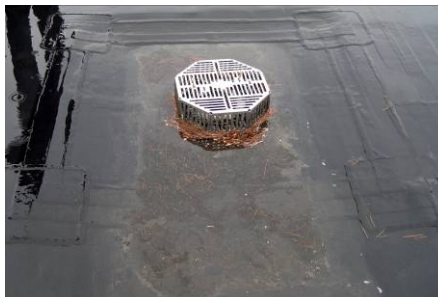
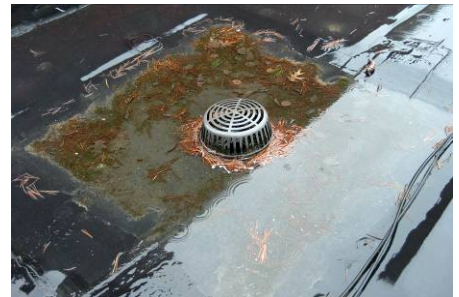
Typical roof drains  
set in sumps

The roofs all drain internally to roof drains that are installed in sumps. There was a reroofing project done in 1992 that originally included installation of tapered insulation to improve drainage to the drains but apparently much of the tapered insulation was deleted around the outer areas of roof that has resulted in those areas being flat with no pitch. It is not known why areas of the tapered insulation were deleted. The lack of tapered insulation over much of the roof is a contributing factor to water draining over the edge of the roof and down the face of the building impacting the windows and the brick. Consideration should be given to correcting this condition in the near future to eliminate the drainage problems by adding a raised curb or parapet or reroofing the affected areas and adding tapered insulation.

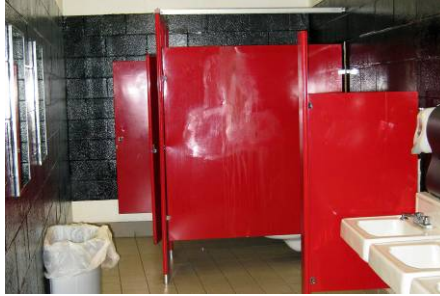
Non-Compliant Student Toilet Room

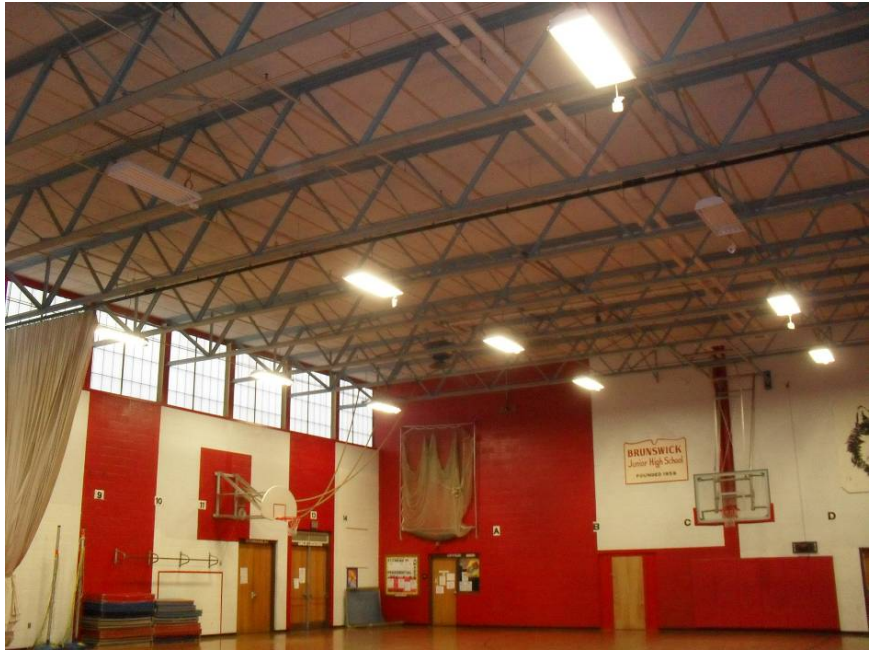
Roof Framing at Gym

The roof framing in the gymnasium consists of Tectum decking and steel bulb tees spanning to open web long-span steel joists. Although the spacing could not be verified, it appears that they are approximately 6 feet on center and span to steel wide flange columns which are supported by the masonry bearing walls on both sides of the gym.

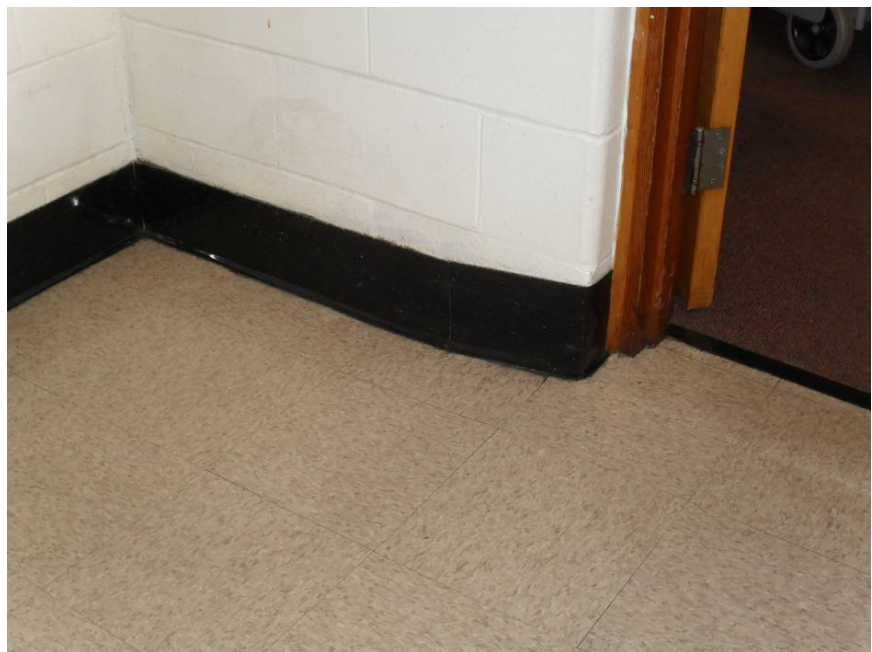
Slab Settlement in  
Classroom Floor

It is our understanding that the floor settlement has been present for a very long time, and the flooring and wall base trim have been adjusted accordingly.

The slab settlement was likely due to poor compaction of the subgrade below the interior slabs. There are several ways to address the issue. One method would be to remove all floor finishes and place a leveling material on the slabs to bring them back to the correct elevation. This solution likely won't work since the extra weight of the new material will likely cause additional settlement to occur. We could also attempt to pressure-inject flowable grout under the slabs to raise them, but because the slabs have settled, it would suffer severe cracking if they are elevated as much as 5". The only real long-term solution would be to remove the existing slabs and properly compact and possibly replace the subgrade material prior to pouring new slabs. This would be very costly and an unwise investment for a building of this age and condition.

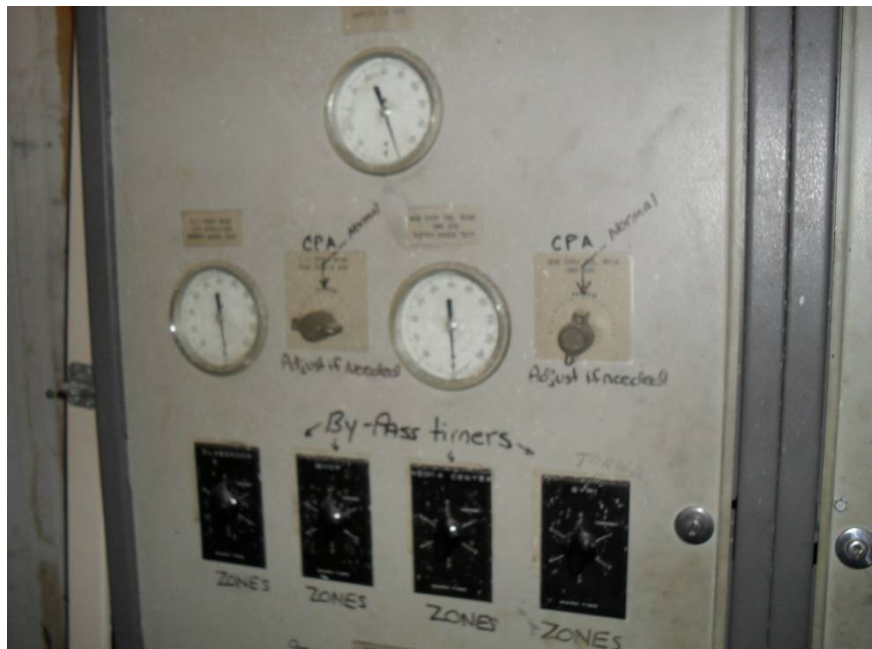
Figure 10 – Exist  
Pneumatic Control Panel

The temperature controls in the facility are a combination of pneumatic and DDC control. Reports are that this system has not provided consistent temperature control throughout the facility. Some areas are quite warm while others can be quite cool. The system as installed is Siemens and is also being serviced by Siemens.

There are reports that the school has experienced areas where the temperature is not consistent. We believe that most of these issues can be resolved with modifications to the control strategies. We recommend removing any remaining pneumatic system control which includes all controllers, air compressor, dryers, tubing, actuators, sensors and all other associated accessories. These areas are primarily in the gymnasium wing. The Siemens Apogee DDC system should be expanded to cover the entire facility. This control system will be expanded by Siemens and will all be mapped back to the main head end in the Facility Director's office. Opinion of probable cost - \$50,000.

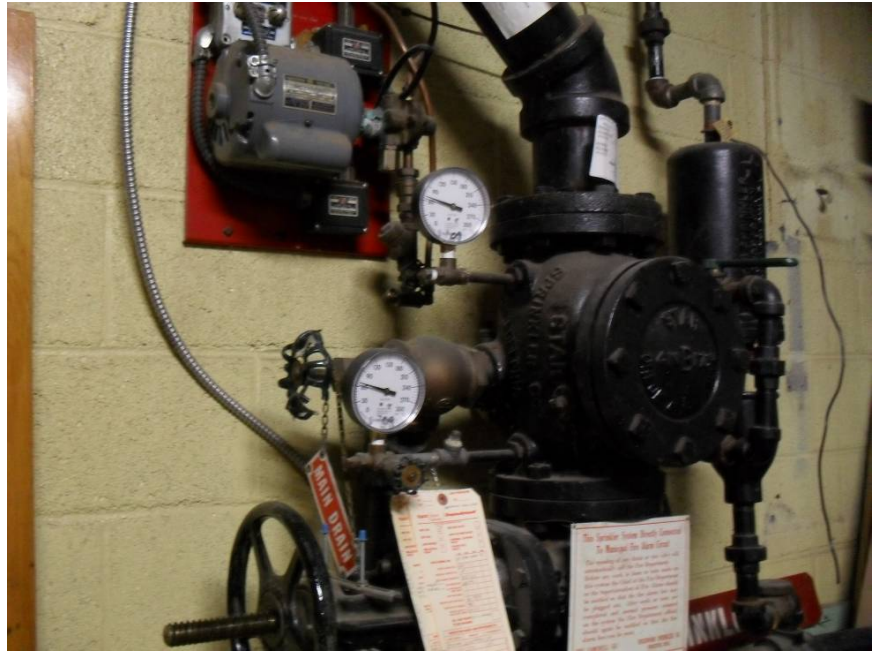
Figure 12 – Sprinkler Entrance

The sprinkler system enters the building in the storage area adjacent to the kitchen. The line size coming in is 4". Based on conversations with staff and site observations, only the common areas are served by this sprinkler system such as the kitchen area, corridors and other sporadic areas around the school. Occupied spaces such as classrooms and offices are not outfitted with adequate sprinkler systems.

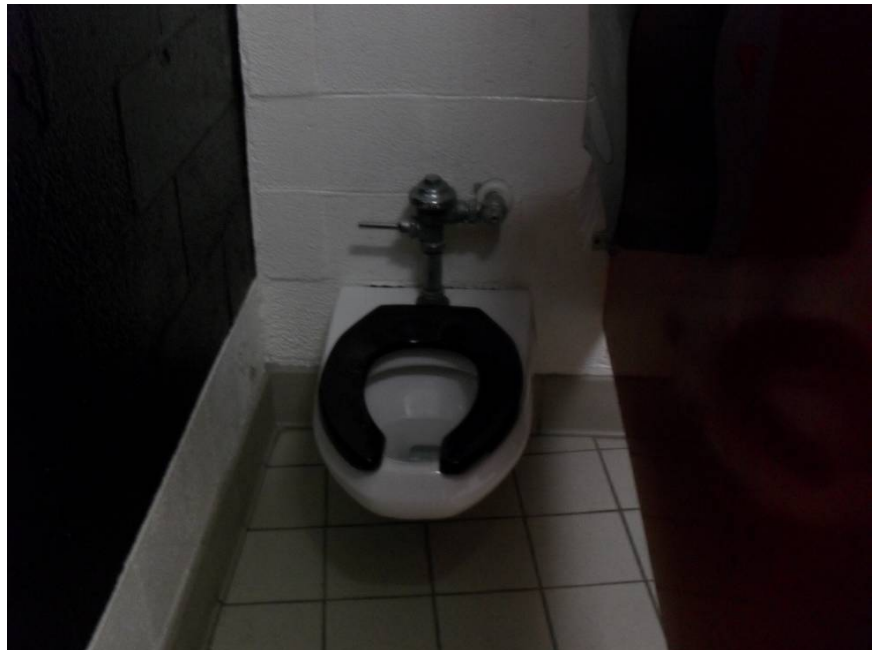
Figure 13 - Typical Water Closet

The plumbing fixtures appear to all be original. The water closets are approximately flushing at 3.5 gallons per minute and the urinals are flushing at 1.25 gallons per minute. No handicap fixtures were noted throughout the school.

Plumbing	<p>Since all of the plumbing fixtures appear to be original, we would recommend replacing them with low flow fixtures. Even though there are several handicap stalls located throughout the facility the plumbing fixtures located within the stalls are not handicap accessible and will also be required to be brought up to comply with ADA requirements. Additional modifications will be required to make all lavatories and toilets accessible as well. Opinion of probable cost - \$1,000 per fixture.</p> <p>Reconnect DHW recirculation loop piping in the connecting corridor area of the 100, 200 and 300 wings. Opinion of probable cost - \$24,000.</p> <p>The existing gas fired domestic water heater located on the Mezzanine above the stage is not currently DDC automated. Recommend providing full automation. Opinion of probable cost – \$12,000.</p>

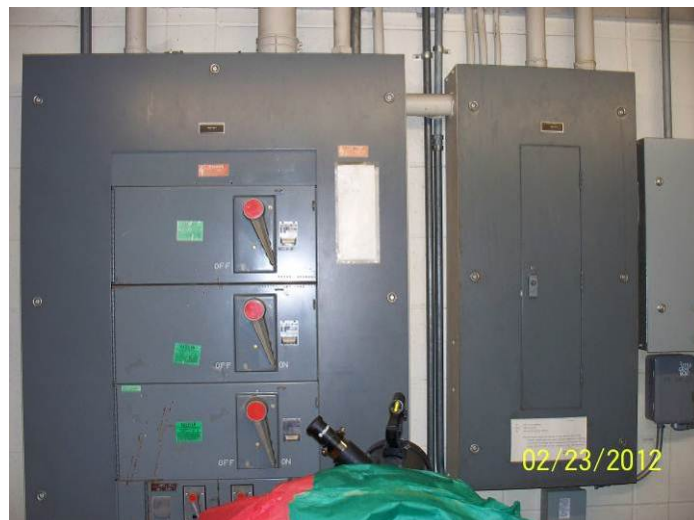
Distribution equipment  
(MDP1) in Media  
Center wing. (FPE  
switch & fuse)

- § The equipment that comprises the service entrance is in violation of the National Electric Code because of lack of required clearances.
- § Also, there may be a mistake in the labeling of the mains for MDP1 and MDP2, this should be verified.

The existing service entrance equipment should be upgraded, reducing the number of mains and providing required clearances and additional capacity if necessary. All of the older sub-panels should be replaced with new panels providing additional circuit capacity and maintainable equipment. Additional transformer capacity will be required if additional loads are added to the building.

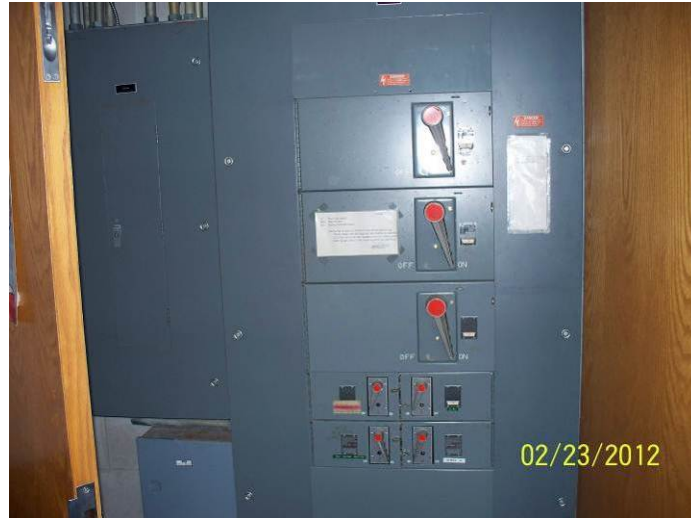
Distribution equipment  
(MDP2) in Shop wing.  
(FPE switch & fuse)

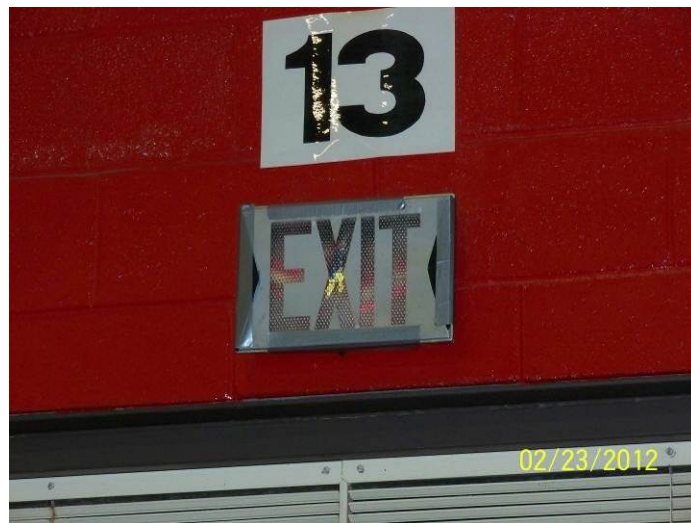
## Exit sign in disrepair

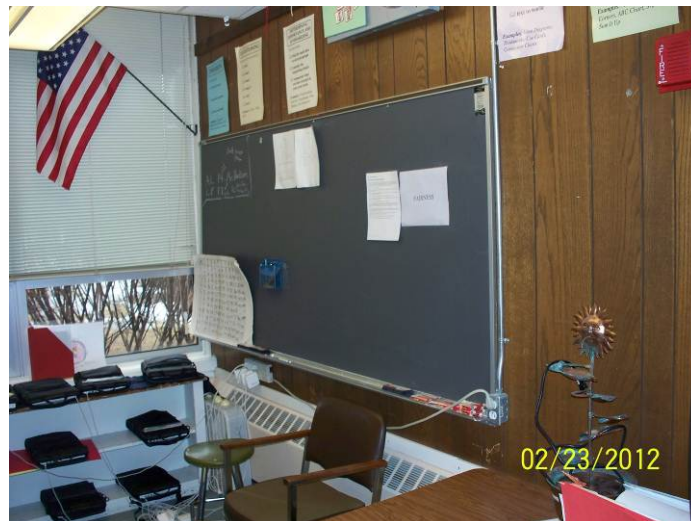
Surface receptacle has been added, but, plug-strip is still required to provide power for charging station.

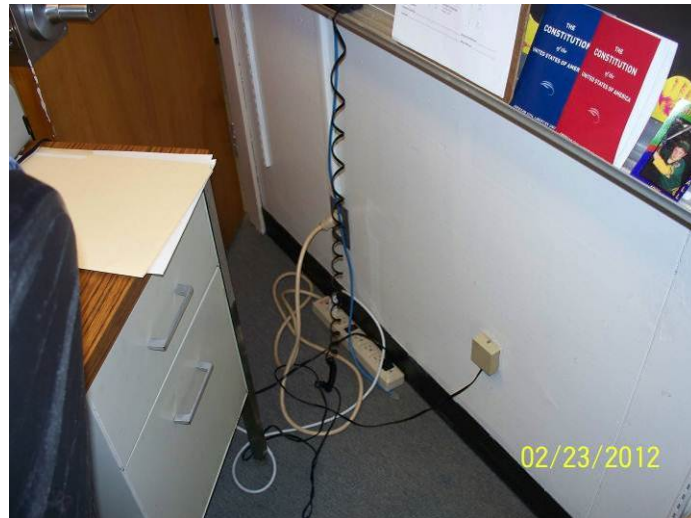
Plug-strip being used to serve desk area.

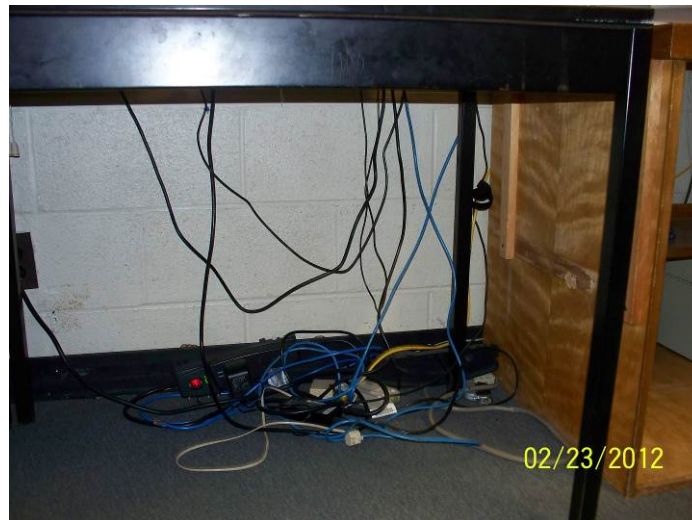
Wiring hazard and 120V wires entwined with data wiring can cause interference.

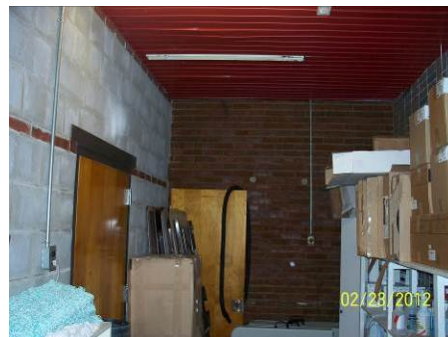
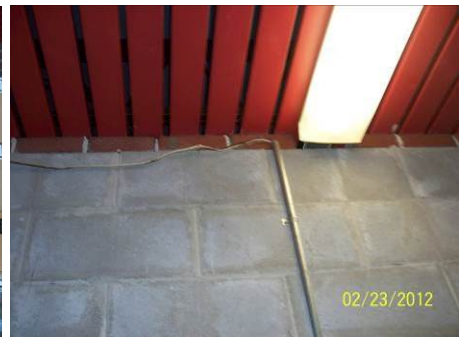
Surface mounted handy box and conduit (left-most) is fed with "free-air" THHN. This is a code violation.

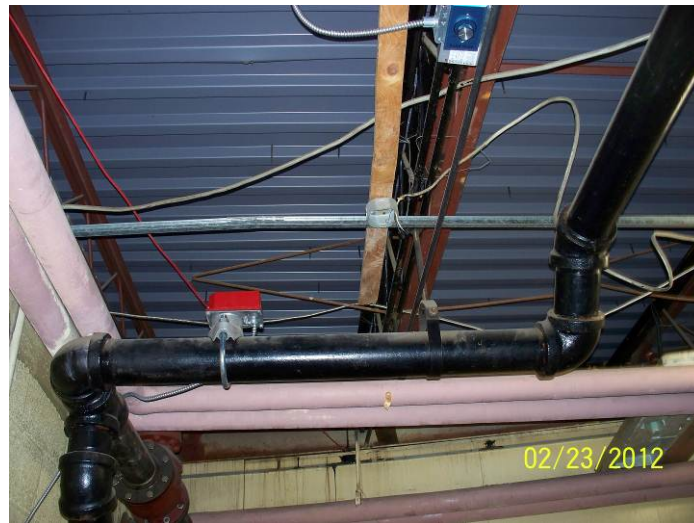
Open box with discontinued wiring?

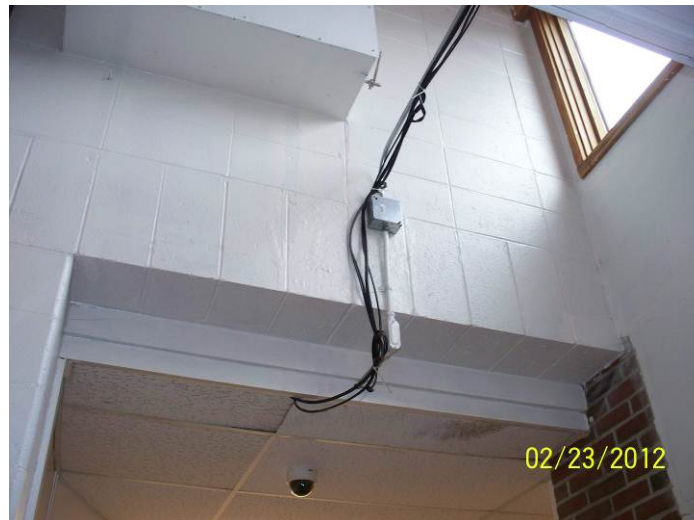
CCTV Camera in  
corridor and exposed  
wiring.

The existing CCTV camera system is quite complete and appears to be very functional. It is located in a room that is very small, and needs more space. Much of the wiring has been strung down the halls and runs through the suspended ceiling system. This creates a potential for damage to the cables and is very insecure.
