## Jordan Acres Elementary School

### Overview

Part of the goal of this analysis is to assist the Brunswick School Department in determining whether Jordan Acres should be reopened or be closed permanently. And if the school is reopened, determine what the grade configuration and student population should be.

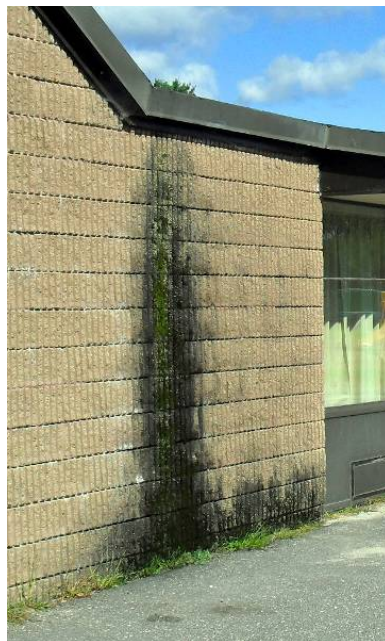
The exterior of the building consists primarily of scored, split-face concrete block, which is regarded as a highly absorbent material that is not recommended for use due to moisture problems. Some areas have smooth face concrete block, which is less absorbent. Many areas of the exterior walls that have the scored, split-faced block have turned black from moisture infiltration and in some instances moss is growing vertically up the walls. Some of the walls receive plenty of sun, while others receive limited sun.

Previous reports have indicated that runoff from the roof was a major cause of the moisture in the walls and that reroofing the building did little to help eliminate the problem. The exterior walls need to be opened up, inspected and tested to accurately determine the cause and the extent of the moisture problem. Depending on the results of the testing, the walls should be thoroughly cleaned with possibly other corrective action being taken to eliminate the problem from reoccurring. Corrective action may include extending the roof overhang, adding gutters and downspouts as well as possibly replacing the exterior masonry to a less absorbent material.

Moisture problems at the exterior walls

Southeast side with sun exposure

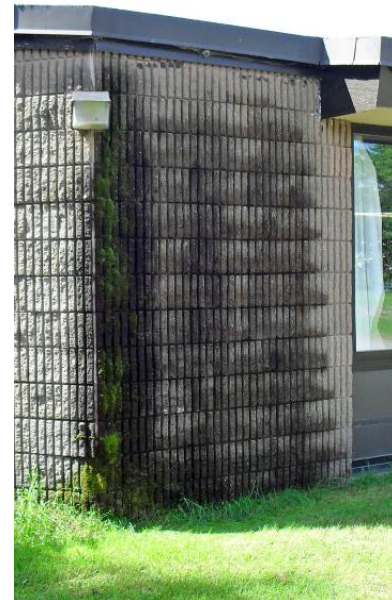
Northeast corner with no sun

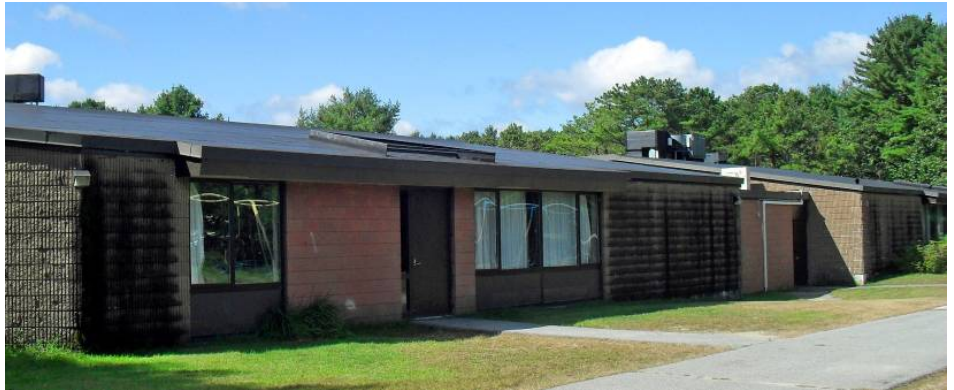
Moisture problem on scored,  
split-faced block

No moisture problems on  
smooth faced block

Water from roof runs down  
face of scored, split-faced  
block. Note overhang at  
windows and smooth block.

Northeast facing wall with no sun exposure

Drainage from the roof and drainage around the building need to be improved to help eliminate the problems that have been continuing for many years. Issues related to water draining down the face of the building and moisture accumulating at the base of the exterior wall need to be corrected. Removing and replacing the affected concrete masonry may be necessary to eliminate mold issues around the exterior of the building.

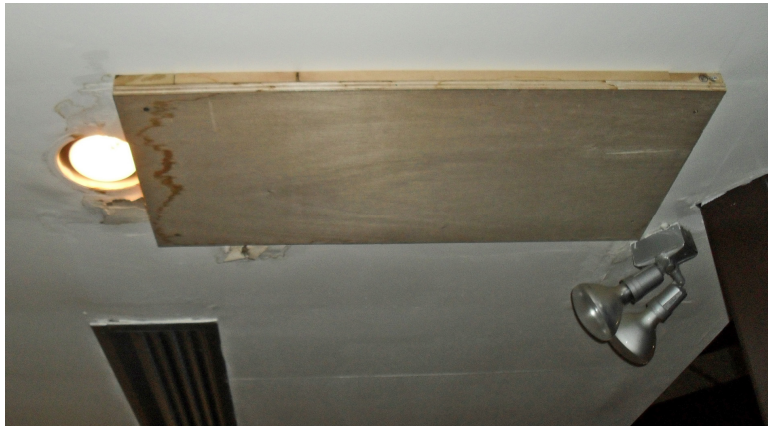
The building has been reroofed since it was originally constructed. The current roof is EPDM and appears to be in relatively good condition, although there was a report of one area leaking in the library.

Water damaged ceiling in Library

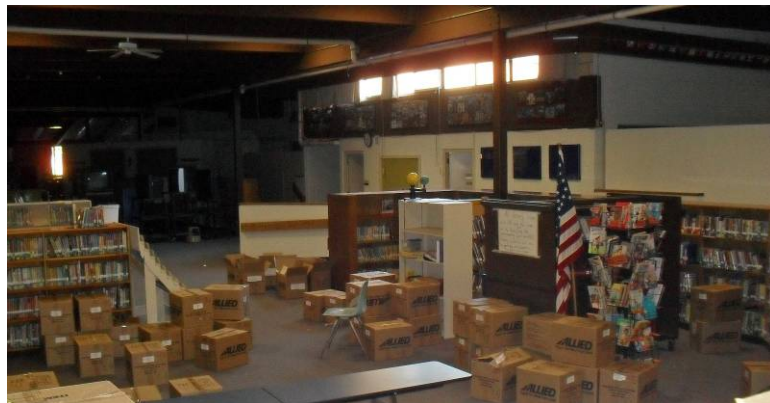
Jordan Acres is a single-story building that is considered reasonably accessible with the main entrance being at grade level and fully accessible. The library, however, at the center of the building is at a lower elevation from the main floor by about 18” but can be accessed by a ramp albeit from one side of the building only. The library also includes a depressed reading area with stepped risers that start flush with the main floor of the library. Each of the amphitheaters is at the same elevation as the main floor of the classrooms but each has three stepped risers. The seating capacity of the amphitheaters does not require distribution of handicap seating among the different levels but access to the amphitheaters is restricted due to inadequate clearances at the doors.

Access to the library is limited to the right side of the building only, meaning a person in a wheelchair would have to travel from the left side of the building through the multi-purpose space to get to the right side of the building in order to use the ramp down into the library. If the building configuration is maintained, an additional ramp should be added to provide access from both sides of the building. General circulation from one side of the building to the other side of the building is also impeded because travel requires going through the multi-purpose space or through the library.

Library is at lower elevation than rest of building. Ramp is behind shelving in center of picture.

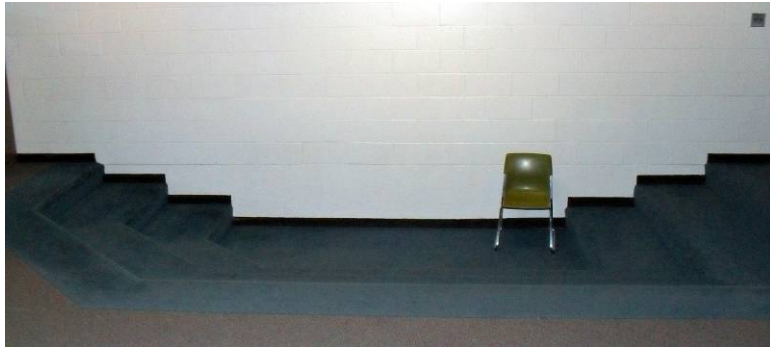
Stepped reading area in Library

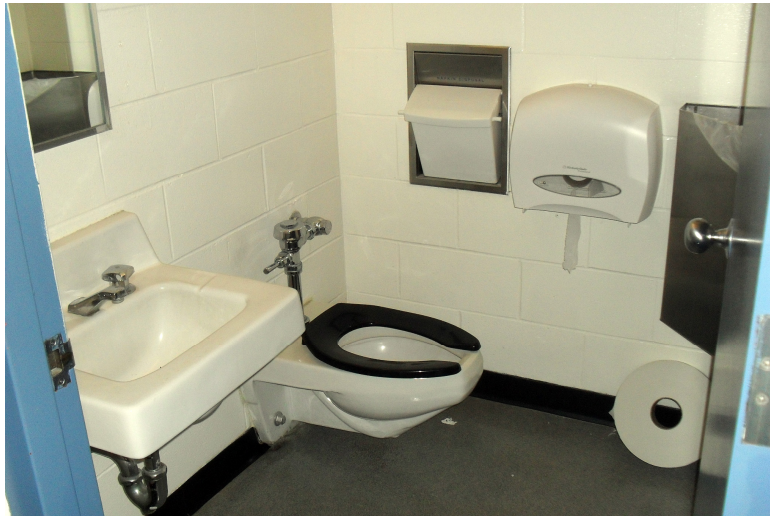
With the exception of one or two toilet rooms, none of the staff or student toilet rooms are compliant with ADA requirements. Even the toilet rooms that have been partially modified are not be fully compliant. All toilet rooms would need to be completely renovated and enlarged to provide proper fixtures and adequate clearances. In lieu of fully renovating all toilet rooms, at least one accessible toilet room per gender should be provided in each wing. However, fully renovating the toilet rooms would also update the plumbing fixtures with water conserving fixtures as described in the mechanical section of this report.

Non-compliant single user toilet room

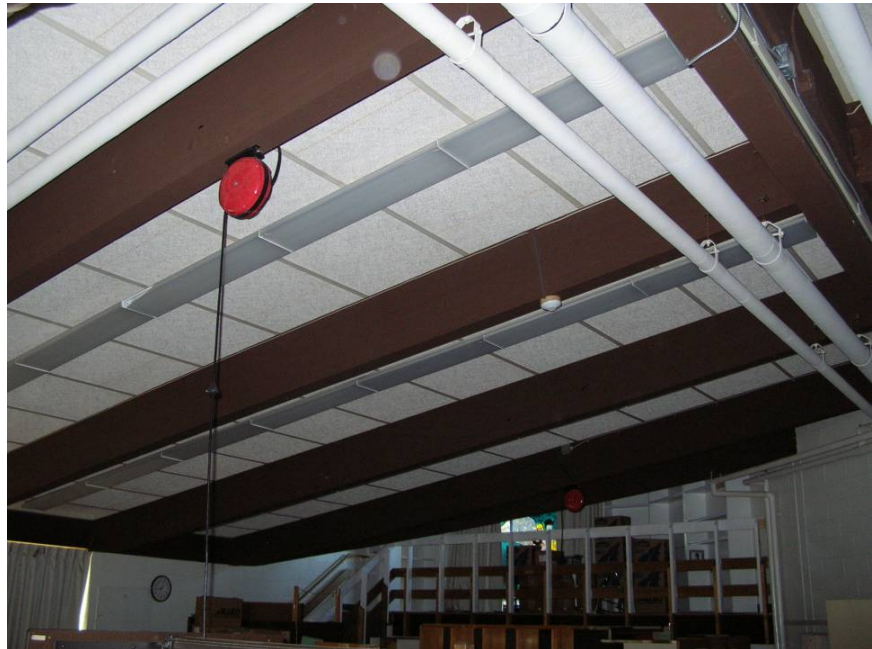
Typical Glulam Roof  
Framing

Visual observations were performed and in general the structure appears to be sound, and no obvious deterioration or damage was visible. It is our understanding that one of the glulam purlins was noticeably split at the lower end of the sloped beam. This damaged beam has since been replaced with a similar glulam wood beam.

Although no detailed analysis was performed, a previous engineering study has indicated that the glulam roof framing may not meet current code. The original 1971 drawings indicate a design snow load of 40 psf for the majority of the roof, and 60 psf in the areas surrounding the higher gym roof and the lower roof section in the rear of the building. This higher snow load was likely specified to account for drifting in these areas. As the previous report indicates, the method for determining required snow drifts is much more detailed in the current building code. Therefore, it is possible that the framing in these drift areas may not be capable of supporting the new loading.

Due to the some changes in design methodology and material uncertainty, it is not clear if the remaining glulam roof framing could meet current code requirements. Further detailed analysis would have to be performed once the intended use is established.

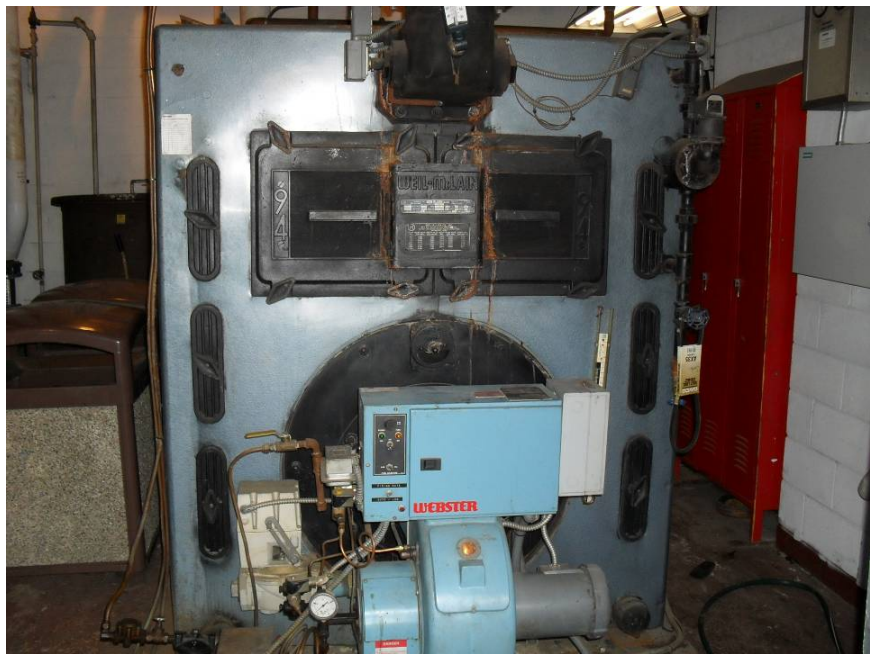
Figure 1 – Cast Iron Boiler

The existing school was built in 1972 and the original boiler is still in place. The main boiler plant consists of a Weil McLain, 16 section, cast-iron boiler. The boiler model is 1694 and has a net capacity of 3,385.1 mbh.

Because the existing cast iron boiler and oil burner is almost 40 years old and clearly showing its age, we would recommend replacing the boiler with a high-efficiency boiler capable of dealing well with low return water temperatures. The removal of this boiler would include all connecting HWS & R piping, induced draft fan, breeching, five horizontal expansion tanks, and oil piping. This replacement type of boiler design would allow us to save significant energy on typical standby losses normally associated with “hot” boilers. New breechings, engineered combustion air system, insulated HWS & R piping, oil piping, expansion tanks and controls would also be included in this installation.

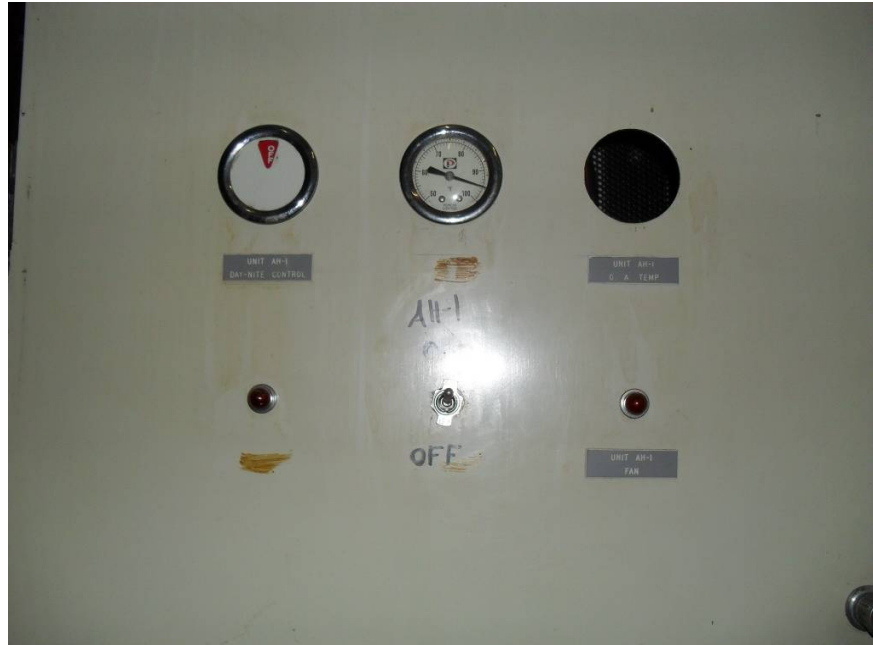
Figure 11 - Pneumatic control panel

The temperature controls in the facility are primarily pneumatic with a bit of updated DDC control as well. It has been reported that this system has not provided consistent temperature control throughout the facility. Some areas are quite warm while others can be quite cool.

The existing pneumatic control system in the facility is also clearly showing its age. Although a pneumatic control system was virtually the only viable control option available when the school was originally designed and constructed, these systems have proven over time to be quite inefficient and difficult to control and maintain. We recommend removing the complete pneumatic control system which includes all controllers, air compressor, dryers, tubing, actuators, sensors and all other associated accessories. A new direct digital control (DDC) will be provided for the entire facility. This control system would be provided by Siemens and would be tied back into the main head end in the Facility Directors office.

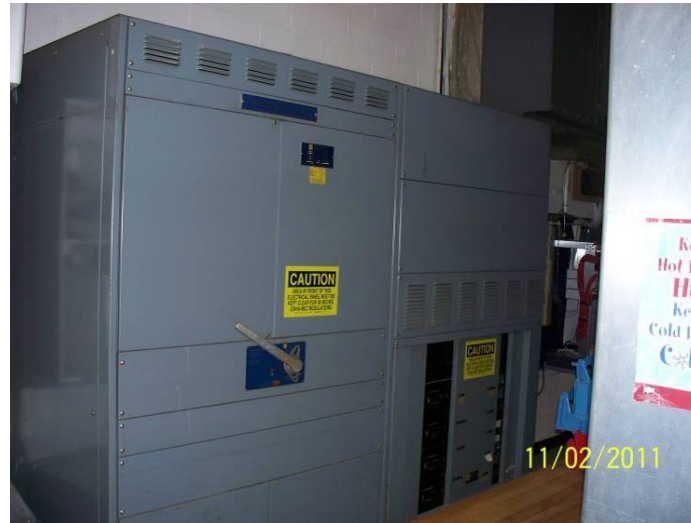
Service Entrance  
Switchboard

The electrical service entrance is a Square D 1600 amp, 120/208V, 3Ø, 4W bolted pressure contact switch. Our experience is and the Schneider/Square D website <http://ecatalog.squared.com/pubs/Electrical%20Distribution/Services/1910HO0804.pdf> confirms that periodic maintenance, cleaning and lubrication of a bolted

pressure contact switch is required to provide reliable operation. Failure to properly maintain the switch could result in downtime if operation of the switch is necessary. In many cases, bolted pressure contact switches have been installed without maintenance for many years, and fail to operate properly or re-engage after being de-energized or “shut-off”.

The existing service entrance equipment should be inspected and tested by Square D service technicians to verify condition and proper operation. A shut-down of the service is required for this procedure. This inspection/test costs between \$3,000 and \$5,000. Parts found to be damaged or non-functional are charged separately in addition to the testing fee.

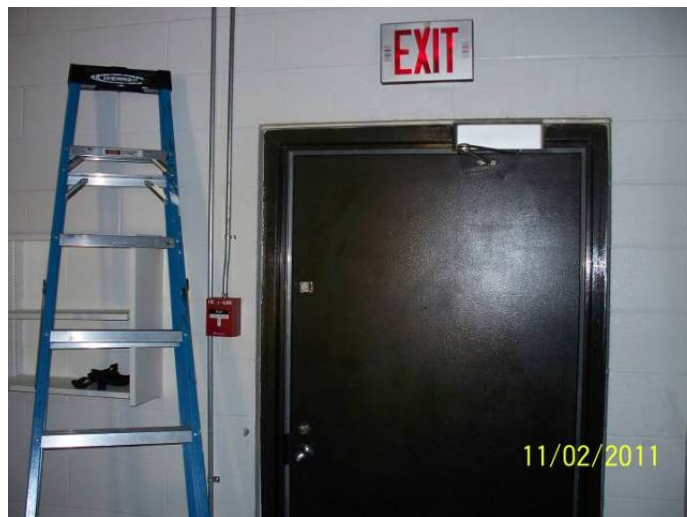
Typical internally illuminated exit sign

Exit signs appear to have been upgraded with LED retro-fit kits but are not very evenly illuminated and some are in poor condition. This may be of concern to the local code officials. Also, some signs are not internally illuminated and do not have an emergency lighting fixture nearby to illuminate in case of a power outage. It is a code requirement that all non-internally illuminated signs be illuminated with emergency lighting during a power outage. No record of testing of the emergency units was observed. It is very possible that the emergency battery units will not function properly if a strict testing and maintenance policy is not being followed. Also, emergency lighting fixtures are spaced such that they will not provide an average of 1 fc throughout all paths of egress.

All battery units should be tested to verify proper operation. Internally illuminated exit signs should be added at all required egress doors and units that are in poor condition should be replaced. Emergency lighting units should be added so that all paths of egress are properly illuminated.

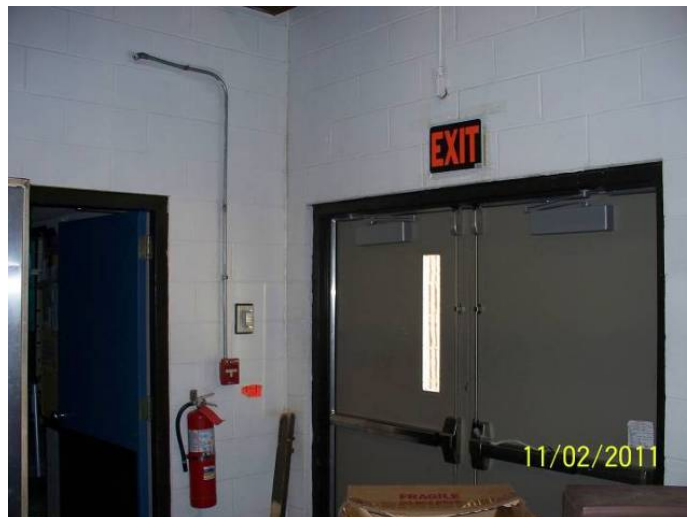
Non-illuminated exit sign

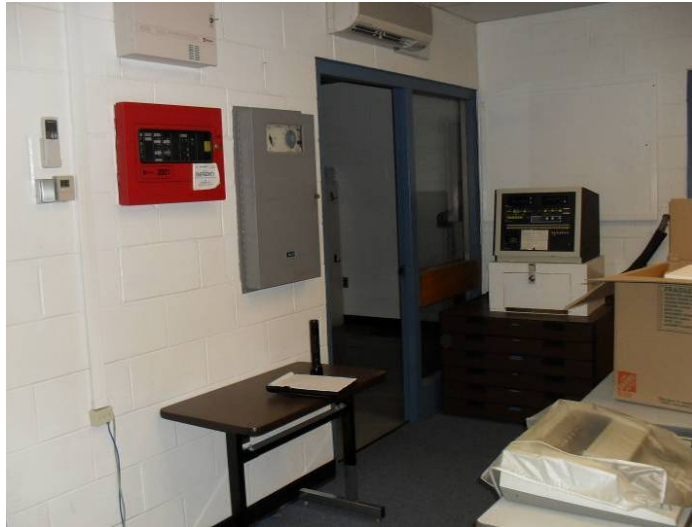
Fire alarm control panel  
In Main Office

The fire alarm control panel is a Simplex 2001 and is located in the Main Office, it appears to be original equipment (1972 – 40 years). This system communicates with Seacoast Security using a Silent Knight dialer (located near the Electrical Service Entrance). If/when an alarm condition is reported Seacoast contacts the Brunswick Fire Department. There are smoke detectors throughout the corridors and spaces that are open to corridors. Heat detectors are installed in private offices and other storage type spaces. There are pull stations located at all egress doors. Audio/visual devices are located throughout the school.

The fire alarm control panel is now obsolete and is no longer supported by the manufacturer. Although, additional audio/visual devices have been added since the school was built there are some locations that are not properly covered. This system is beyond its life expectancy and should be replaced.

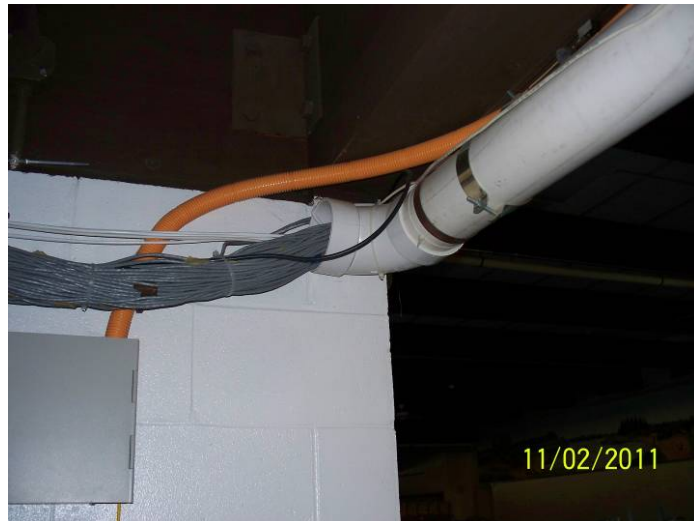
Data Cabling run in  
DWV pipes

The existing phone system appears relatively new and functional, however the phone wiring is in worse condition. Most if not all cables are run in surface raceways, with many not extended completely to the point of use. Data cabling has been run through the “Open Concept” space in drain waste and vent pipe. This is not a proper use for this “piping system”. Conduit rated for electrical cables should be used. Also, it appears that most spaces are lacking sufficient “drops” for telephone and data when compared to modern schools.

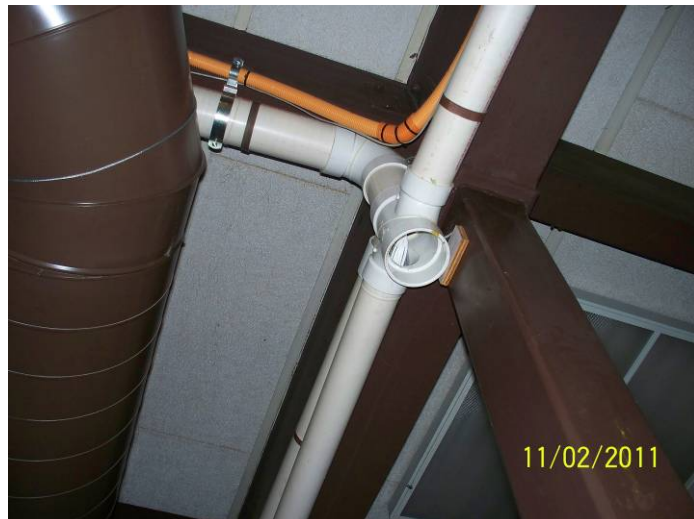
Typical Data Cabling  
routed in DWV pipe

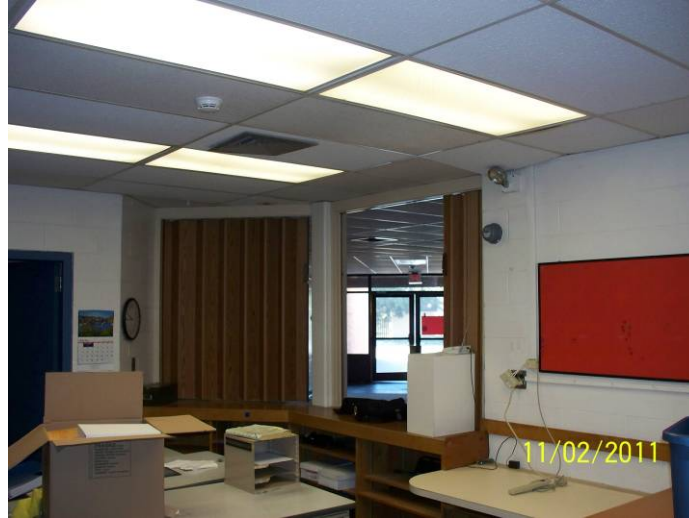
Typical Tel/Data  
cabling run surface to  
point of use

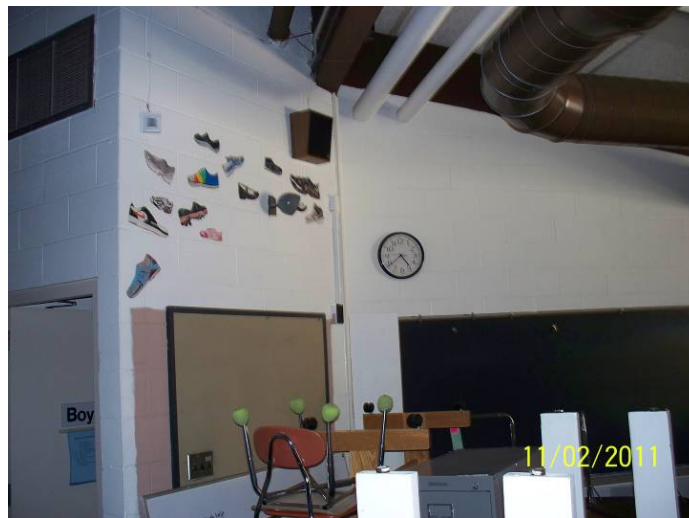
4:40 – Not working

Clocks throughout the school indicate a different time, some may be controlled by the central system whereas others are not.

The existing system should be removed and replaced with a new system if it is deemed necessary to have a central clock system in the building.

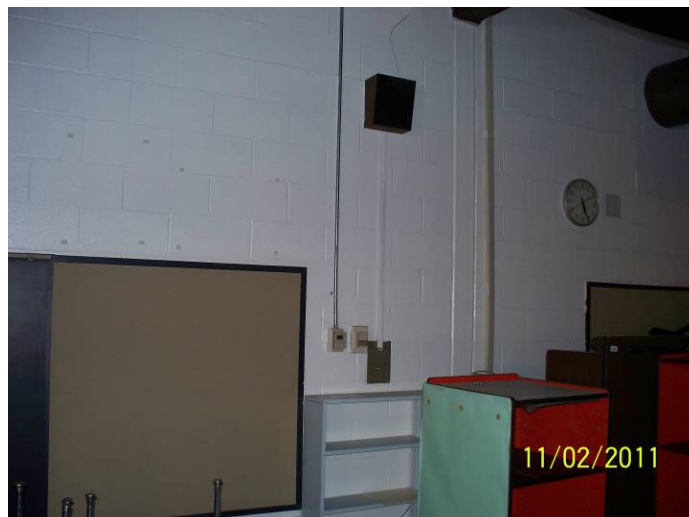
5:25 – Not working

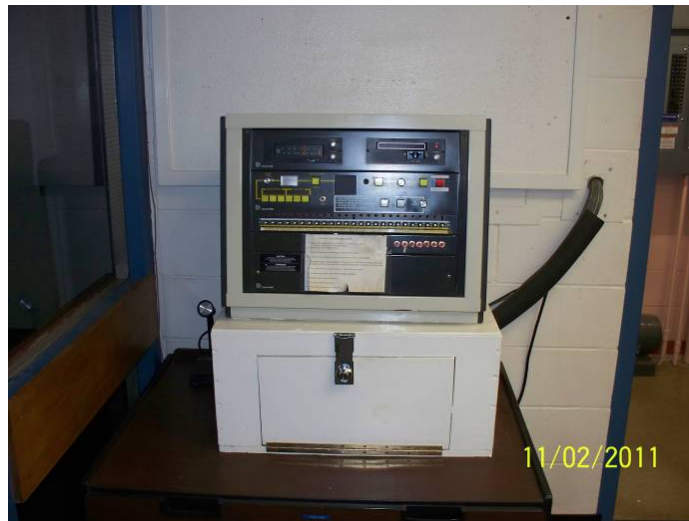
#### Main Console

The existing Dukane Intercom system is beyond its useful life and much of the surface wiring to the speakers is susceptible to damage. Dukane no longer manufactures parts for switch-bank type systems, therefore, any repairs requiring parts could lead to lengthy down time. Spare parts come from “old stock” and salvaged parts from old consoles.
