## Meeting Notes

To	
Paul Perzanoski, Facilities Committee, John Paige, Jean Skorapa, Paul Austin, JPL, RDM, JWT, BKB, FILE	
From	
Jeff Larimer	
Date	
December 5, 2011	
Project	
Brunswick School Department Facilities Master Plan Study Brunswick, ME Project No. 11533	
Subject	
STAFF MEETING OF NOVEMBER 28, 2011	
Present	
Jill Hodgdon	HBS Music
Shane Hutchings	HBS/Coffin PE
Lynn D'Agostino	HBS PE (previously JA)
Nancy Gray	HBS Art (previously Coffin)
Wende Sairio	HBS Library (previously Longfellow)
Margy Soule	Coffin Library
Sharon McCormack	BJRH/Coffin Art
Danielle Murphy	Coffin Music
Janet Rivard	Coffin Nurse
Emily Moll	HBS Art (previously Longfellow)
Nancy Farrand	HBS Counselor (previously JA)
Cindy Brown	HBS Music
Paul Austin	BSD Director of Student Services
Jeff Larimer	Harriman

### Capital Asset Management & Hazardous Materials Reports

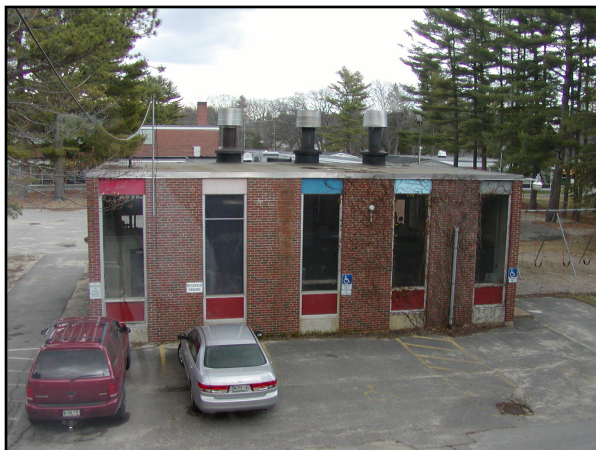
Boiler House

Front elevation of Boiler House.

There are three boilers; one is the original 44 H. B. smith that is out of service, the other two boilers and H. B. smith 4500 installed in 1983 with preferred burners designed to burn multi-grade fuel oil. They are currently burning No. 2 oil stored in a 10,000 underground oil tank. There are pneumatic controls located in the boiler room.

\*Staff reports removing the old boilers, expanding the tanks, adding a fuel oil transfer pump and installing 3 Buderus boilers, model G615 (1x9 section, 2x12 section) and Riello dual-fuel burners (1xRLS-70, 2xRLS-100). One Webster SPM-65-1-DA duplex fuel transfer pump set, 1 Taco AC6 air separator, and 3 Taco CBX-600 expansion tanks. Project was complete during Nov. 2006 for a cost of \$242,710.

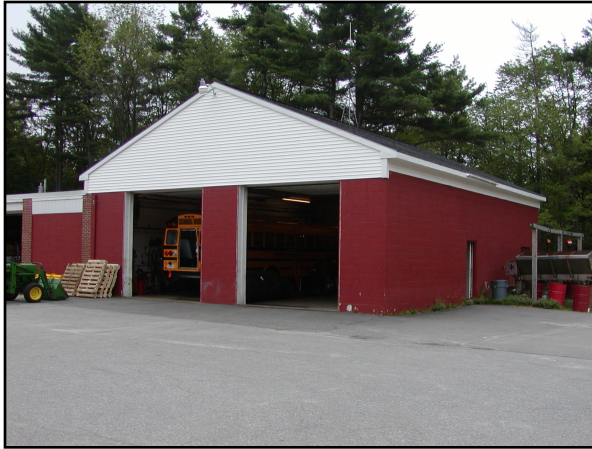
BBG B Wing

Front view of B Wing.

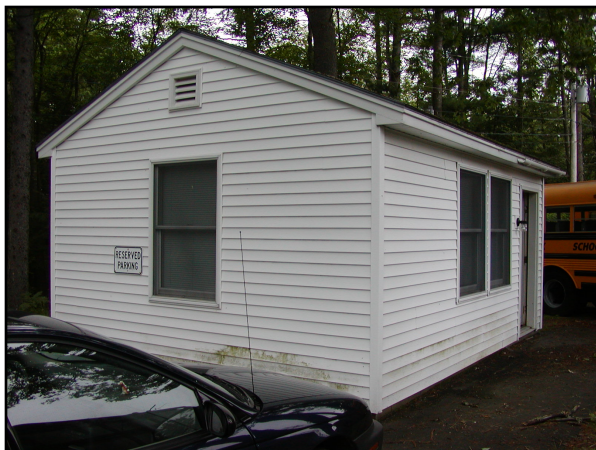
BBG Satellite Office

Side view of Satellite Office.

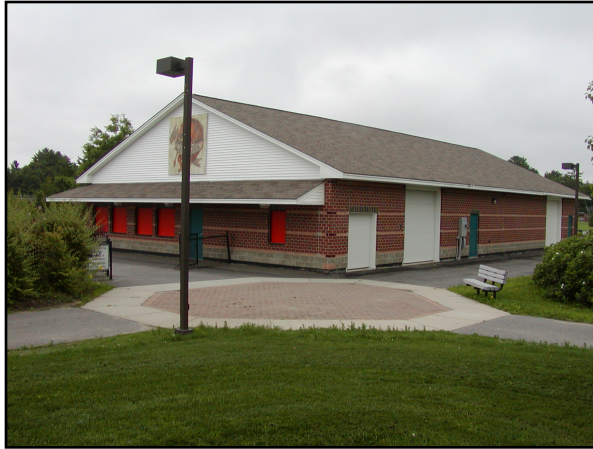
BHS Field House 1

View of Field house from High School.

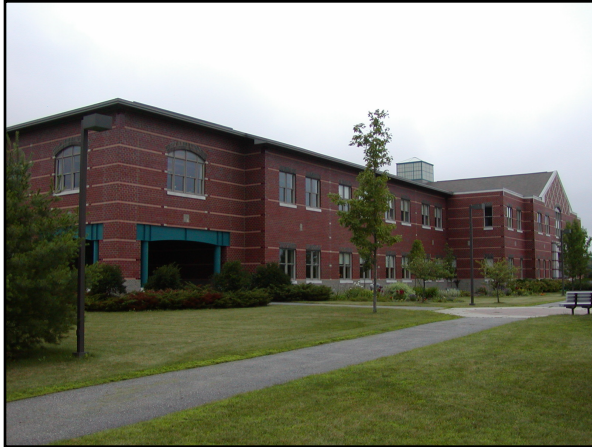
BHS A Wing

Side view of A Wing, 2- story classroom wing.
