## Coffin Elementary School

### Overview

### Coffin Elementary School

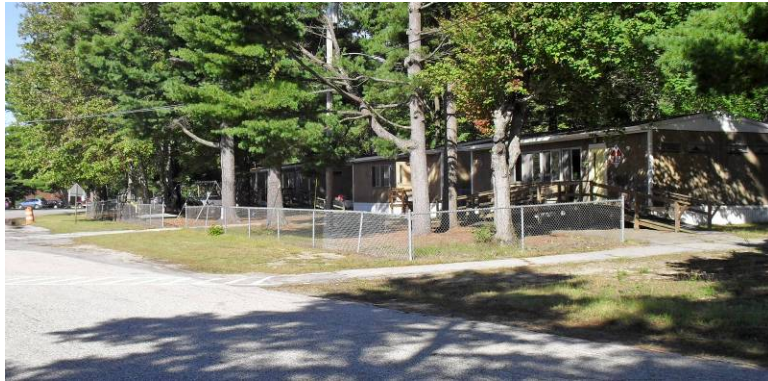
In addition to the main building, there are six temporary classroom buildings. Four of the buildings, in place since 1969, are single classroom modulares located across the main driveway at the front of the school. The other two are leased double classroom portables located in the open space between the rear classroom wing and the kitchen/cafeteria wing. Refer to site plan on previous page.

Portables across main  
driveway at front  
of Coffin School

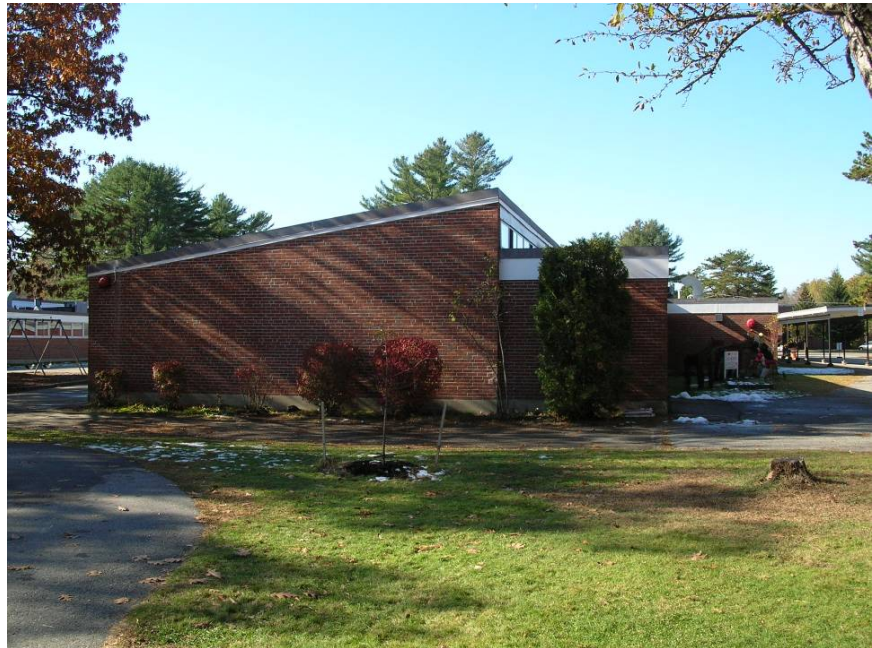
## Typical Classroom Wing

The existing roof framing consists of a combination of wood and steel members supported by interior steel columns and masonry bearing walls. The roof framing in the four classroom wings is identical. According to the original drawings, the members on the sloped surfaces consist of 4x10 wood beams spaced at approximately 6 feet on center. These beams span approximately 11 feet to 14" deep steel wide flange beams that frame to round steel pipe columns at both ends. The decking is indicated to be 2" thick tongue and groove planking spanning the 6 feet between beams. The roof framing in the flat roof areas consists of 2 x 12 joists spaced at 16" on center. These joists span 8 feet and 15 feet and are supported by masonry bearing walls.

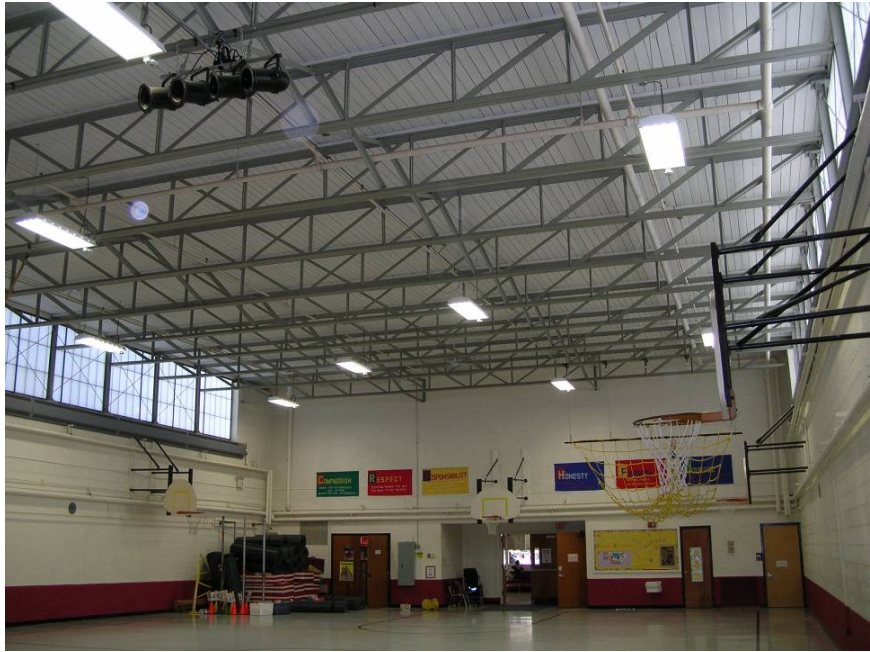
Roof Framing at Gym

The roof framing in the gymnasium consists of the same 2" wood decking on 30" deep long-span open web steel joists. Although the spacing could not be verified, it appears that they are approximately 6 feet on center and span 54 feet. These joists are connected to steel wide flange columns which are supported by the masonry bearing walls on both sides of the gym.

Due to the various ceiling materials, the majority of the roof framing was not visible during our site visit. No demolition was performed to expose any framing. Only the framing in the gymnasium and cafeteria was visible. In general the structure appears to be sound, and no obvious deterioration or damage was visible.

Again, it should be noted that no structural framing plans were available, and no physical verification of sizes was performed. Analysis of the gymnasium and cafeteria roofs was not performed due to lack of information. Further investigation of these areas should be performed to verify their adequacy.

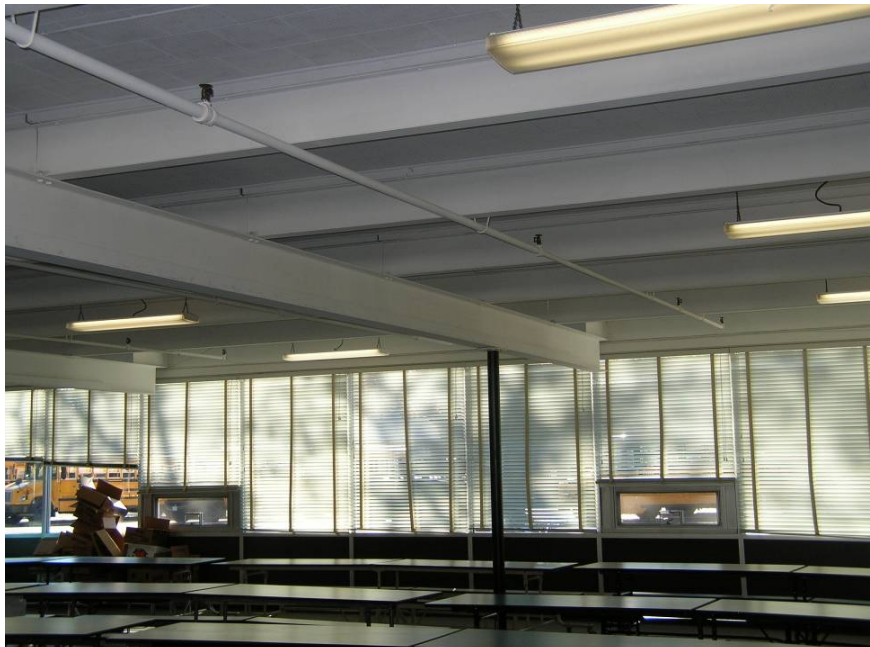
Roof Framing at Cafeteria

The roof framing in the cafeteria consists of 2" wood decking on 10" deep wide flange beams spaced at approximately 6 feet on center. These beams span approximately 19 feet to three 14" double cantilevered beams. The center span is 26 feet and the cantilevers are 12 feet on each side. These cantilevered beams were reinforced in 1992 during a re-roofing project. The interior columns are round steel pipe columns.

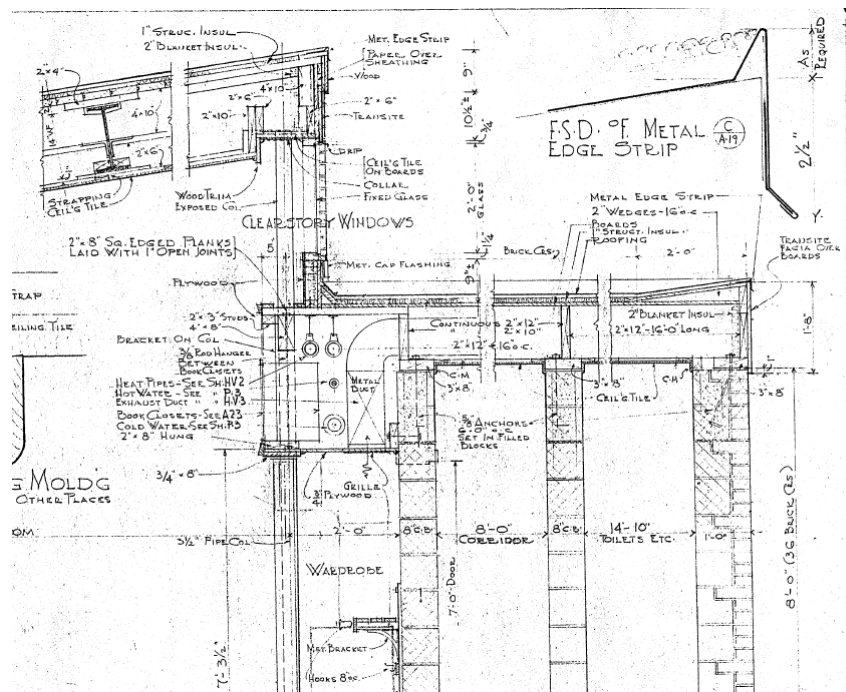
Typical Section at  
Classroom Roof

Our limited analysis indicated that the wood and steel framing at the classroom wings is capable of supporting the current code required snow loads without reinforcement. This is based on the following assumptions:

- § All framing sizes are as indicated on architectural sections
- § No alterations have been done to any framing members
- § No damage due to water infiltration has occurred
- § The wood species used is equivalent to Spruce-Pine-Fir #1

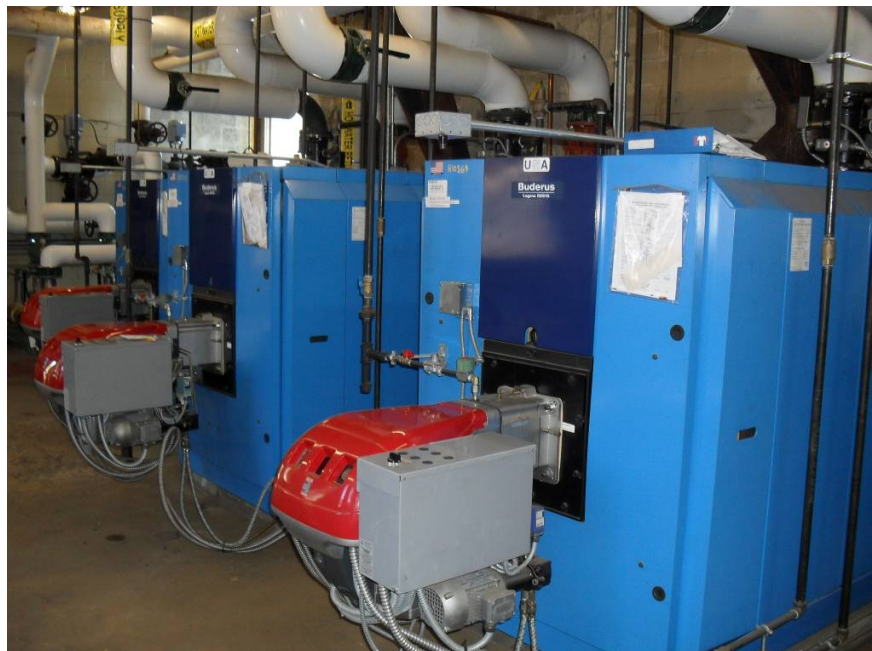
Figure 1 – Cast Iron Boilers

The three boilers that were installed in 2006 are manufactured by Buderus. Each of the boilers is equipped with dual fuel Riello burners. Boiler number one has a gross rating of 1,951 mbh and a net rating of 1,697 mbh. The remaining two boilers have a gross rating of 2,822 mbh and a net rating of 2,454 mbh. When the boilers were converted to burn natural gas a couple years ago, the oil piping coming into the boiler room from a underground oil tank were cut, capped and abandoned in place.

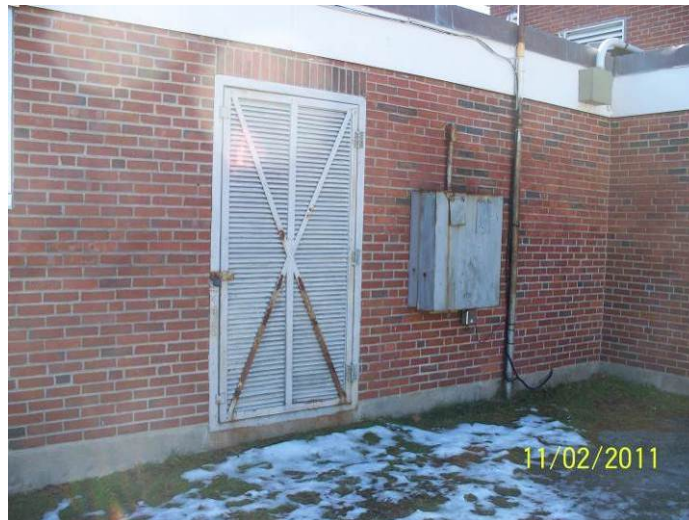
## Transformer Vault

The Coffin Elementary School is served by three 50kVA (150kVA total) transformers located in a locked vault. This 208V-3Ø-4W service is fed from an underground primary distribution system. Information from Central Maine Power indicates that the maximum demand to date has been 86 kW.

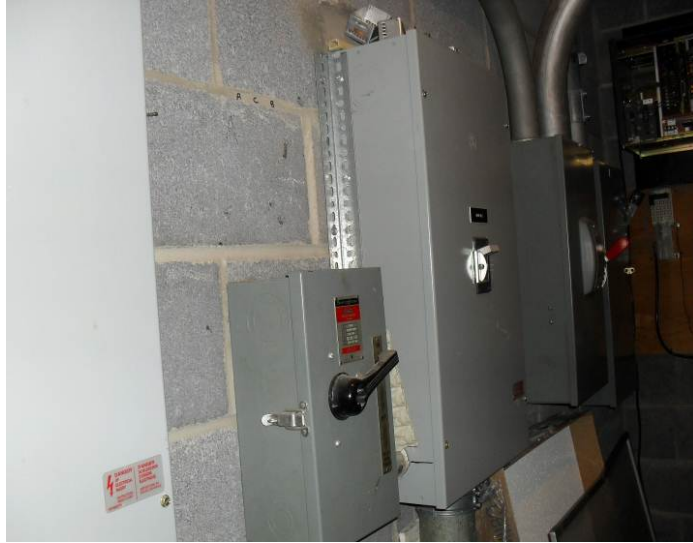
Main #2

The electrical service entrance is made up of a variety of equipment with multiple mains, Main #1, Main #2, Main #3 (mobiles), and Main #4 (mobiles). None of this equipment has the clearances required by NEC. Main #1 & #2 are circuit breakers and the rest are fused switches.

The equipment that comprises the service entrance is in violation of the National Electric Code because of lack of required clearances. Also, the configuration of multiple main breakers may be a safety concern as it is quite confusing as to which main controls which sub-panels. The capacity of the existing service is currently limited by the transformers located in the vault to 150kVA, but, the equipment when totaled (Main #1 - 400A @ 208V/3Ø), (Main #2 - 400A @ 208V/3Ø), (Main #3 - 200A @ 208V/1Ø), (Main #4 - 200A @ 208V/1Ø) is capable of approximately 297kW. This is very low for a building of this size (57k SF +/-). Most of the existing sub-panels are relatively new and in good condition, but, the panels in the Kitchen area are not in good condition and have been modified.

The existing service entrance equipment should be upgraded to combine distribution and eliminate mains, provide required clearances and additional capacity if deemed necessary. The main distribution panel is very old and unsafe and should be replaced as soon as possible. The electrical needs in the Kitchen should be evaluated and the panels upgraded accordingly. Replacing the existing service entrance equipment and getting the required clearances is going to be difficult as there is limited space available to work with.

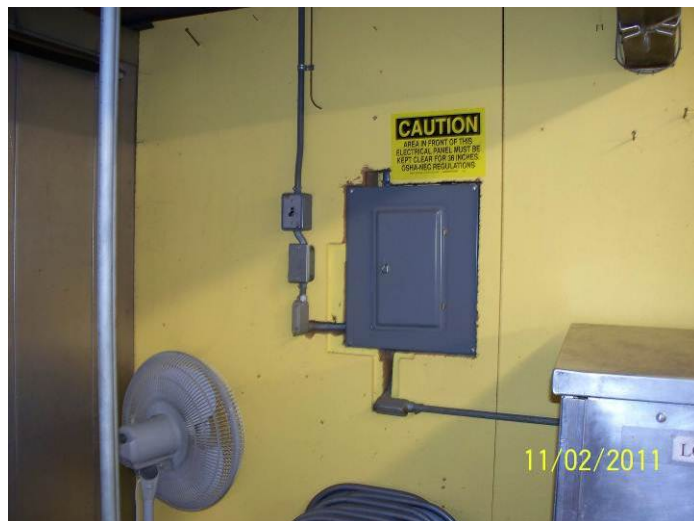
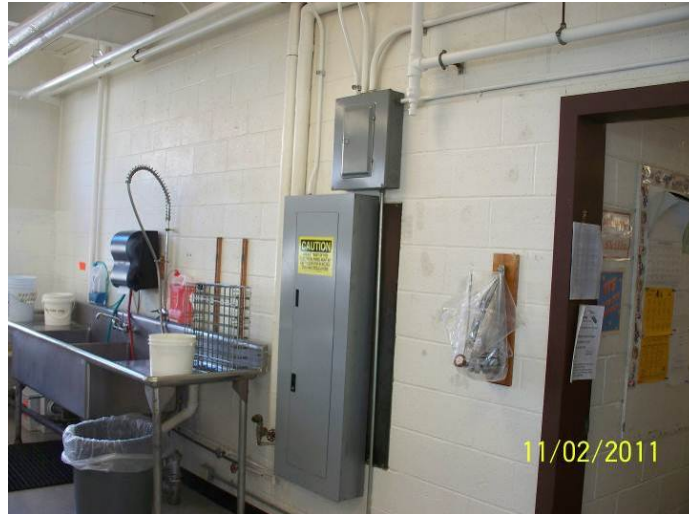
The main distribution panel is a very old fuse type panel, with some dead-front panels missing that expose live parts when the door is opened. Sub-panels are located in the corridors of each wing, multi-purpose space, boiler room, and kitchen. This is a good distribution that limits the lengths of branch circuits to acceptable distances. Most sub-panels appear to be in serviceable condition. The panels in the kitchen have been modified indicating the original panels do not provide the necessary circuitry.

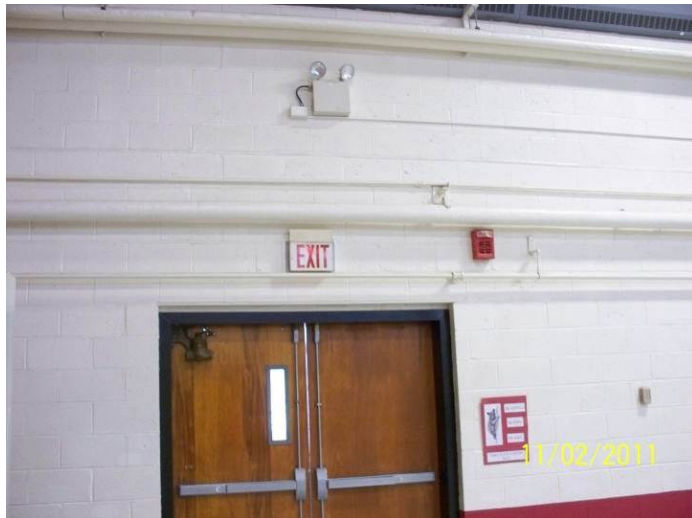
The Coffin Elementary School is served with self-contained (each unit has its own battery) exit signs and emergency life safety lighting throughout the building. Many of the exit signs do not appear to be working under normal conditions.

Self-contained exit sign (appears to be ON)

All battery units should be tested to verify proper operation. Internally illuminated exit signs should be added at all required egress doors and units that are in poor condition should be replaced. Emergency lighting units and exit signs should be added so that all paths of egress are properly marked and illuminated.

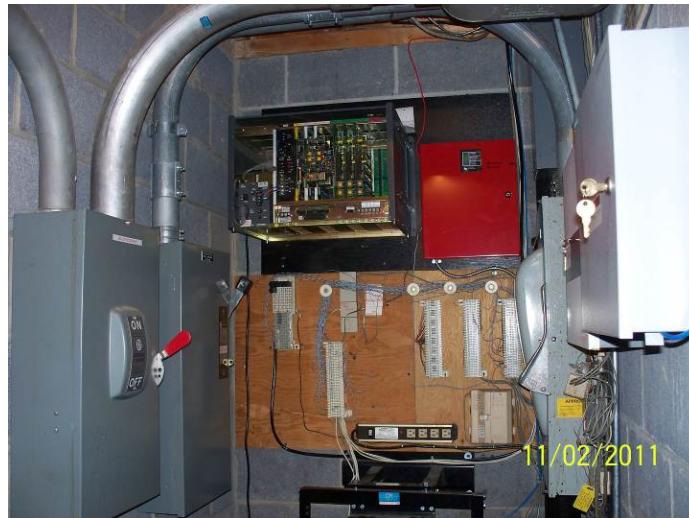
Telephone Backboard

The phone system is by Avaya and is rack mounted in the Electrical room between Main #3 and Main #4. This system is impeding on the required clear space in front of the electrical equipment. This system appears to be in service able condition. Also, the school network fiber connection to the internet was noted at this location. connection to the internet. There is also a data rack at the opposite end of the room that is floor mounted in front of the electrical main distribution panel, impeding the required clear space in front of that panel. Voice/data outlets appear to have been added throughout the school as needed, with cabling strung and run haphazardly. In locations where multiple PC's are located, wireless hubs have been installed.

The existing phone system appears functional, but, the space it occupies is needed for required clearance for electrical equipment. Voice/data cabling is in very poor condition in this building. All cables are run on building surfaces, many without raceways. These cables are very susceptible to damage. Also, it appears that most spaces are lacking sufficient “drops” for telephone and data when compared to modern schools.

A new space should be allocated for voice/data equipment to provide clear space in front of the electrical equipment. The existing cabling system should be replaced with new cables that are properly supported and protected. Connectivity should be upgraded to at least Cat 5e and to Cat 6 if budget allows.

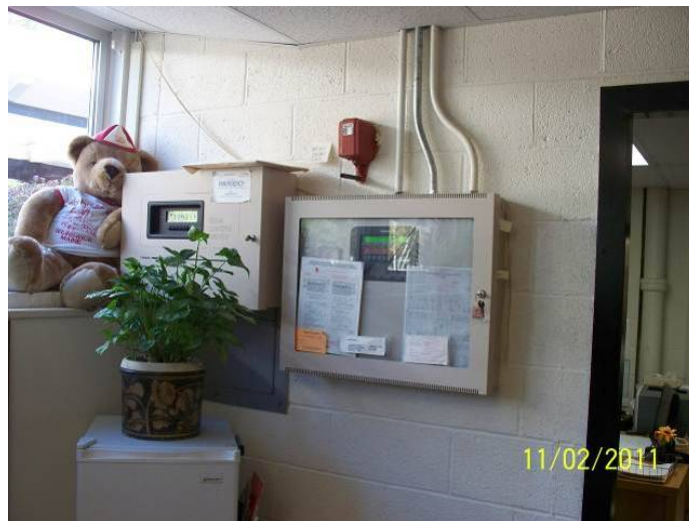
The existing system is a Simplex #6351 Master Time Control Center and is located in the main office. This system is reported by Simplex to be functional at this time. A system upgrade to automatically adjust to Daylight Savings Time is available.

Clock control panel in Main Office

The system is in serviceable condition and appears to be working properly at this time.

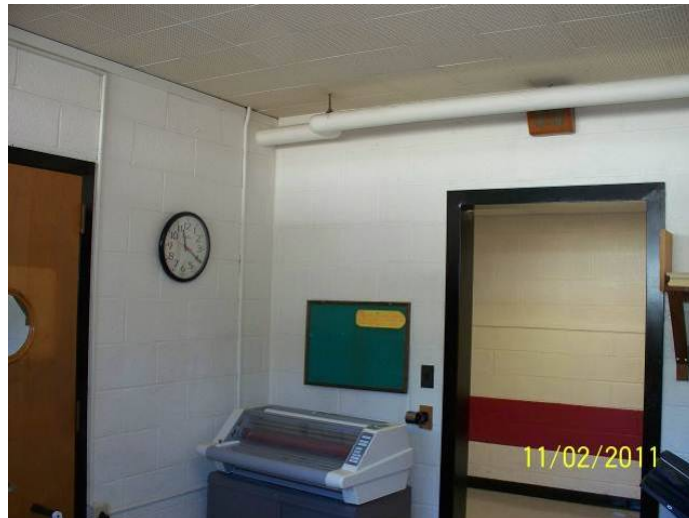
Typical clock (1)

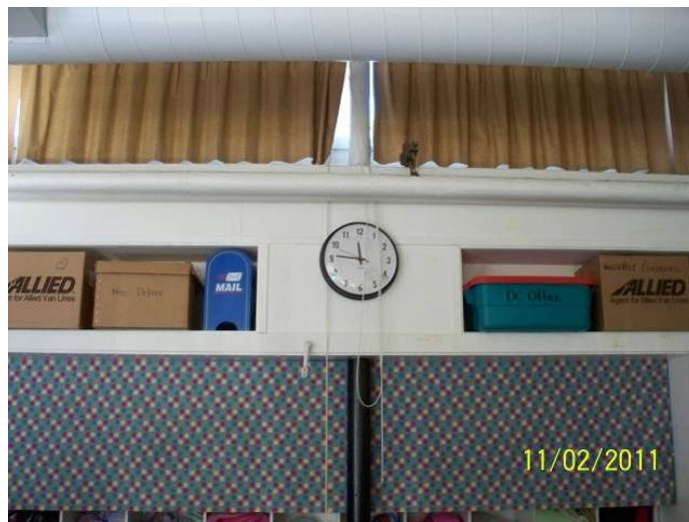
Typical clock (2)
