# Brunswick Junior High School

## Overview

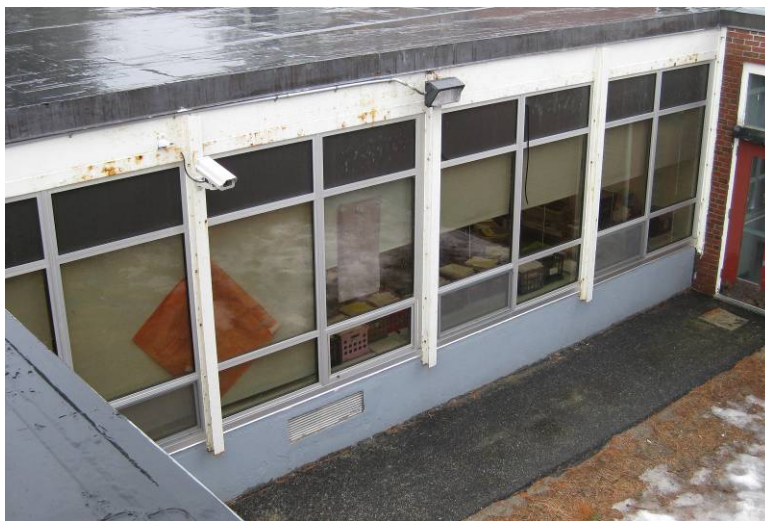
Original 1959  
Windowwall

There have been a variety of window types used relative to the different additions and renovations. Aluminum windowwall was used on the original 1959 building along with the 1966 classroom addition. The 1976 additions and the 1983 renovations used non-clad wood windows. There is glazed aluminum storefront at the main and gym entrances. All glazing appears to be insulated glass. It has been reported that much of the original windowwall is leaking. In addition, some of the wood windows are rotting. This is particularly evident at the clerestory windows of the 1976 classroom addition. The windows in the gym are translucent wall panels – Kalwall - that were installed in 2000. Replacement of the original windowwall and the rotting wood windows should be a priority and are currently included in the capital improvement budget. Replacement of the remaining wood windows in the two story wing, although not a high priority, should be considered for a future project.

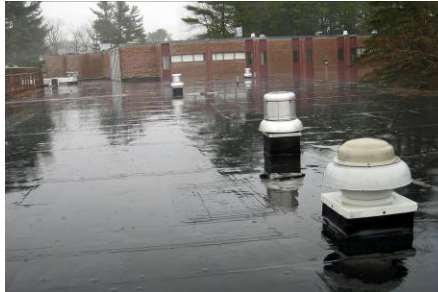
1966 wing looking east

All of the roofs are of a single-ply rubber membrane that is fully adhered typically over a base of rigid insulation. The one exception is the roof on the two-story classroom wing, which includes a layer of stone for ballast that is typically installed over top of the loose laid membrane to keep the membrane in place. The roof on the classroom wing was done in 1983 during the fire restoration.

The roofs all drain internally to roof drains that are installed in sumps. There was a reroofing project done in 1992 that originally included installation of tapered insulation to improve drainage to the drains but apparently much of the tapered insulation was deleted around the outer areas of roof that has resulted in those areas being flat with no pitch. It is not known why areas of the tapered insulation were deleted. The lack of tapered insulation over much of the roof is a contributing factor to water draining over the edge of the roof and down the face of the building impacting the windows and the brick. Consideration should be given to correcting this condition in the near future to eliminate the drainage problems by adding a raised curb or parapet or reroofing the affected areas and adding tapered insulation.

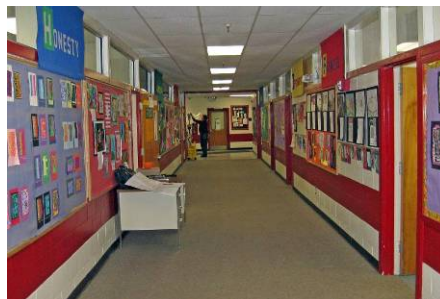
1959 Admin & Classroom Corridor

In many instances, the carpet in the Admin area and in the 1966 wing was installed over the original vinyl asbestos tile. Some of the areas that originally had vinyl asbestos tile have had vinyl composition tile installed directly over the asbestos tile thus encapsulating it. A few areas have had the asbestos tile removed and replaced with new flooring. The carpets in most areas are past their useful life and should be considered for replacement. At the time the carpeted areas are replaced, whether it is with new carpet or vinyl composition tile, the original asbestos tile should be removed at that time.

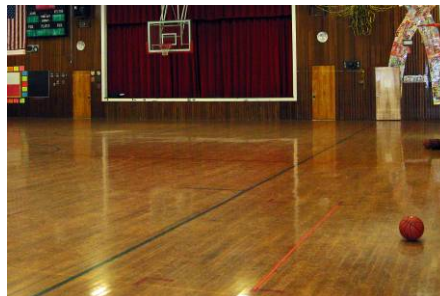
The gym floor is wood and generally in good condition but is in need of refinishing to restore it to its original condition. The adjoining small gym has a resilient floor and is in reasonable condition. The fitness room and locker rooms are painted concrete while the toilet and shower areas are ceramic tile.

Main Gym – Wood Floor

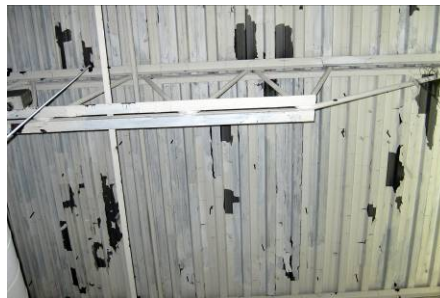
Painted Metal Deck in Art/Chorus

Most of the suspended ceilings are in reasonably good shape. Some of the ceilings in the 1966 classrooms have some tile that have been displaced and may just need some readjustment. The painted finish on the exposed metal deck in the chorus and art rooms is peeling off and needs to be stripped and refinished. The peeling is probably attributable to incompatibility between the metal deck and the paint. The metal ceiling in the lobby has loose sections and the original integrated lights are no longer used. This ceiling should be considered for replacement.

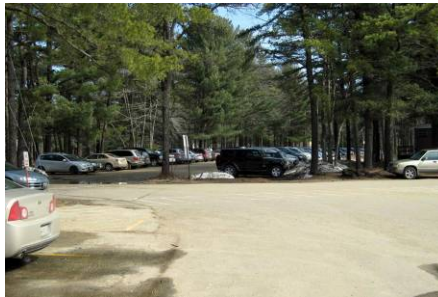
Main Drive at Parking Lot

Overall, the driveway and parking pavements are in acceptable serviceable condition, without significant deterioration. A program of patching cracks with hot-applied flexible crack sealer will help prolong the pavement life by keeping water from saturating the cracks and accelerating break-up. Currently there is no fire truck access drive around the west and south sides of the building. Historically, the maintenance crews have plowed a roadway around the building on the grass during the winter. A gravel or paved access drive approximately 10 feet wide would be recommended around the building. There are also approximately four doorways around the building that open on to lawn areas with no walkway. In the winter these doors must be accessed with a shoveled path away from the building for emergency exit. Gravel or paved walks should be constructed to each exterior door to facilitate snow removal and emergency exiting, and perhaps could be combined with a new fire lane.

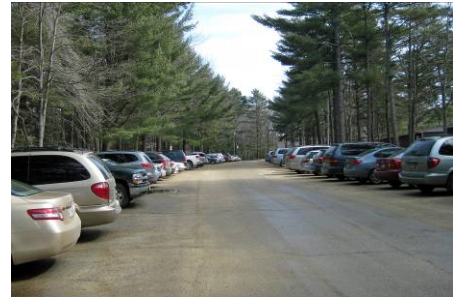
Shared Parking Lot

There is one large parking lot shared by staff and visitors for both schools that accommodates approximately 109 vehicles. There is some designated parking along the main driveway in front of the junior high school and adjacent to the boiler house. Between the two schools, there are a total of about 169 parking spaces including designated handicap spaces. It has been reported that the total number of spaces currently provided is inadequate during certain events.

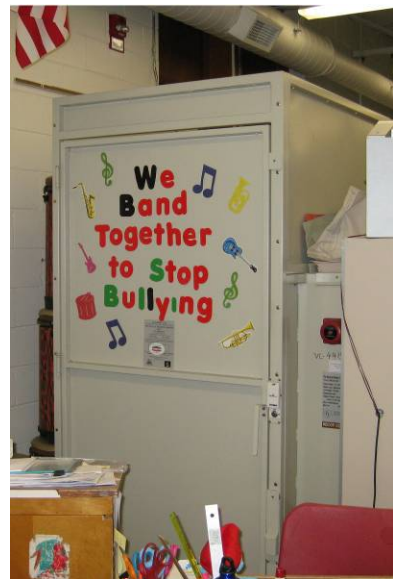
The music room and the stage are also at different levels than the first floor. Two vertical lifts have been installed – one at each location – to provide access to those two functions. It does not appear that the lifts are used frequently as both are blocked by furniture.

Vertical Lift in Music Room

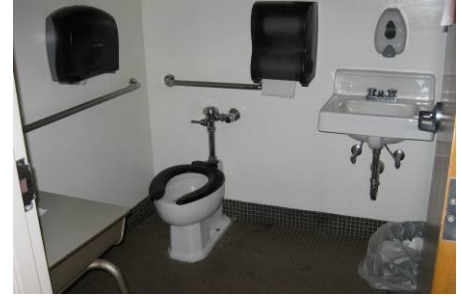
None of the student toilet rooms and most of the staff toilets rooms are not handicap accessible. A couple of single user toilets have had modifications made to them to provide limited accessibility but they are not fully compliant as they lack proper clearances, fixtures, pipe protection and grab bars. The existing toilet rooms should be fully renovated to provide compliant and accessible fixtures, paths of travel and maneuvering clearances. New fixtures would also offer water

Non-Compliant "Handicap" Toilet Room

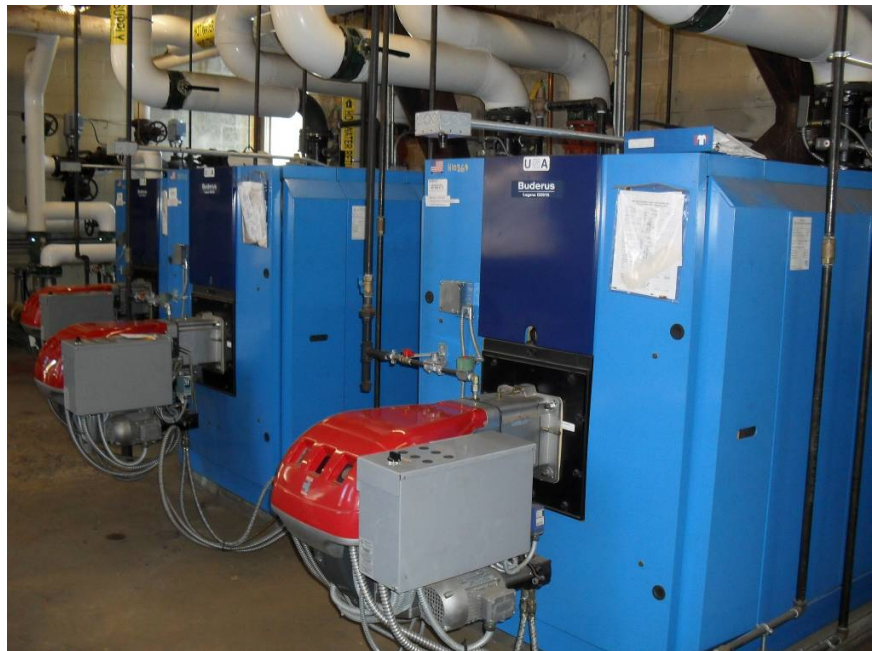
The three boilers that were installed in 2006 are manufactured by Buderus. Each of the boilers is equipped with dual fuel Riello burners. Boiler number one has a gross rating of 1,951 mbh and a net rating of 1,697 mbh. The remaining two boilers have a gross rating of 2,822 mbh and a net rating of 2,454 mbh. When the boilers were converted to burn natural gas a few years ago, the oil piping coming into the boiler room from an underground oil tank were cut, capped and abandoned in place.

Figure 1 – Cast Iron Boilers

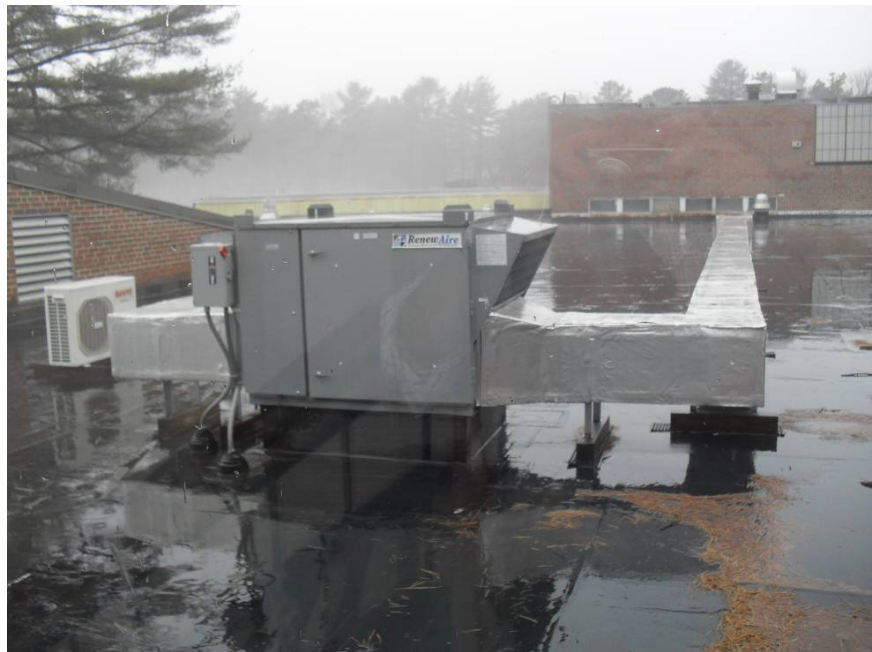
Figure 7 - Typical rooftop energy recovery unit

Over the recent several years (2006 to present), the primary ventilation system for the 200 wing classrooms, a portion of the 300 classroom wing and the cafeteria was upgraded with the installation of 9 rooftop energy recovery units and one inside energy recovery unit. These units range in airflow capacity from 1,500 cfm down to 380 cfm. These units are all manufactured by Renewaire except for the Cafeteria unit, which is manufactured by Cook. A significant amount of the ductwork serving the 200 wing is exposed to the elements and located on the roof. The ductwork serving the 300 wing area is located within the facility however it is exposed along the common corridor. During the 1983 renovation of the classroom wings (100 and 200), new ceiling hung unit ventilators were provided. Outside air was brought into the backs of the UV's via ducts that were connected to exterior wall louvers. Independent barometric pressure relief dampers and louvers were provided to account for relieving the air to the outside. Some of the ductwork associated with a couple of these units is exposed with exposed heating coils and associated piping. A five ton Trane rooftop cooling only unit was also recently provided for the Administration area of the facility. Its ductwork is primarily exposed within the space.

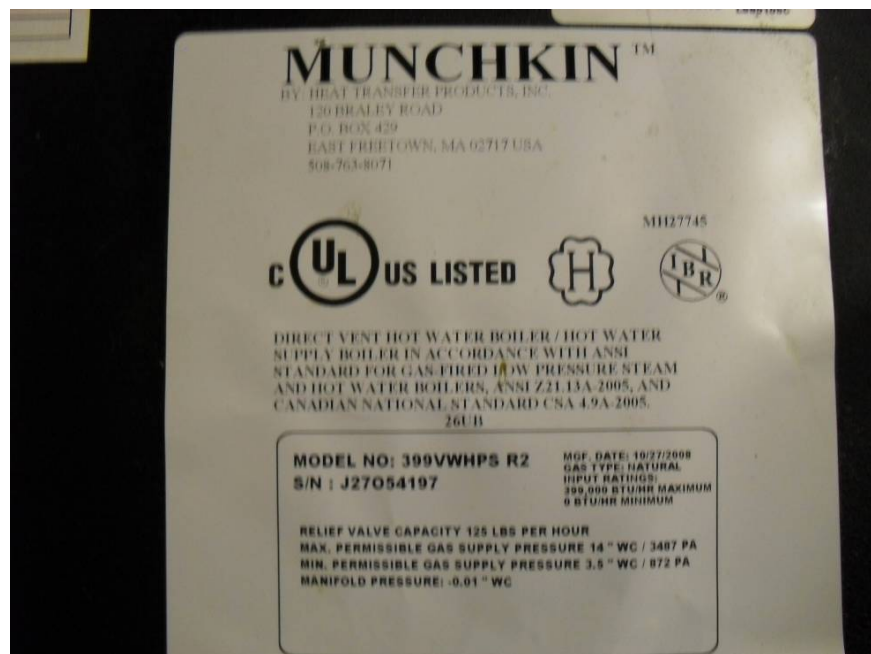
Figure 8 – Primary Domestic Water Heater Nameplate

The primary source for domestic hot water is provided by a natural gas fired direct vent hot water heater. The water heater is manufactured by Munchkin. The model number is 399VWHPS R2. Its input capacity is 399.9 mbh. The DHW is connected to three 115 gallon Superstor tanks. This water heater is relatively new and should last for several years to come. There is a DHW recirculation loop throughout the facility. The recirculation pump is located adjacent to the storage tanks. Reports are that the pump still takes significant time to get hot water out to the more remote parts of the school. Further investigation revealed that during the 1983 construction work in the 100 and 200 wings, the DHW recirculation loop piping was actually disconnected. We believe that if the piping in this area is reconnected to the primary recirculation loop, the time in which it takes to get DHW down to the ends of the 100, 200 and 300 wings will be dramatically reduced. There are also a couple other isolated electric water heaters located within the school. One in the health sciences wing and one in the Special Ed wing.

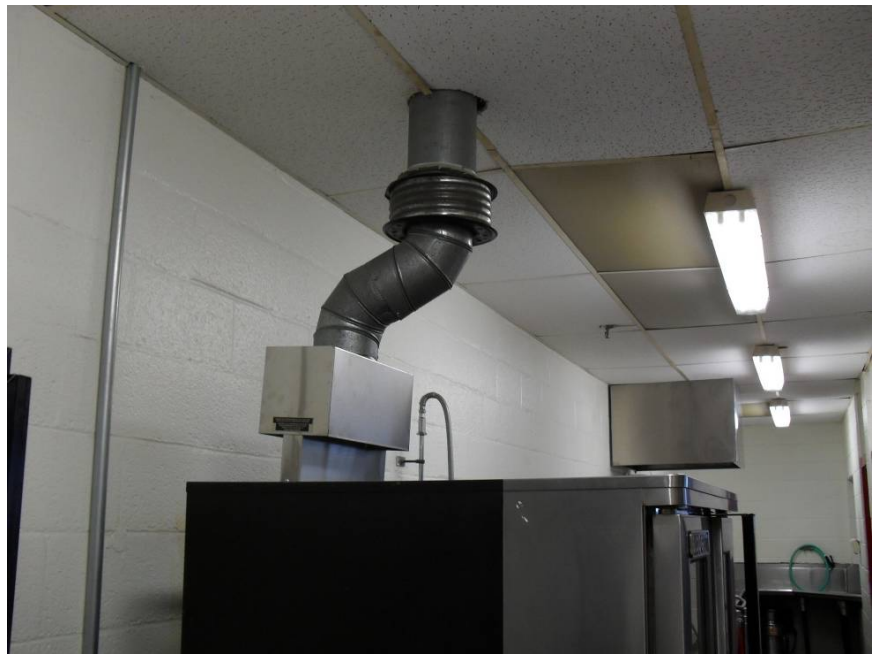
Figure 11 – Kitchen  
Ovens and Dishwasher  
Hood

The kitchen which is located directly off the cafeteria is only used as a warming kitchen. It is equipped with a couple of commercial ovens and a commercial dishwasher. During the end of 2011 and the first of 2012, a new roof mounted energy recovery unit was installed to provide a higher level of ventilation. A duct mounted hot water heating coil is located in the supply duct main just as it drops through the suspended ceiling outside the Ala Carte area of the cafeteria. The duct work is all exposed in the cafeteria. At the time of our site visit, the system had not been activated and automated by the control system. At the time of this writing, we have been told that it is now completely automated and operational.

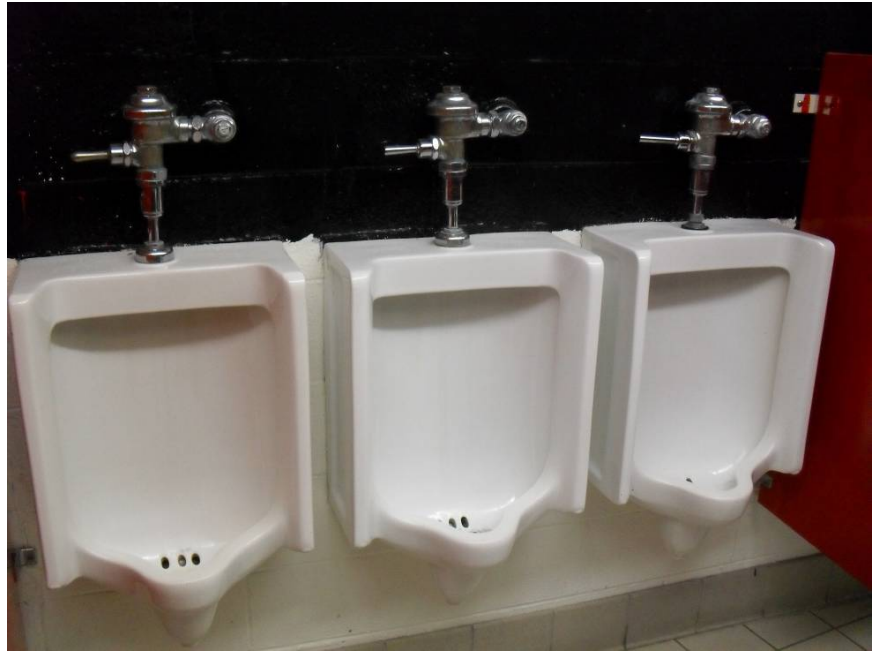
Figure 14 - Typical  
Urinal Bank

The plumbing fixtures appear to all be original. The water closets are approximately flushing at 3.5 gallons per minute and the urinals are flushing at 1.25 gallons per minute. No handicap fixtures were noted throughout the school.

Plumbing	<p>Since all of the plumbing fixtures appear to be original, we would recommend replacing them with low flow fixtures. Even though there are several handicap stalls located throughout the facility the plumbing fixtures located within the stalls are not handicap accessible and will also be required to be brought up to comply with ADA requirements. Additional modifications will be required to make all lavatories and toilets accessible as well. Opinion of probable cost - \$1,000 per fixture.</p> <p>Reconnect DHW recirculation loop piping in the connecting corridor area of the 100, 200 and 300 wings. Opinion of probable cost - \$24,000.</p> <p>The existing gas fired domestic water heater located on the Mezzanine above the stage is not currently DDC automated. Recommend providing full automation. Opinion of probable cost – \$12,000.</p>

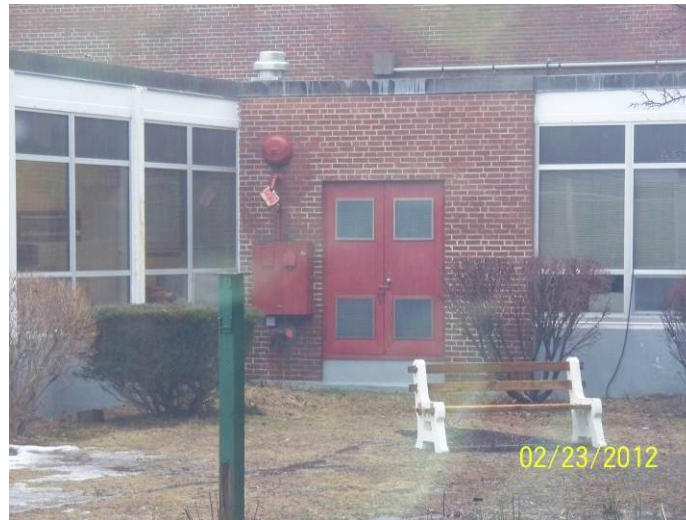
#### Transformer Vault & CMP Metering Cab.

The Brunswick Junior High School is served by three 50kVA (150kVA total) transformers located in a locked vault. This 208V-3Ø-4W service is fed from an underground primary distribution system originating at the utility pole in front of the school. Information from Central Maine Power indicates that the maximum demand to date has been 136 kW.

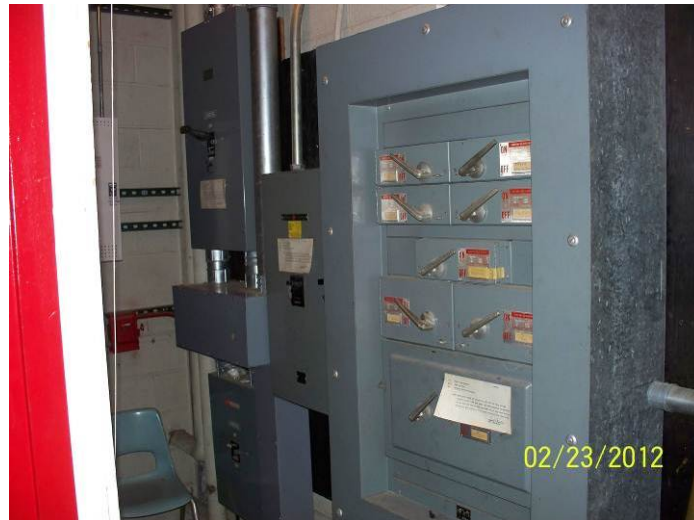
Main Disconnects:

The existing electrical service consists of multiple main disconnects that have been added over the years as the school has been expanded. The original electrical service was rated for 400A at 208/120V, and is located in an electrical room that backs up to the transformer vault. This room is very small and does not provide the clearances required by the NEC. Also located in this room are the main disconnects for the following 1976 additions; “Shop/Home Economics” (600A-208/120V), “Media-Center/Library” (400A-208/120V) and the “Gym/Cafeteria” (100A-208/120V). All main disconnects are circuit breaker type, the main distribution panel is switch and fuse. As the school has expanded distribution panels have been added and are fairly well distributed. This provides efficient electrical service to loads throughout the school. Sub-panels serving branch circuits are scattered throughout and are of many different manufactures/types, most of which are no longer manufactured.

- § The equipment that comprises the service entrance is in violation of the National Electric Code because of lack of required clearances.
- § Also, there may be a mistake in the labeling of the mains for MDP1 and MDP2, this should be verified.

The existing service entrance equipment should be upgraded, reducing the number of mains and providing required clearances and additional capacity if necessary. All of the older sub-panels should be replaced with new panels providing additional circuit capacity and maintainable equipment. Additional transformer capacity will be required if additional loads are added to the building.

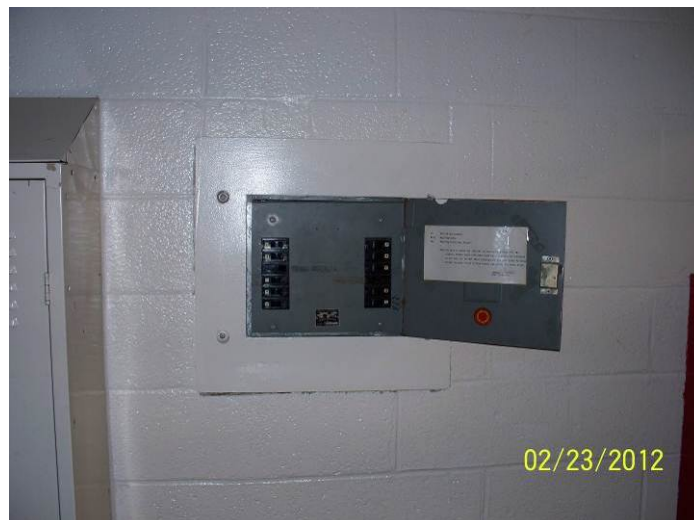
Typical panel (L6)  
located in corridor near  
Gymnasium.

- § Most of the existing sub-panels appear to be original (installed when the respective additions were built), between 30 and 40+ years old. Much of the equipment is from manufacturers that are no longer in business and other equipment has been discontinued and is no longer supported by replacement parts.

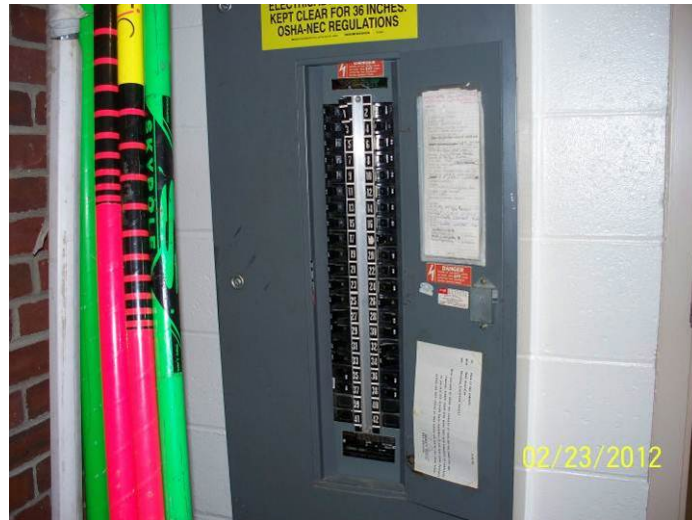
Sub-Panel (LG) located  
in Gym Storage

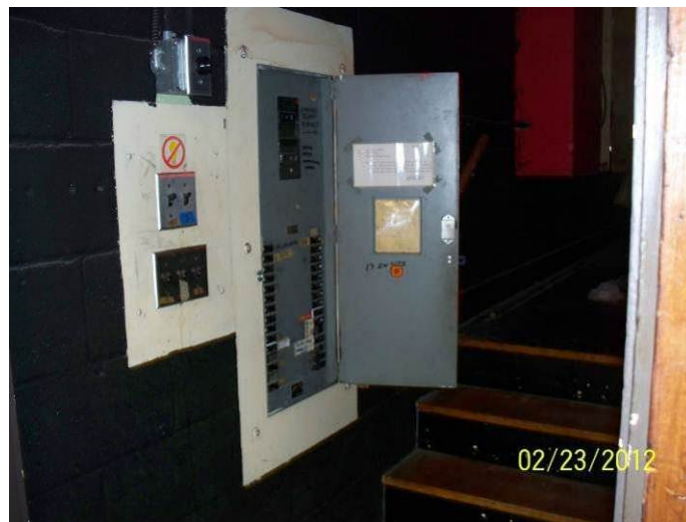
Sub-Panel (L5)  
located in Stage area

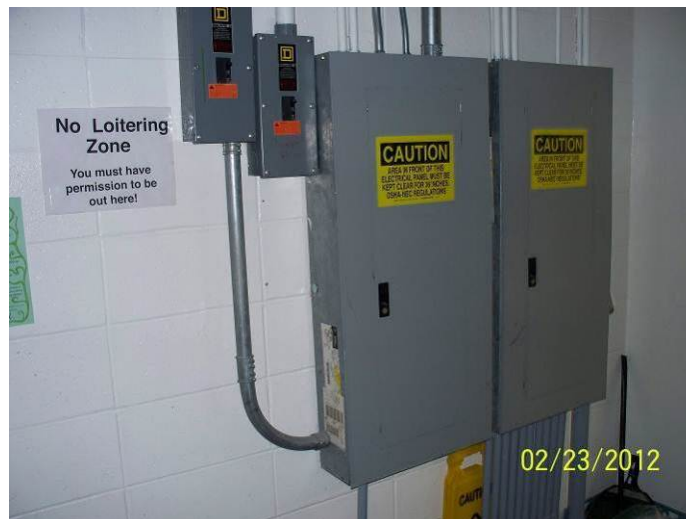
Sub-Panel (PM) in  
Shop Wing

- § The panels located in the Shop/Home Economics wing are relatively new and in good condition.

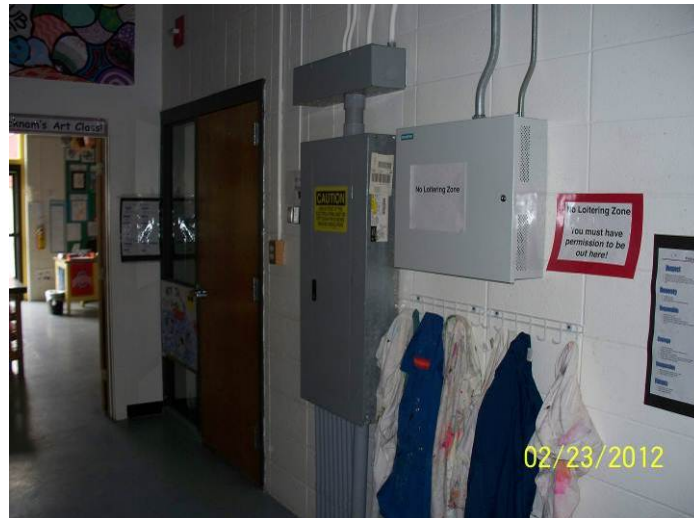
Sub-Panel (PW) in  
Shop Wing

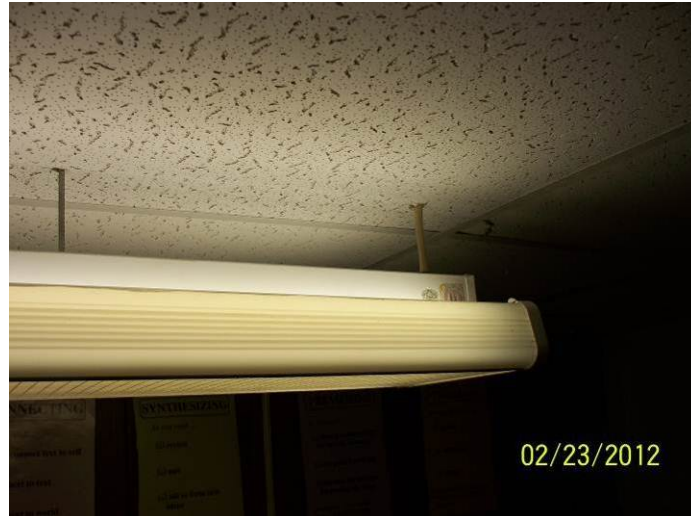
Romex - passing through  
ceiling tile.

- § Romex is not approved for use other than as building wiring. All fixtures being fed with romex through ceiling tiles should be retrofitted with cords through canopies and junction boxes. It is a code violation to run wiring through building finishes.
-

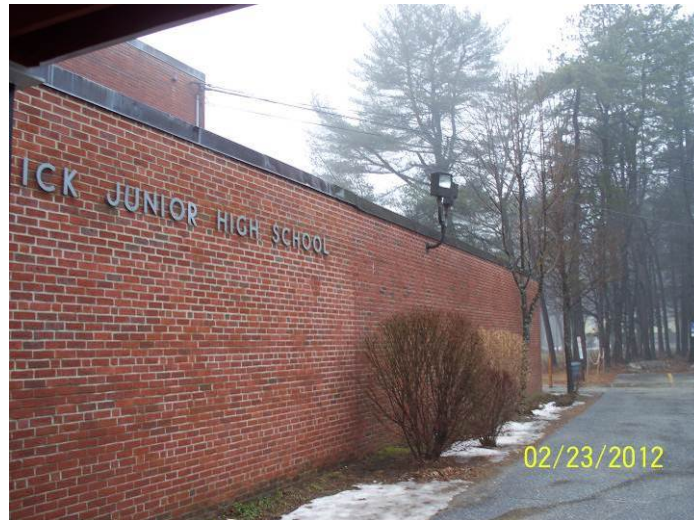
Flood Lights at front of school

The existing lighting fixtures throughout the facility have been upgraded to T8 lamps and electronic ballasts (T5 lamps in Gymnasium), are in relatively good condition and appear to provide adequate illumination. Most spaces have automatic controls to shut off lights when spaces are not occupied. Few, if any rooms/spaces appear to be candidates for day lighting controls, as there are many tall trees around the school. None of the exterior fixtures are full-cutoff, this creates a lot of glare and could lead to light trespass complaints from neighbors.

- § Cove type lighting in classrooms should be reviewed closely and most likely be eliminated to provide a more efficient installation.
  - § Exterior lighting should be considered for replacement with more efficient LED full cutoff fixtures.

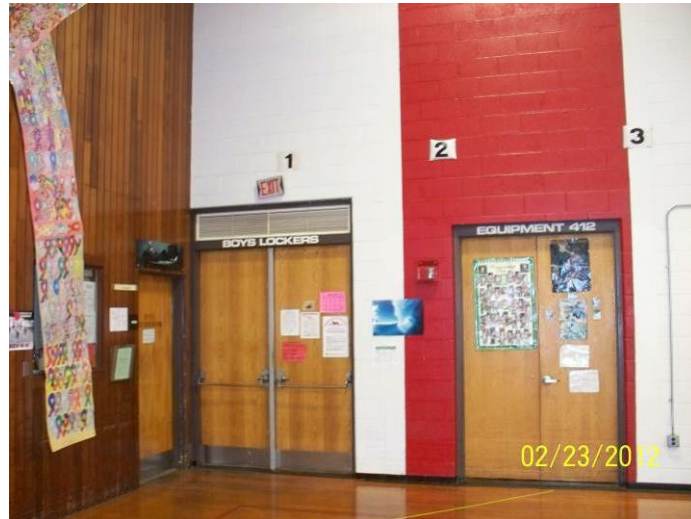
This school is primarily served with central emergency battery units and remote emergency heads and exit signs; there is no emergency generator. Some self-contained emergency battery units with integral emergency heads are being used to supplement the remote emergency lighting heads. Many of the existing exit signs were identified as being in a state of disrepair.

Exit Sign  
(Gymnasium)

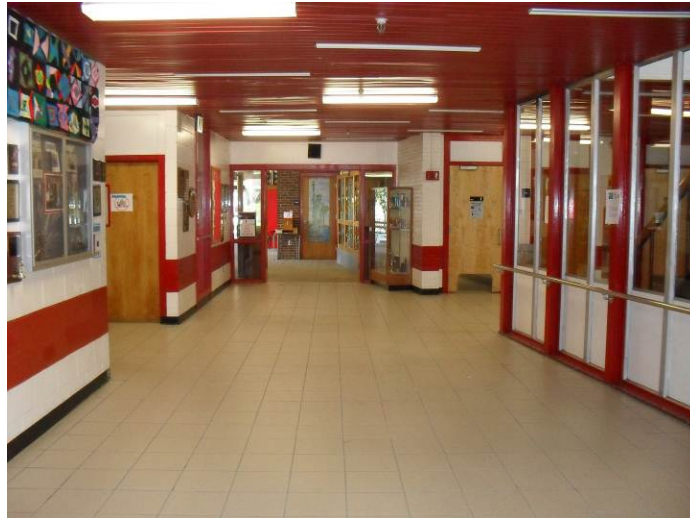
No Exit Signs are visible (approaching Main Lobby)

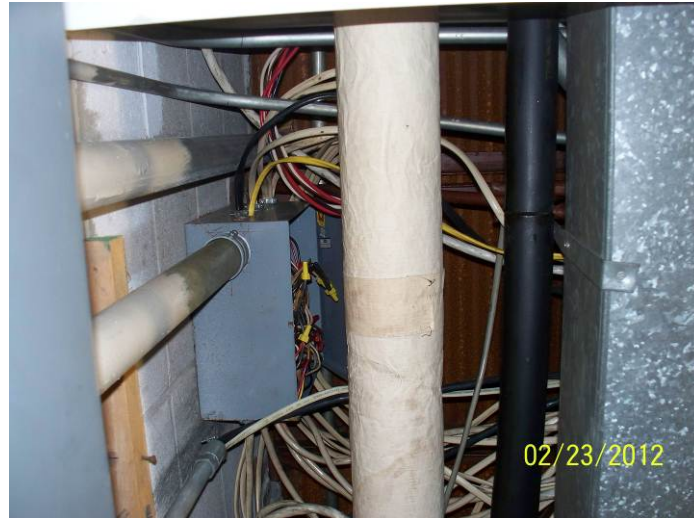
Romex wiring and open junction box.

Additional receptacles are required throughout the school to provide service where needed. In many locations this has been done, but, it appears (from the use of cords/power strips) there are many more areas that need additional receptacles. Exterior receptacle outlets should be added as needed to provide service for maintenance purposes. Also, it was noted that Romex has been used throughout this facility; current codes do not allow the use of this wiring method in this type of construction. If wiring is added to this school in the future, it should be done with an approved non-combustible material type. Also, the NEC requires the removal of all discontinued wiring. And as wiring/circuits are revised and no longer needed they should be removed completely back to the source.

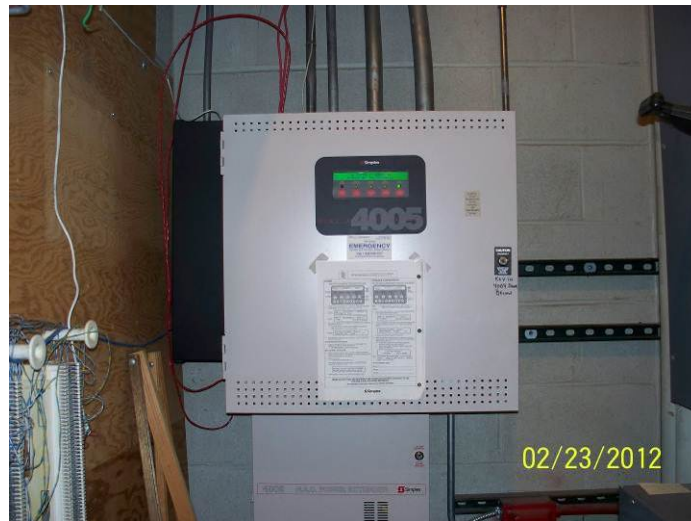
Fire alarm control panel  
In Main Electric room

The fire alarm control panel appears to be in good condition and is still supported by the Manufacturer. This control panel should provide adequate service until the entire system can be upgraded. There many locations throughout the school that are not properly covered by the existing audio/visual appliances. Also, there are many egress doors that do not have a pull station within five feet.

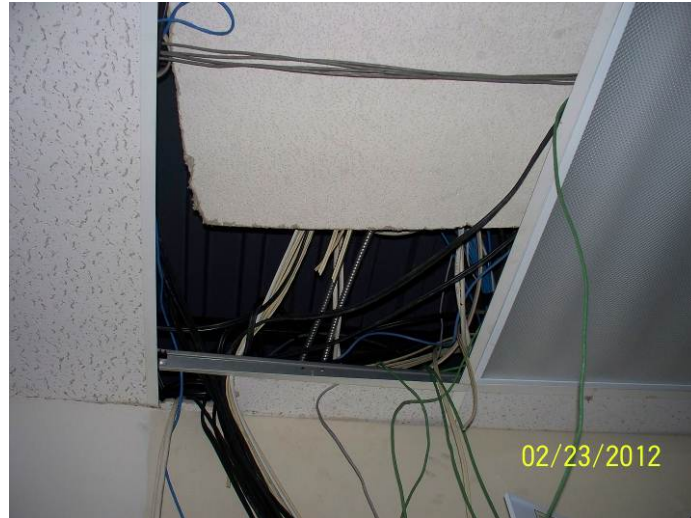
Wiring hazard and 120V wires entwined with data wiring can cause interference.

Wiring passing through ceiling. (line and low voltage running parallel)

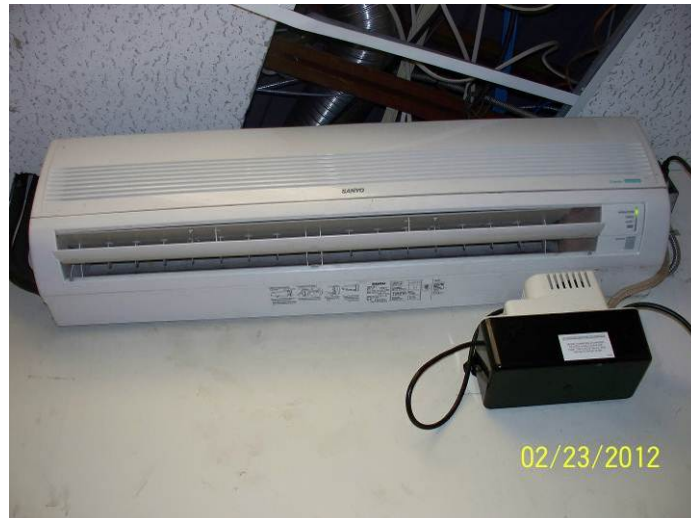
Data Room AC unit.

The existing space being used as a Data/Communications Room is very small and is completely full of equipment, not leaving any space at all for expansion. This room is so congested that proper clearances for working on equipment are not available. The existing phone system appears functional and should provide somewhat reliable service, providing the room does not over heat causing equipment failures. Voice/data infrastructure in the building is a combination of wired and wireless with most cabling being run concealed in the wall and above ceilings. There are some instances where data cables run through ceiling tiles to termination points; these cables are very susceptible to damage. Also, it appears that most spaces are lacking sufficient “drops” for telephone and data when compared to modern schools.

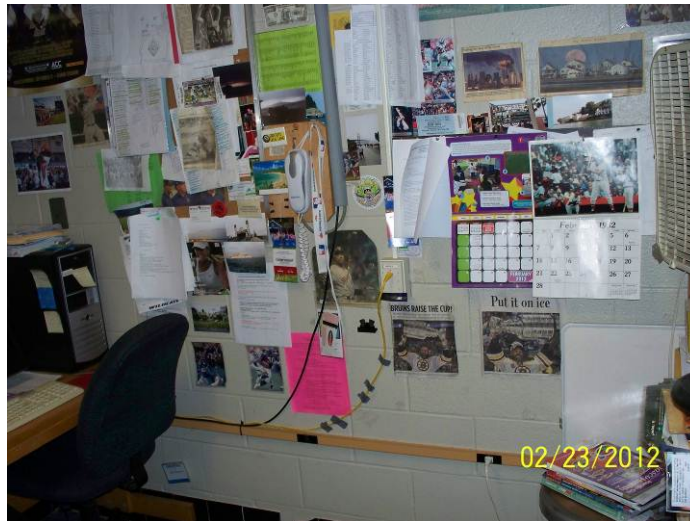
Network wiring parallel to line voltage wiring.

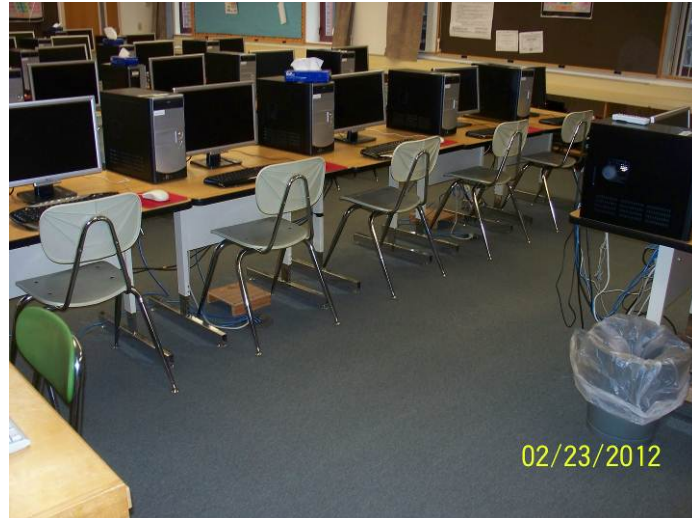
Data wiring through  
floor in Computer Room.

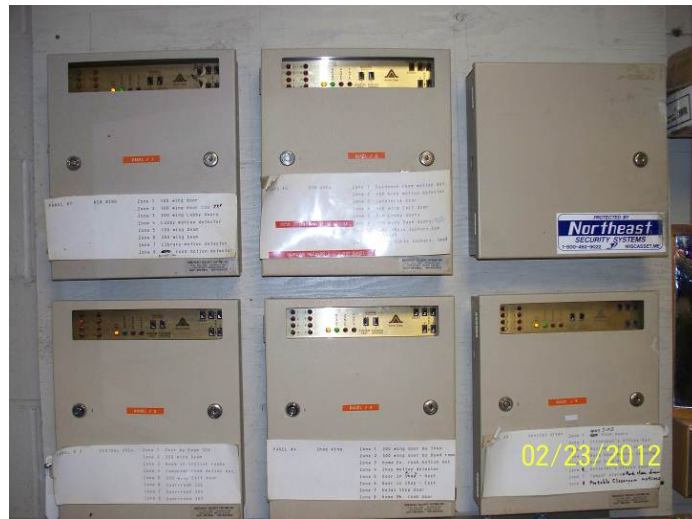
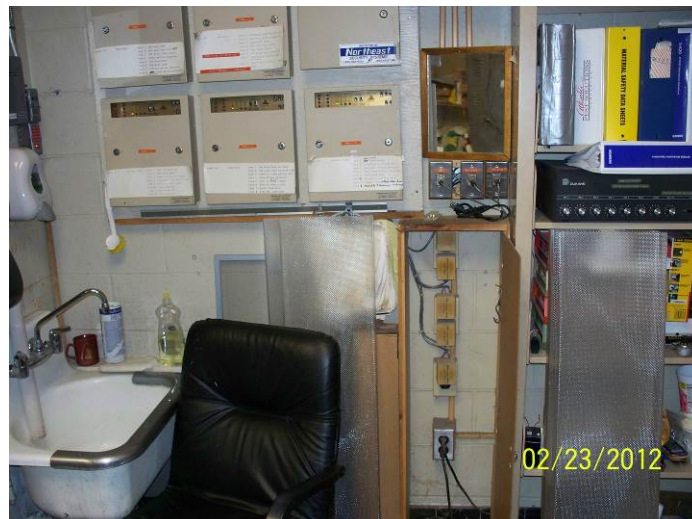
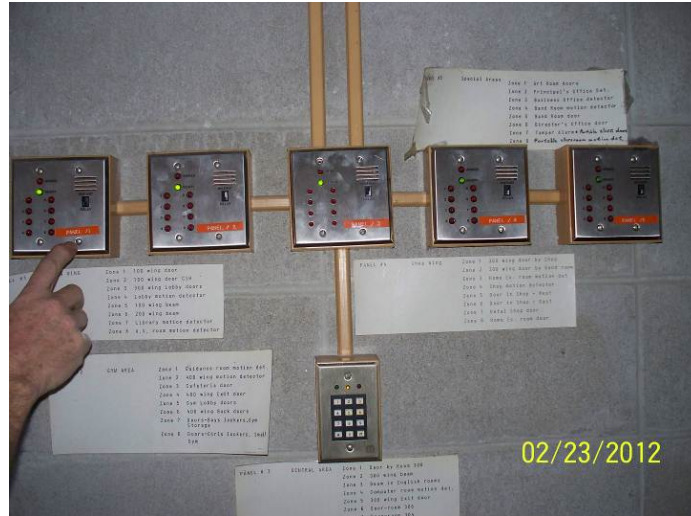
### Security Panels (Custodial Office)

### Security Panels and power supplies

### Remote Annunciators

The existing system is outdated and should be replaced completely with a new system. An access control system with swipe card access should be included if necessary.

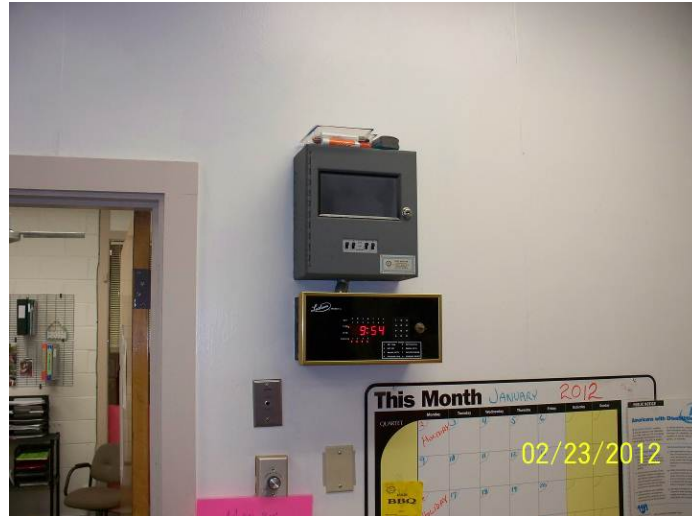
Lathem control panel in  
Main Office

The existing “system” of clocks is not functional.

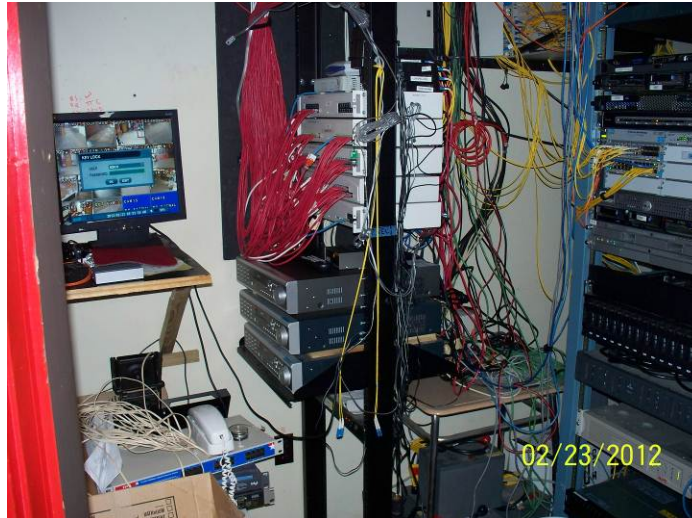
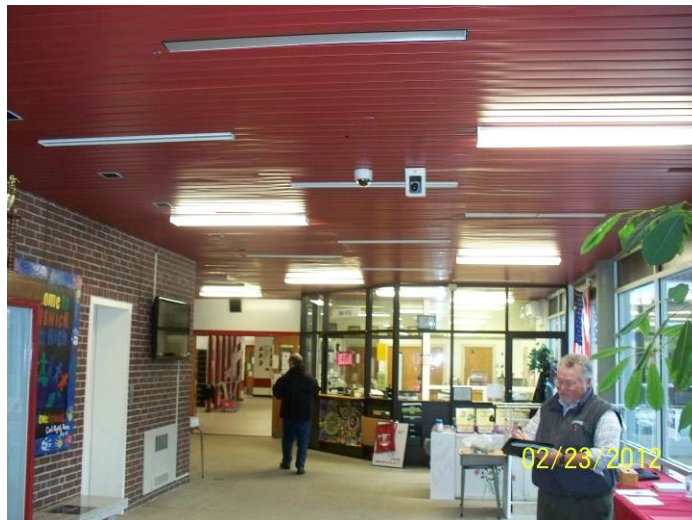
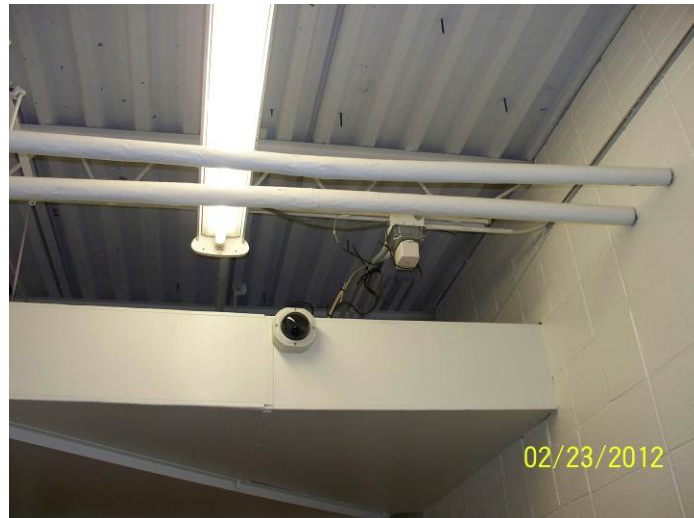
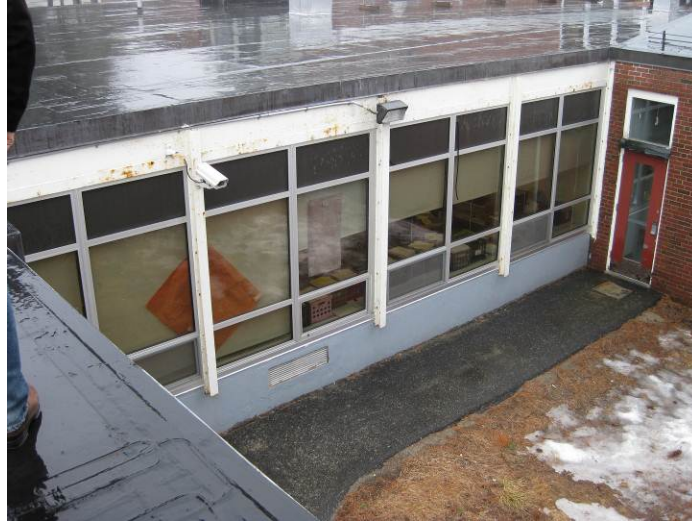
The existing CCTV camera system is quite complete and appears to be very functional. It is located in a room that is very small, and needs more space. Much of the wiring has been strung down the halls and runs through the suspended ceiling system. This creates a potential for damage to the cables and is very insecure.
