## Jordan Acres Elementary School

### Overview

Part of the goal of this analysis is to assist the Brunswick School Department in determining whether Jordan Acres should be reopened or be closed permanently. And if the school is reopened, determine what the grade configuration and student population should be.

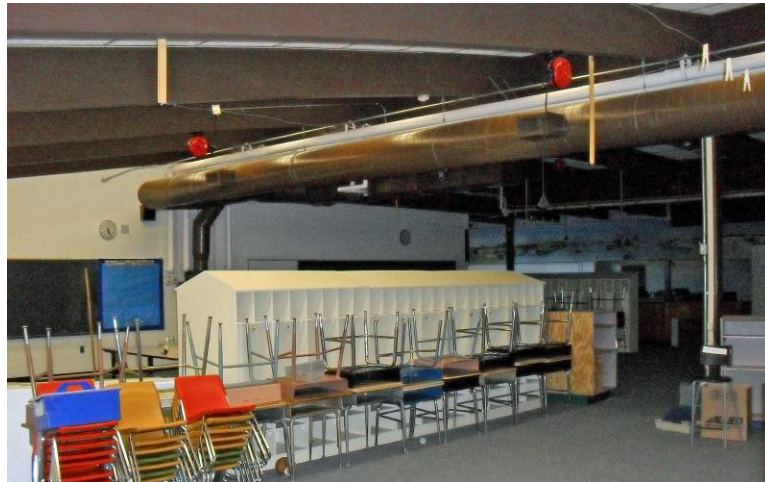
Ceilings in the open areas are exposed wood fiber decking that also serves as the roof deck. Some of the interior office spaces have suspended acoustical tile. Ceilings appear to be in good condition.

Typical Open Classroom Pod

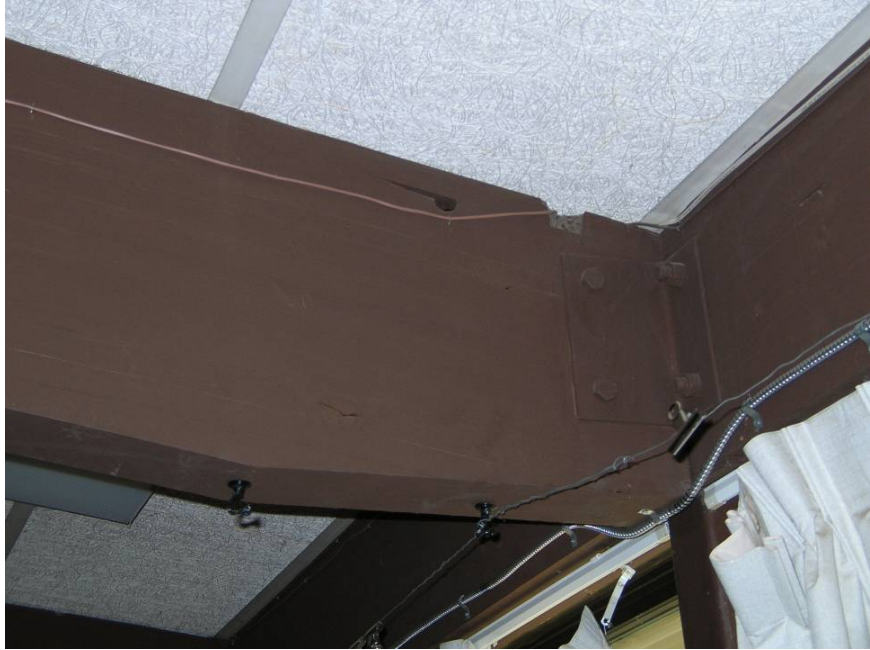
Detail at glulam beam connection

Visual observations were performed and in general the structure appears to be sound, and no obvious deterioration or damage was visible. It is our understanding that one of the glulam purlins was noticeably split at the lower end of the sloped beam. This damaged beam has since been replaced with a similar glulam wood beam.

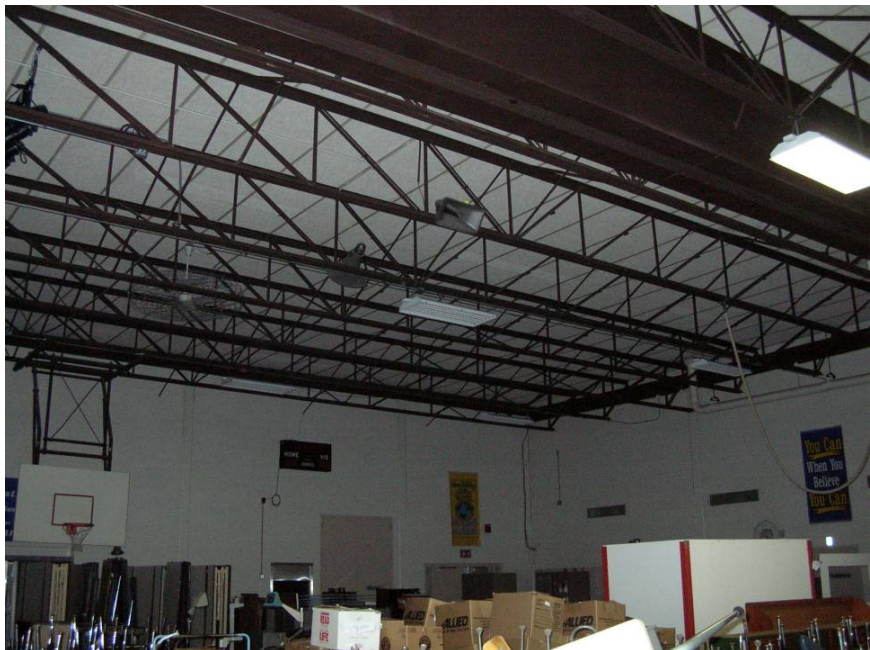
Roof Framing at Gym

The roof framing in the gymnasium consists of the same 2 1/2" Tectum decking and steel bulb tees spanning approximately 6 feet to 40" deep open web steel bar joists. The joists span approximately 67 feet and bear on steel wide flange beams and steel tube columns at the perimeter. The gym roof framing is higher than the surrounding wood roofs.

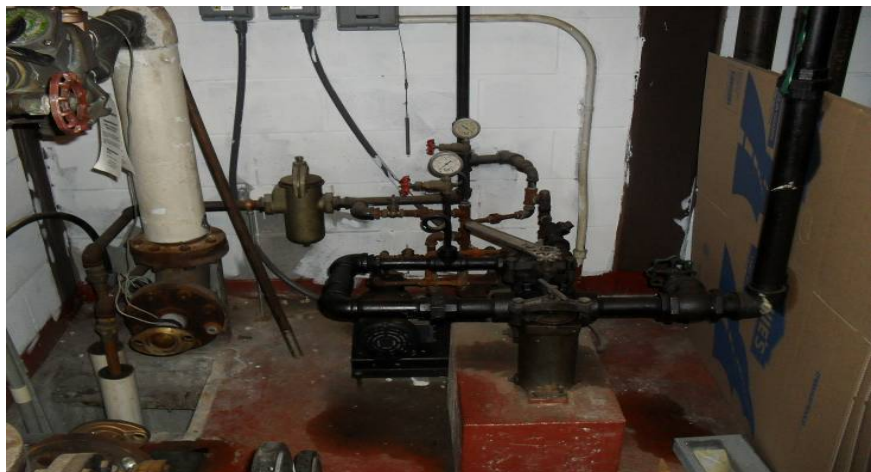
Figure 3 – Oil Transfer Pump Set

There is one existing steel underground fuel storage tank with an interstitial monitoring system in the tank and one in-ground monitoring well located just outside the boiler room. Underground suction and return piping runs from the tank into a pit in the corner of the boiler room. The oil piping connects to a duplex fuel oil transfer pump set located in the boiler room which brings the oil in from the tanks and circulates it through a pressurized distribution loop. The burner pulls oil off the distribution loop at a quantity matching the burners firing rate.

Because the existing cast iron boiler and oil burner is almost 40 years old and clearly showing its age, we would recommend replacing the boiler with a high-efficiency boiler capable of dealing well with low return water temperatures. The removal of this boiler would include all connecting HWS & R piping, induced draft fan, breeching, five horizontal expansion tanks, and oil piping. This replacement type of boiler design would allow us to save significant energy on typical standby losses normally associated with “hot” boilers. New breechings, engineered combustion air system, insulated HWS & R piping, oil piping, expansion tanks and controls would also be included in this installation.

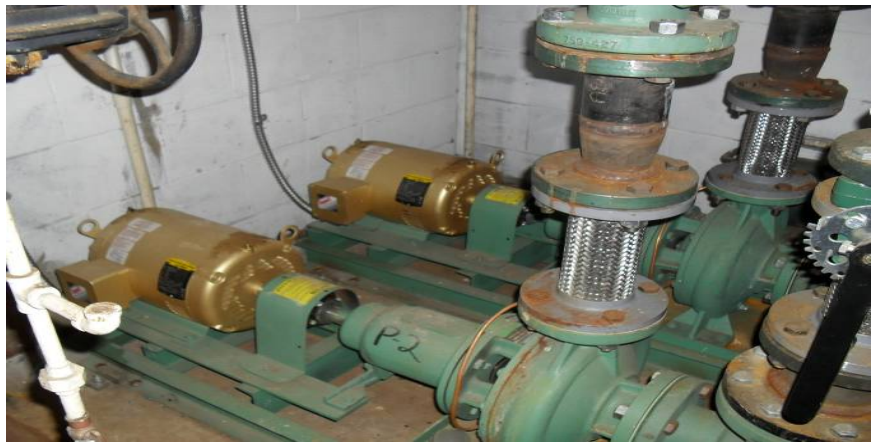
Figure 4 – Base mounted pumps

The original hydronic heating loops consisted of a hot water supply and return loop and a hot water/glycol supply and return piping loop. Several years ago, the glycol loop and all of its accessorized components were essentially taken out of the system and abandoned in place. In 2007, a new set of Taco base mounted pumps were installed to handle the primary heating hot water supply and return for the entire facility. The pumps are rated for 226 gpm @ 65 ft of head. Each of these pumps is provided with individual variable speed drives. The VFD's are controlled by differential pressure sensors located in the piping distribution system.

Remove existing abandoned glycol heat exchanger, its pumps, associated piping and accessories. The base mounted Taco pumps along with their associated VFD’s that were installed in 2007 are still in excellent condition and should be reused.

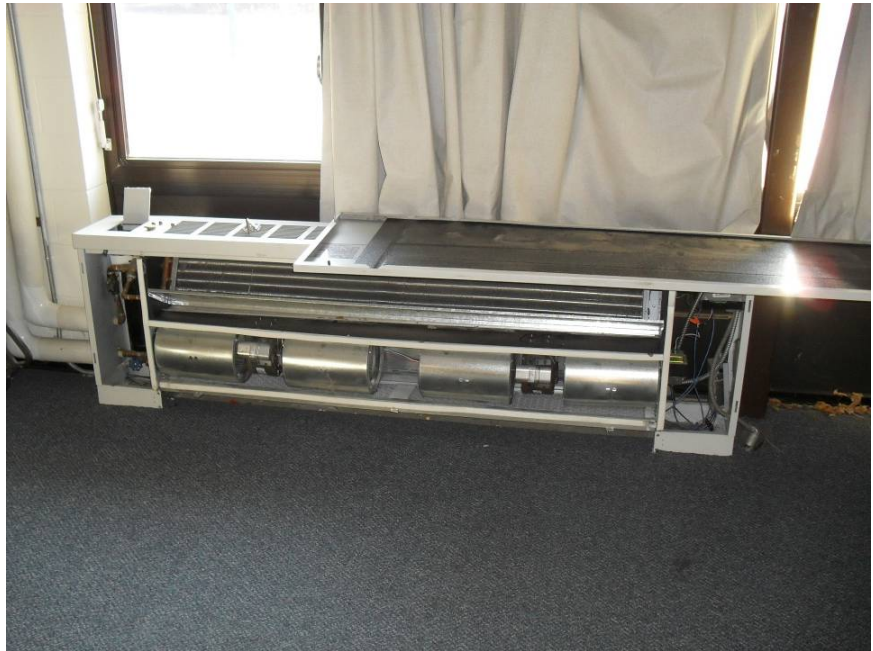
Figure 6 – New unit ventilator in classroom - typical

The primary heating and ventilating in each of the classrooms in the existing facility was originally handled by dedicated unit ventilators. The original unit ventilators were removed a couple years ago and replaced with new MagicAire unit ventilators. These replacement unit ventilators are not connected to outdoor louvers as the existing louvers were blanked off at the time of replacement. At the approximate time of the unit ventilator removal/replacement, new roof mounted energy recovery ventilators were installed. There is a significant amount of supply and return duct work located

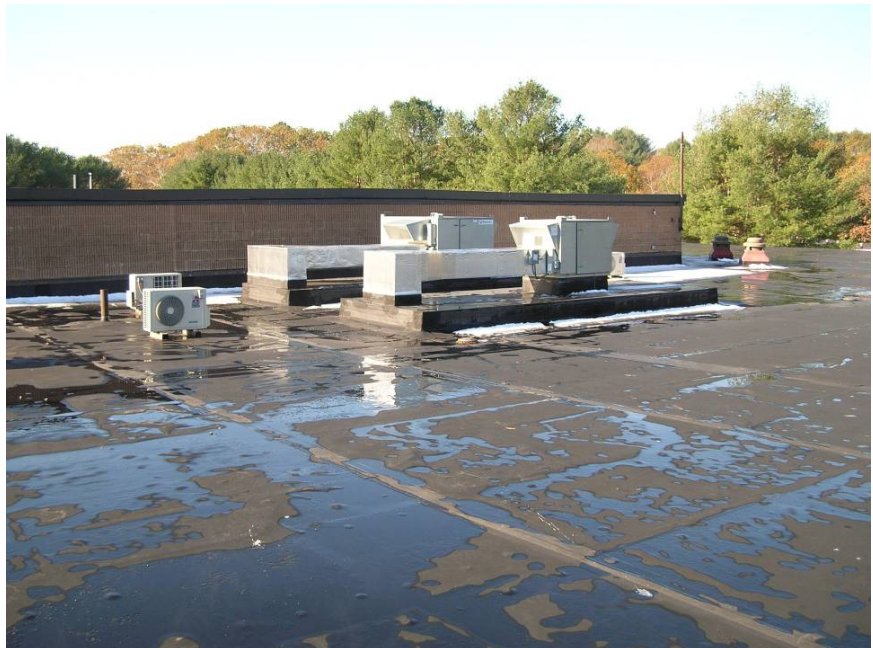
Figure 7 – Typical new Energy Recovery ventilators

on the roof. The ductwork for these several units drops through the roof and runs exposed in the open classroom spaces. Hot water heating coils are interior duct mounted for each of these units. This duct is not insulated.

Ventilation system	The existing rooftop energy recovery ventilators that were installed several years ago are still in good condition. However, because each of these units largely serve open areas with exposed, un-insulated duct work and single dedicated hot water heating coils, the duct distribution system would need to be removed and re-distributed according to new space layouts. Quite a few new duct mounted hot water heating coils would also need to be provided. The coil placement and number of coils would be determined by any new layout of the spaces.
Heating terminal units	We would recommend removing the replacement unit ventilators that were installed a few years ago and replacing them with hot water baseboard radiation in active lengths that are appropriate for any new classroom layout.
Sprinkler	If the building is to be renovated and reused, we would recommend providing sprinklers throughout the entire facility.

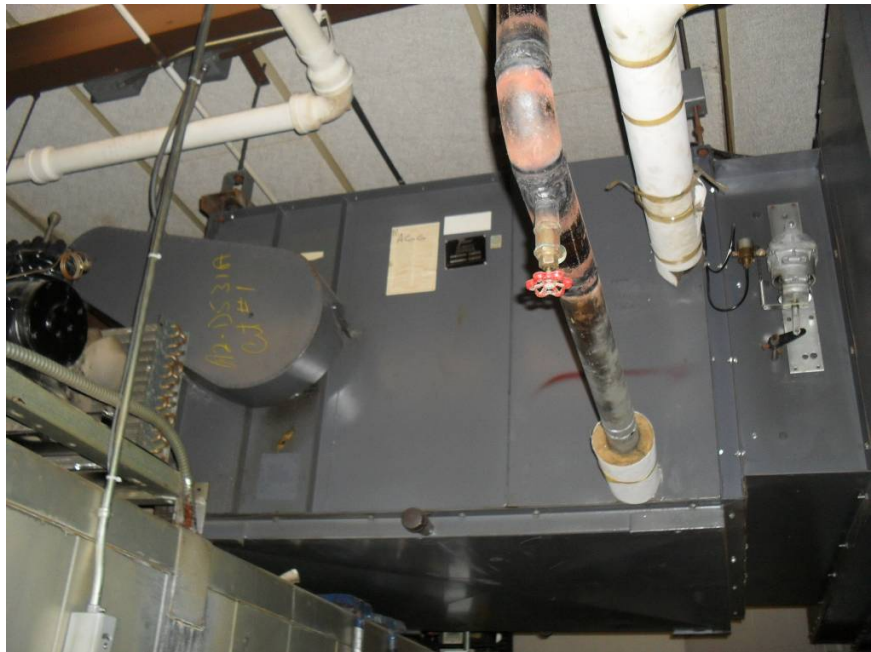
Figure 8 –  
Gym/Multipurpose  
AHU

The Gym/Multipurpose area is served by a single Trane climate changer air handling unit that is ducted to several wall-mounted supply air grilles. This AHU has a hot water heating coil integral to the unit and is pneumatically controlled. Only one of the hot water lines feeding the unit is fully insulated. The other line is partially insulated.

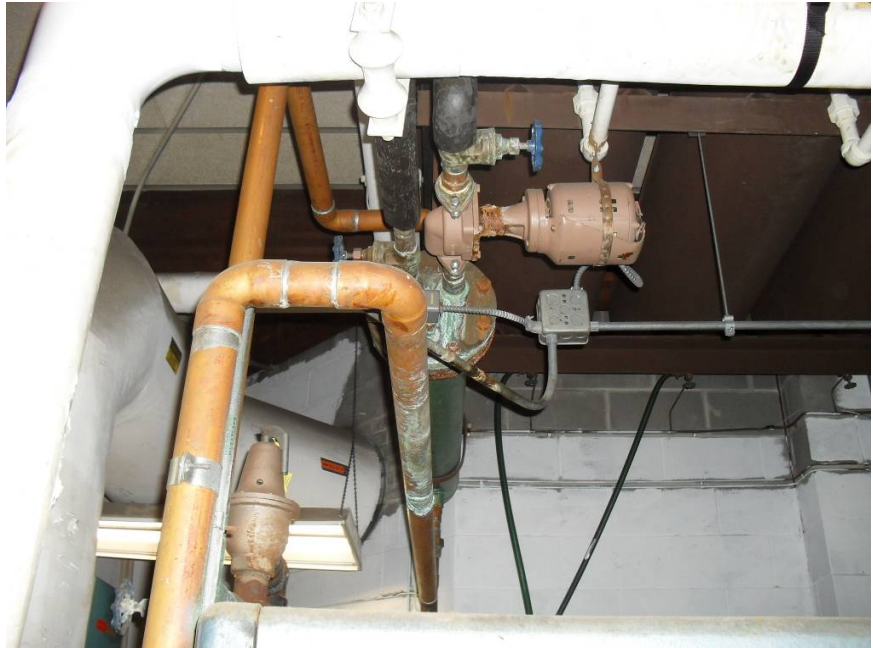
Figure 9 - DHW shell &amp; tube heat exchanger

The domestic hot water is provided by the main heating boiler. A shell and tube heat exchanger located on top of the boiler is sized to handle only a portion of the DHW load within the school. A Patterson-Kelley 72 kW electric water heater located adjacent to the Kitchen storage area handles the remaining DHW load. Although the name plate data on the heater shows it as being installed when the school was first constructed, it appears to be newer than approximately 40 years old.

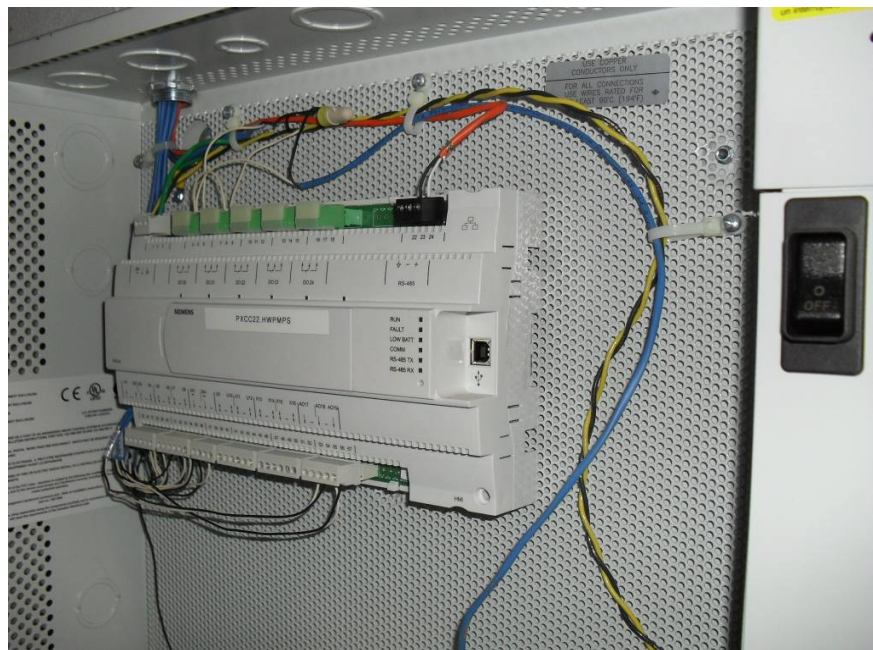
Figure 12 - DDC Controller

The temperature controls in the facility are primarily pneumatic with a bit of updated DDC control as well. It has been reported that this system has not provided consistent temperature control throughout the facility. Some areas are quite warm while others can be quite cool.

The existing pneumatic control system in the facility is also clearly showing its age. Although a pneumatic control system was virtually the only viable control option available when the school was originally designed and constructed, these systems have proven over time to be quite inefficient and difficult to control and maintain. We recommend removing the complete pneumatic control system which includes all controllers, air compressor, dryers, tubing, actuators, sensors and all other associated accessories. A new direct digital control (DDC) will be provided for the entire facility. This control system would be provided by Siemens and would be tied back into the main head end in the Facility Directors office.

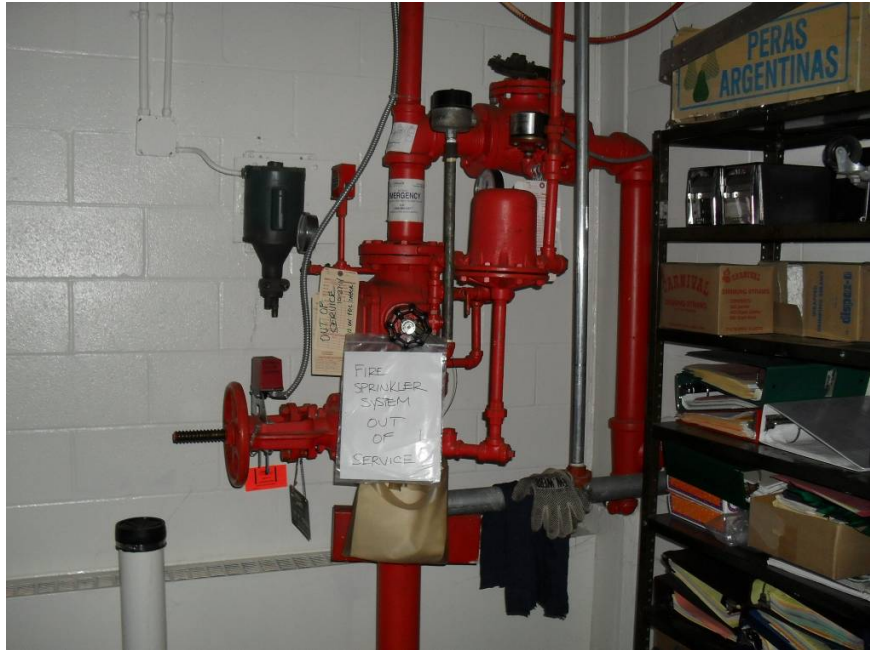
Figure 13

The sprinkler system enters the building in the storage area adjacent to the kitchen. The line size coming in is 4". Based on conversations with staff, the only area that is served by this sprinkler system is the kitchen area. No other sprinkler heads were observed throughout the building.

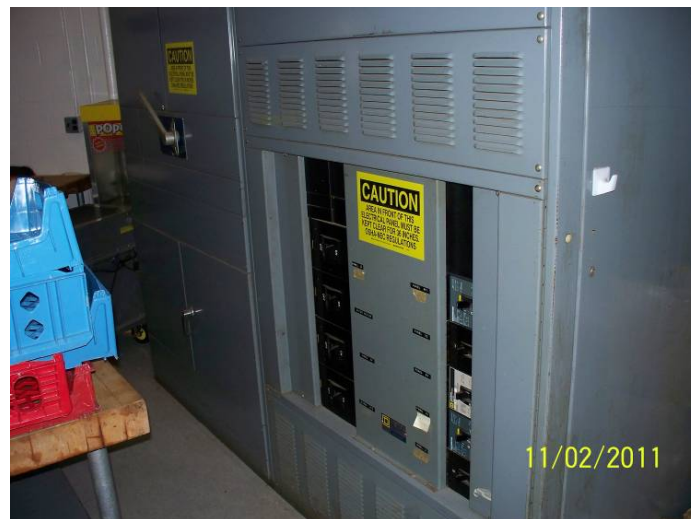
Distribution Section

The main switch and adjacent I-Line distribution section, both rated at 1600A, appear to be “original” equipment (1972 - 40 years), but are in good serviceable condition. The distribution section has a variety of breaker sizes serving the existing sub-panels and some limited space for future breakers.

Although approximately forty years old, the service equipment is operational and appears to be in serviceable condition, and space is available for new breakers that could feed additional sub-panels. The capacity of the existing service is approximately 460kW (1600 x .80 x 360). This should be of sufficient size to accommodate any loads that might be added to a building of this size (40K sf +/-). The existing sub-panels are relatively new and in very good condition, most having a full complement of circuit breakers. With the school being closed and many loads “turned-off” it is difficult to determine how many spare breakers there are in each sub-panel. It was noted that some panels have spare breakers and many spaces for additional breakers.

The existing service entrance equipment should be inspected and tested by Square D service technicians to verify condition and proper operation. A shut-down of the service is required for this procedure. This inspection/test costs between \$3,000 and \$5,000. Parts found to be damaged or non-functional are charged separately in addition to the testing fee.

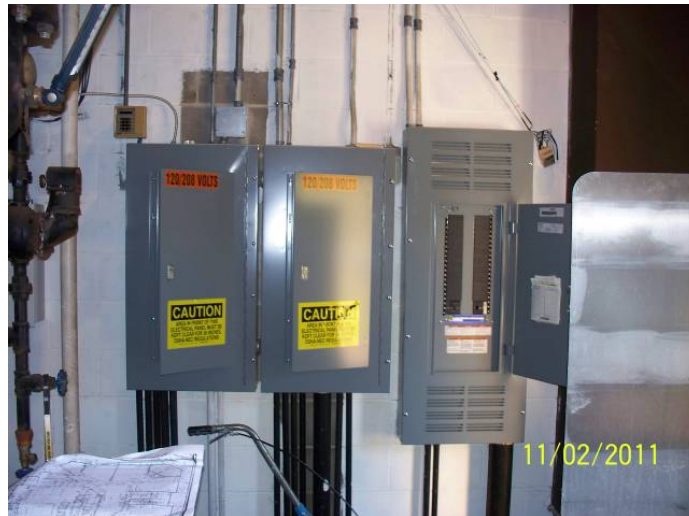
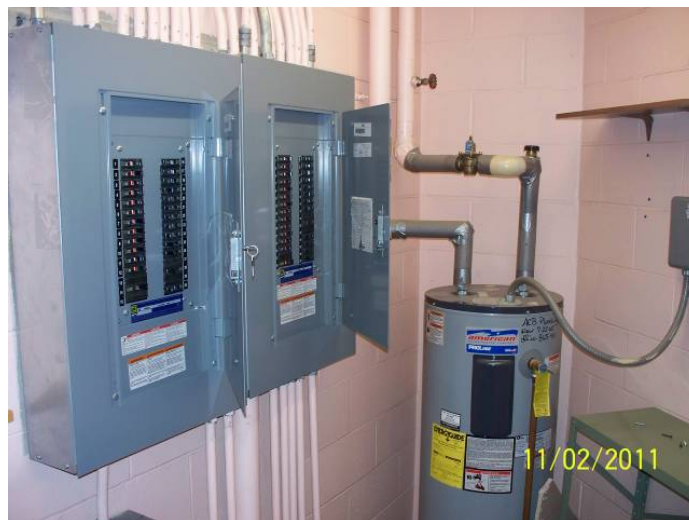
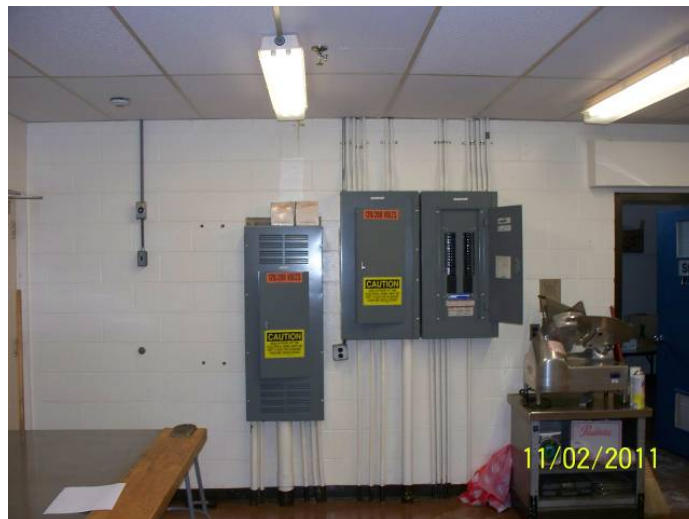
Typical Sub-Panels:  
Boiler Room

Sub-panels are evenly distributed throughout the school in a manner that limits the lengths of branch circuits to acceptable distances. All sub-panels appear relatively new and in very good condition.

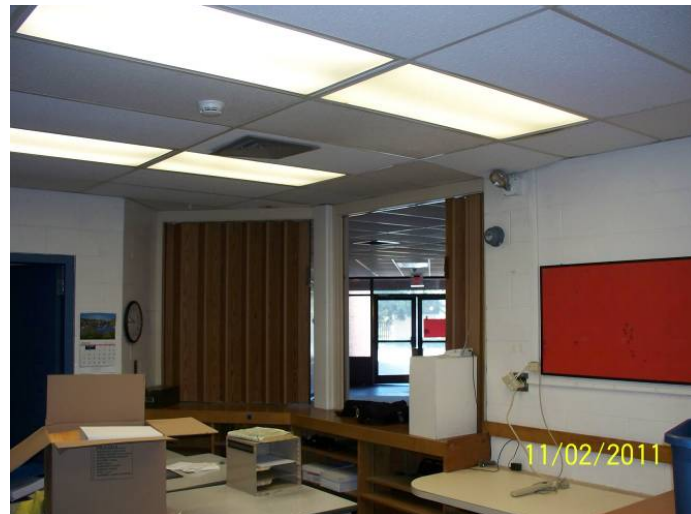
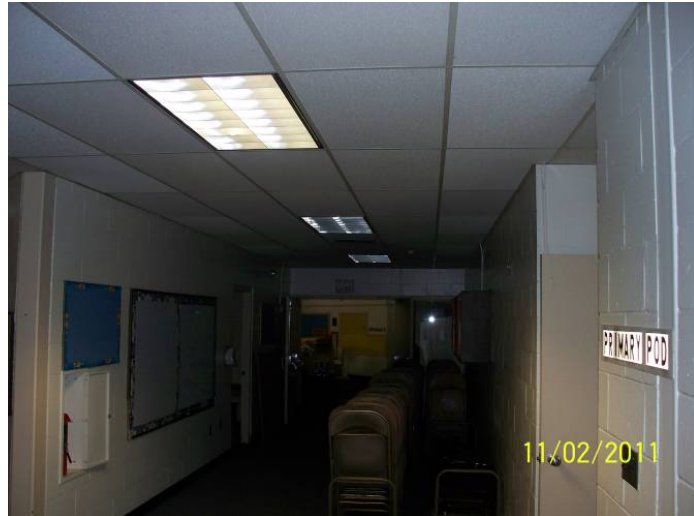
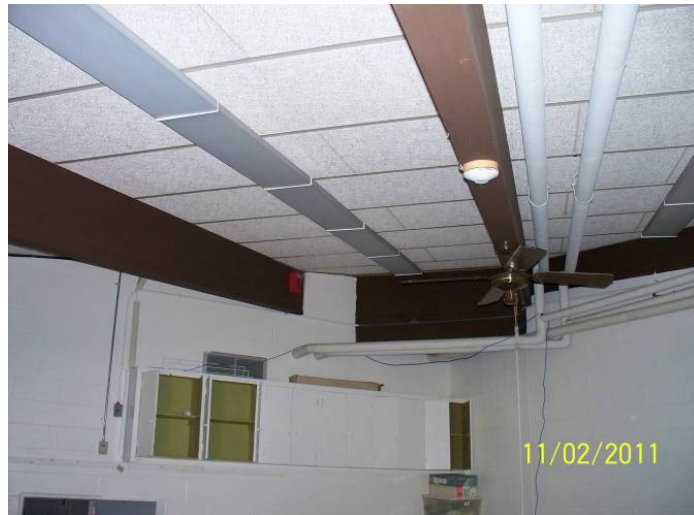
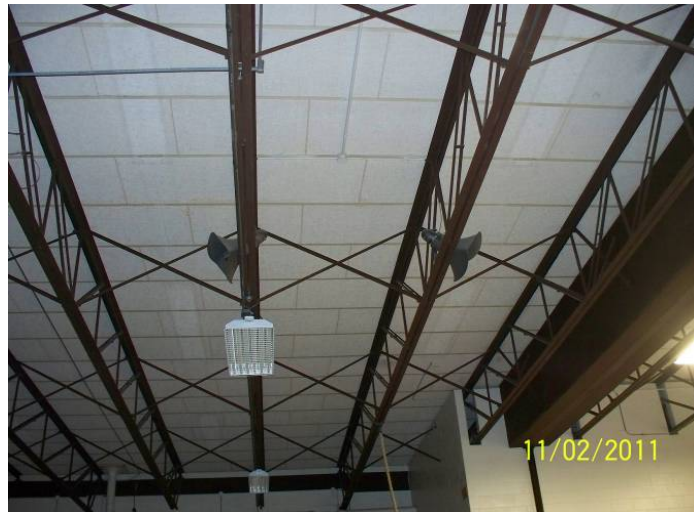
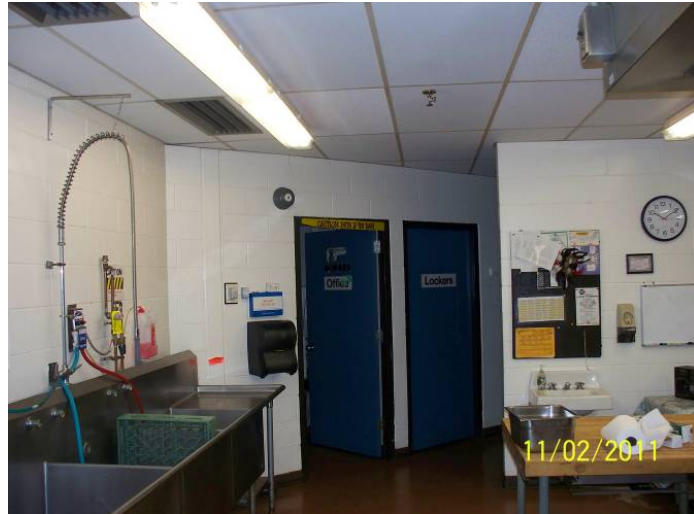
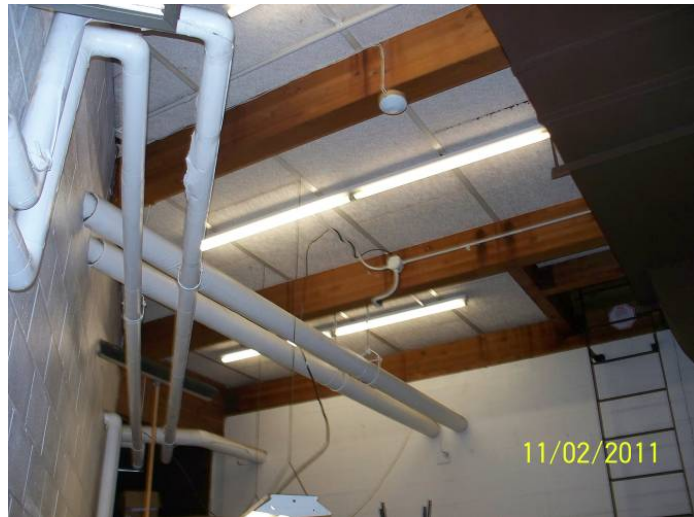
#### Typical Lighting Fixtures

The Jordan Acres Elementary School is served by a variety of lighting fixtures (lens troffers, parabolic troffers, surface wraps, vapor-tight, bare strips, high-bay T8, bare strips), the majority are fluorescent and have recently been upgraded to T8 lamps and electronic ballasts. No automatic controls for interior lighting fixtures were observed.

Although the existing lighting fixtures are in relatively good condition and have recently been upgraded, there are no automatic controls and lighting densities in some areas are extremely high. Some areas appear to be twice what the current energy code allows.

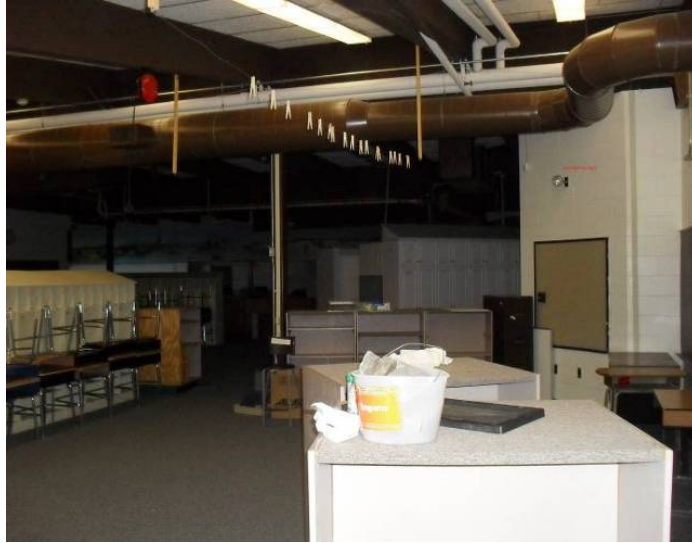
## Typical Emergency Light

Exit signs appear to have been upgraded with LED retro-fit kits but are not very evenly illuminated and some are in poor condition. This may be of concern to the local code officials. Also, some signs are not internally illuminated and do not have an emergency lighting fixture nearby to illuminate in case of a power outage. It is a code requirement that all non-internally illuminated signs be illuminated with emergency lighting during a power outage. No record of testing of the emergency units was observed. It is very possible that the emergency battery units will not function properly if a strict testing and maintenance policy is not being followed. Also, emergency lighting fixtures are spaced such that they will not provide an average of 1 fc throughout all paths of egress.

All battery units should be tested to verify proper operation. Internally illuminated exit signs should be added at all required egress doors and units that are in poor condition should be replaced. Emergency lighting units should be added so that all paths of egress are properly illuminated.

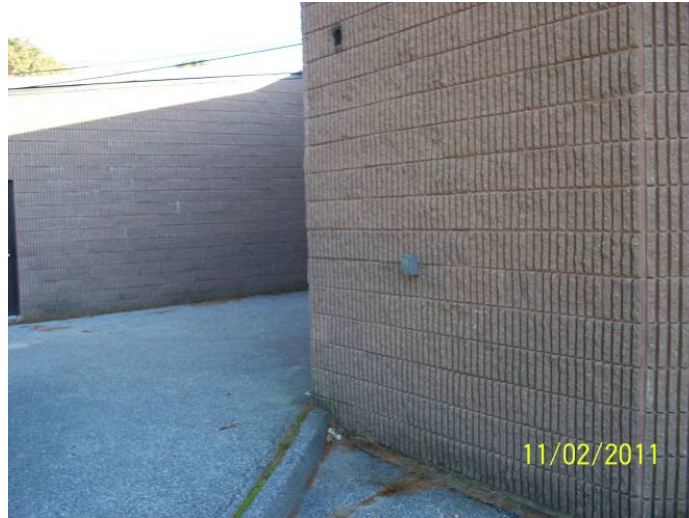
**Jordan Acres Elementary School****Exterior Outlet**

There are wall mounted grounded receptacles located throughout the school. In the “Open Concept” areas there are outlets on retractable cord reels mounted at the ceiling. These create an unsafe condition in an educational setting. Only one exterior outlet was observed in the site survey.

It appears that the Main Office could use additional receptacles to serve counter mounted equipment and other general uses. The “Open Concept” classroom areas will need additional receptacles if those spaces are reconfigured. Additional exterior receptacles may be needed to assist in maintenance functions.

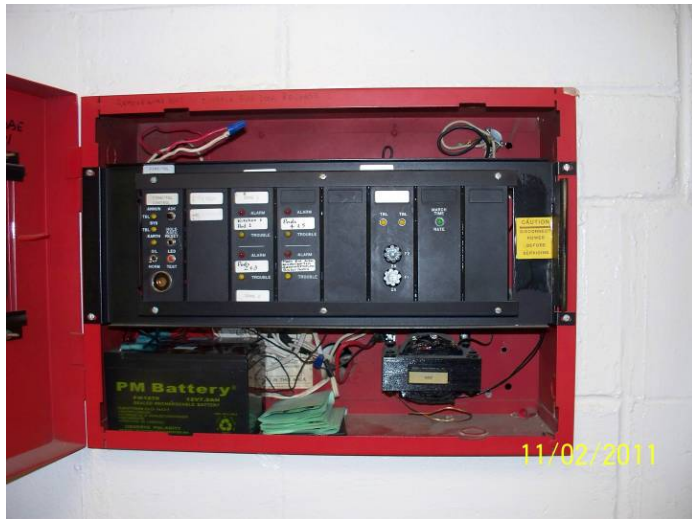
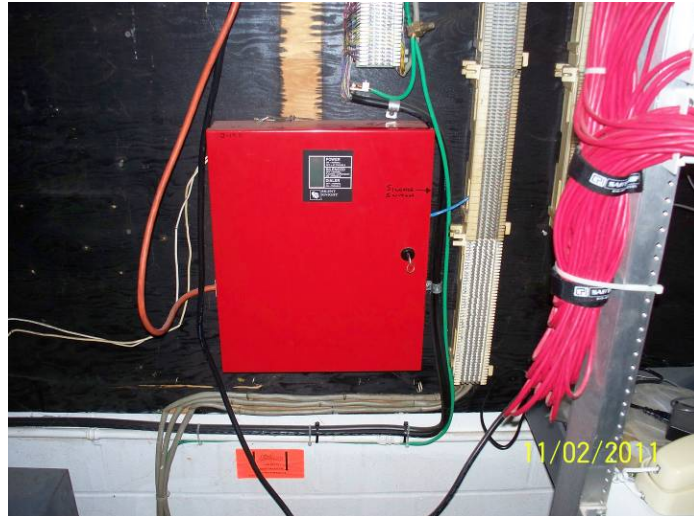
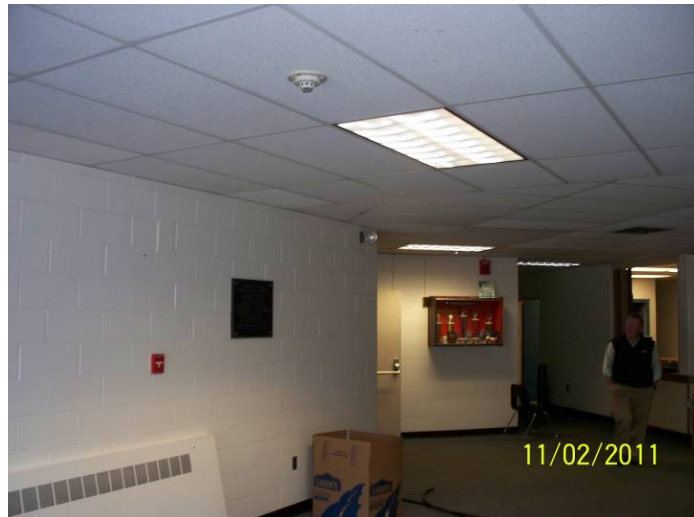
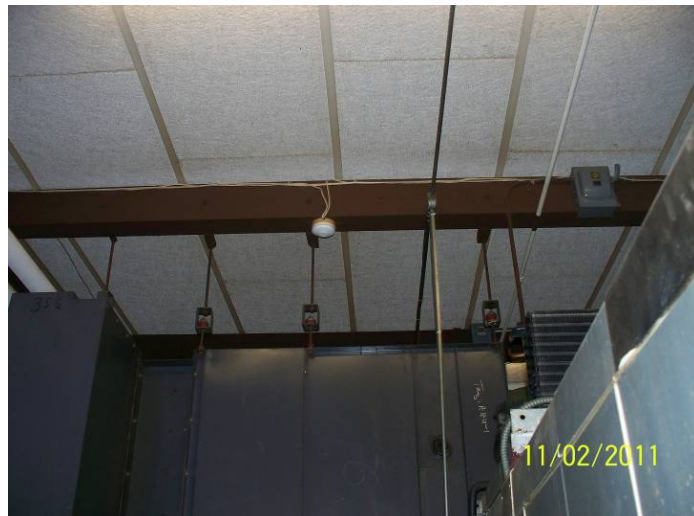
The fire alarm control panel is a Simplex 2001 and is located in the Main Office, it appears to be original equipment (1972 – 40 years). This system communicates with Seacoast Security using a Silent Knight dialer (located near the Electrical Service Entrance). If/when an alarm condition is reported Seacoast contacts the Brunswick Fire Department. There are smoke detectors throughout the corridors and spaces that are open to corridors. Heat detectors are installed in private offices and other storage type spaces. There are pull stations located at all egress doors. Audio/visual devices are located throughout the school.

The fire alarm control panel is now obsolete and is no longer supported by the manufacturer. Although, additional audio/visual devices have been added since the school was built there are some locations that are not properly covered. This system is beyond its life expectancy and should be replaced.

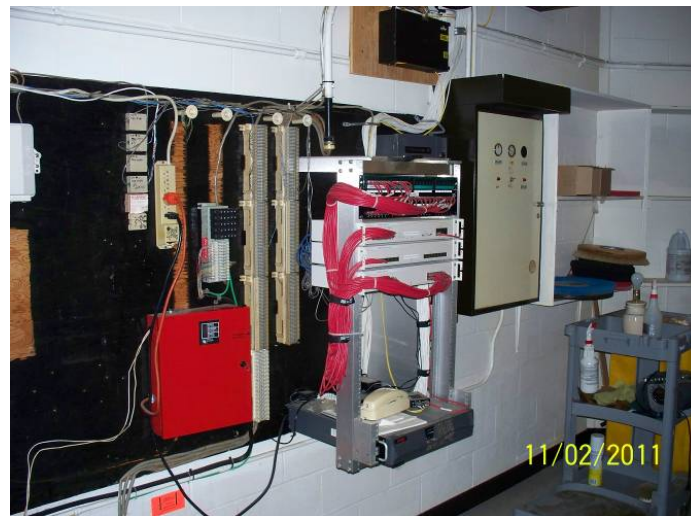
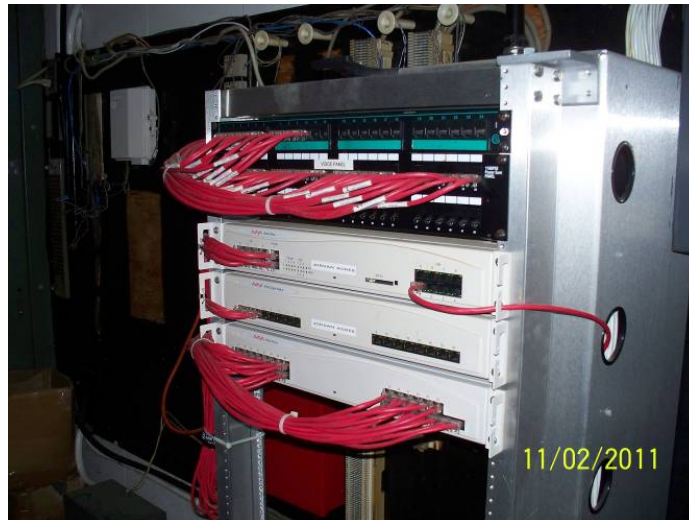
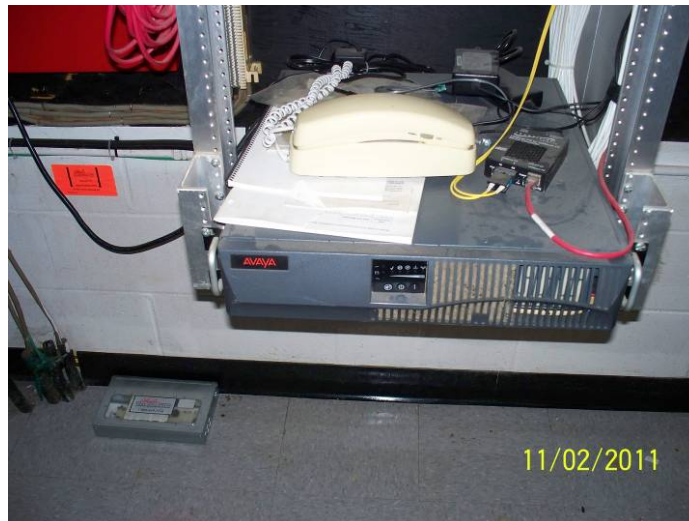
The phone system is by Avaya and is wall rack mounted adjacent to the electrical service entrance and appears to be “relatively” new and functional. Also, at this location was noted the school network fiber connection to the internet. Tel/data outlets throughout the school appear to have been added as needed. Possibly none were installed when the building was constructed.

The existing phone system appears relatively new and functional, however the phone wiring is in worse condition. Most if not all cables are run in surface raceways, with many not extended completely to the point of use. Data cabling has been run through the “Open Concept” space in drain waste and vent pipe. This is not a proper use for this “piping system”. Conduit rated for electrical cables should be used. Also, it appears that most spaces are lacking sufficient “drops” for telephone and data when compared to modern schools.

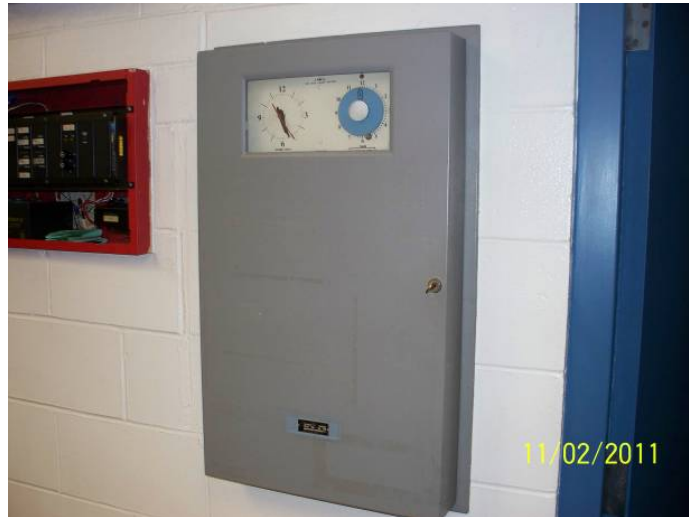
Clock control panel in  
Main Office

An Electric Time Co. model #F2004 clock system is located in the main office. All of the following pictures were taken within one hour of each other. Some of these clocks are not keeping time.

The existing system should be removed and replaced with a new system if it is deemed necessary to have a central clock system in the building.

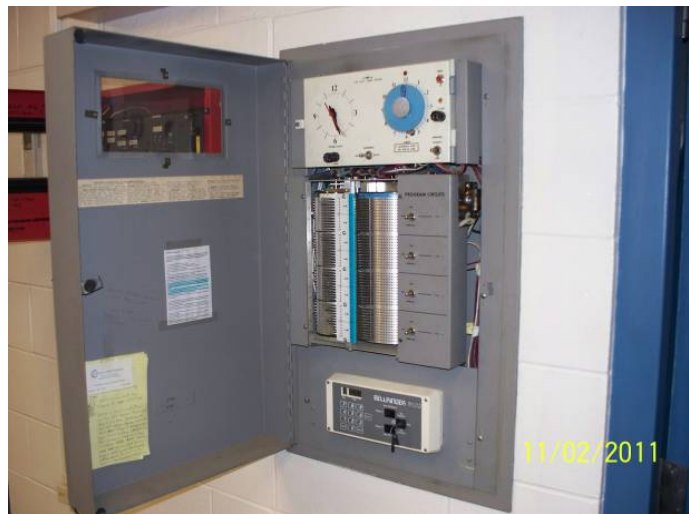
10:10 – May be correct

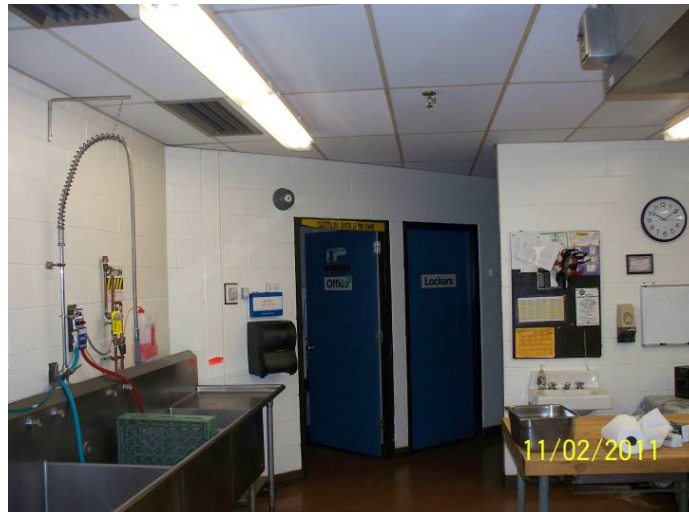
4:40 – Not working

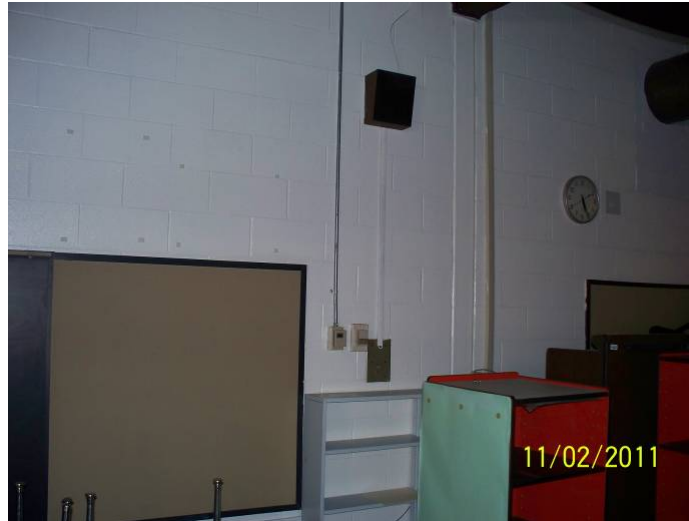
Typical classroom  
speaker

The existing Dukane Intercom system is beyond its useful life and much of the surface wiring to the speakers is susceptible to damage. Dukane no longer manufactures parts for switch-bank type systems, therefore, any repairs requiring parts could lead to lengthy down time. Spare parts come from “old stock” and salvaged parts from old consoles.
